Profile/Photo Observation Report

Street:	N HOBART RD	Flow Control:	Not Controlled
City:	Hobart, IN	Year Renewed:	
Location:	Other	Tape/Media #:	
Purpose:	Not Known	Dia/Height:	10"
Use:	Sanitary	Material:	VCP
Drain Area:	NA	Lining:	
Category:	NA		
Comment:

Location Details:		Direction of Survey:	Upstream
US MH:	M-802-008	DS MH:	M-902-068
		Total Length Surveyed (ft):	28.2

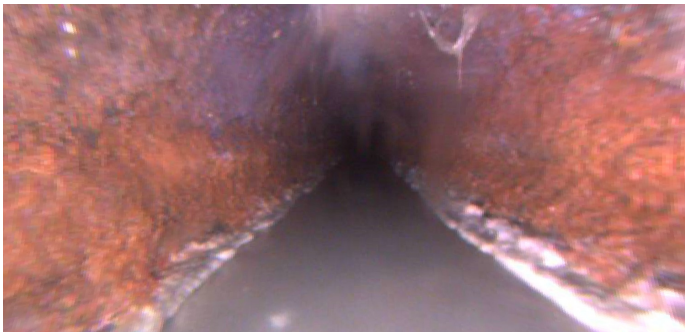
Code:	MWL
Description:	Water Level

Distance (ft):	.0
Structural Grade:	0
O&M Grade:	0
Clock Start/From:	
Clock To:	
1st Value:	
2nd Value:	
Value Percent:	5.000
Continuous Index:	
Within 8" of Joint:	NO
Remarks:

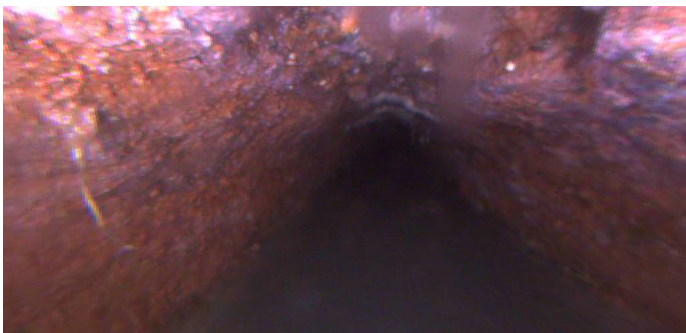
Code: **MSA**
Description: **Abandoned Survey**

Distance (ft): **28.2**
Structural Grade: **0**
O&M Grade: **0**
Clock Start/From:
Clock To:
1st Value:
2nd Value:
Value Percent:
Continuous Index:
Within 8" of Joint: **NO**
Remarks: **DAE**
