Profile/Photo Observation Report

Street:	OFF N HOBART RD	Flow Control:	Not Controlled
City:	Hobart, IN	Year Renewed:	
Location:	Main Highway - Suburban/Rural	Tape/Media #:	
Purpose:	Resurvey	Dia/Height:	10"
Use:	Sanitary	Material:	PVC
Drain Area:	NA	Lining:	
Category:	NA		
Comment:

Location Details:		Direction of Survey:	Upstream
US MH:	M-802-011	DS MH:	M-802-012
		Total Length Surveyed (ft):	73.0

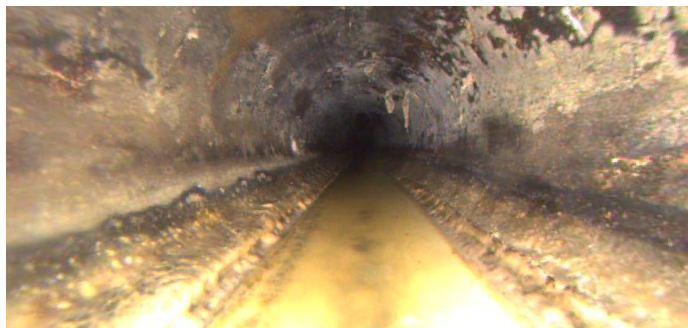
Code: **AMH**
Description: **Manhole**

Distance (ft): **.0**
Structural Grade: **0**
O&M Grade: **0**
Clock Start/From:
Clock To:
1st Value:
2nd Value:
Value Percent:
Continuous Index:
Within 8" of Joint: **NO**
Remarks: **M-802-012**

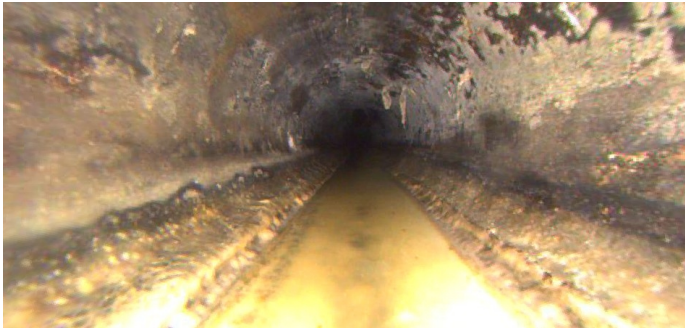
Code:	MWL
Description:	Water Level

Distance (ft):	.0
Structural Grade:	0
O&M Grade:	0
Clock Start/From:	
Clock To:	
1st Value:	
2nd Value:	
Value Percent:	10.000
Continuous Index:	
Within 8" of Joint:	NO
Remarks:

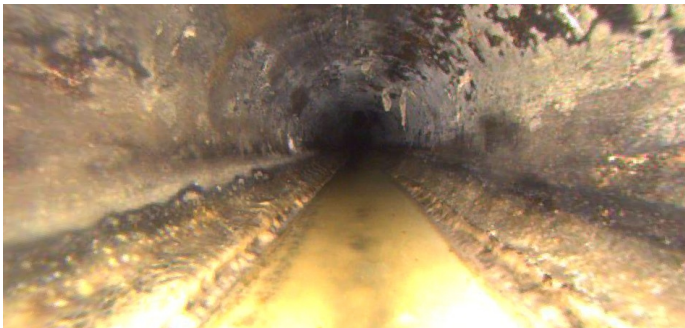
Code:	DAGS
Description:	Deposits Attached Grease

Distance (ft):	.0
Structural Grade:	0
O&M Grade:	2
Clock Start/From:	4
Clock To:	8
1st Value:	
2nd Value:	
Value Percent:	10.000
Continuous Index:	S01
Within 8" of Joint:	NO
Remarks:

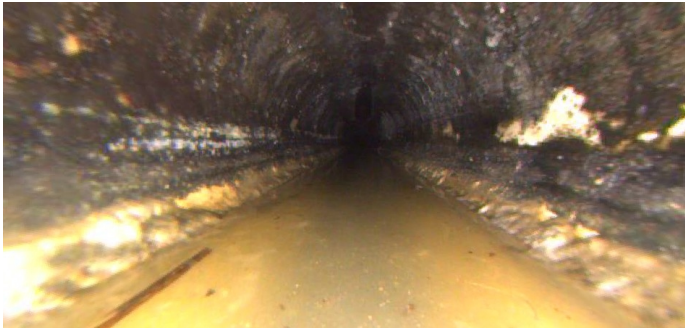
Code: **MWL**
Description: **Water Level**

Distance (ft): **39.8**
Structural Grade: **0**
O&M Grade: **0**
Clock Start/From:
Clock To:
1st Value:
2nd Value:
Value Percent: **25.000**
Continuous Index:
Within 8" of Joint: **NO**
Remarks:

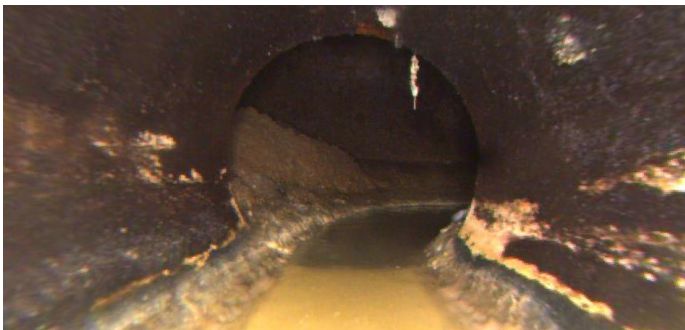
Code: **DAGS**
Description: **Deposits Attached Grease**

Distance (ft): **70.3**
Structural Grade: **0**
O&M Grade: **2**
Clock Start/From: **4**
Clock To: **8**
1st Value:
2nd Value:
Value Percent: **10.000**
Continuous Index: **F01**
Within 8" of Joint: **NO**
Remarks: **Clock positions vary**

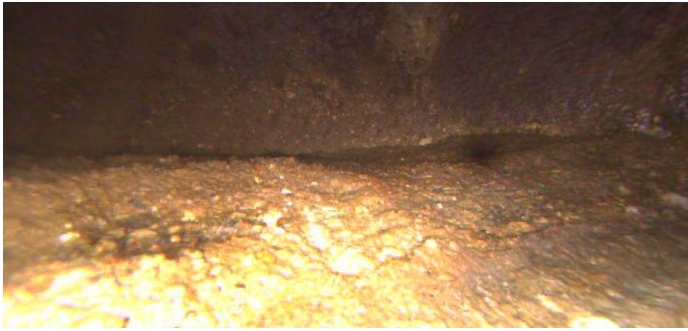
Code:	AMH
Description:	Manhole
Distance (ft):	73.0
Structural Grade:	0
O&M Grade:	0
Clock Start/From:	
Clock To:	
1st Value:	
2nd Value:	
Value Percent:	
Continuous Index:	
Within 8" of Joint:	NO
Remarks:	M-802-011
