Profile/Photo Observation Report

Street:	N Hobart Rd	Flow Control:	Not Controlled
City:	Hobart, IN	Year Renewed:	
Location:	Main Highway - Suburban/Rural	Tape/Media #:	
Purpose:	Resurvey	Dia/Height:	10"
Use:	Sanitary	Material:	PVC
Drain Area:	NA	Lining:	
Category:	NA		
Comment:

Location Details:		Direction of Survey:	Upstream
US MH:	M-802-011	DS MH:	M-802-012
		Total Length Surveyed (ft):	73.0

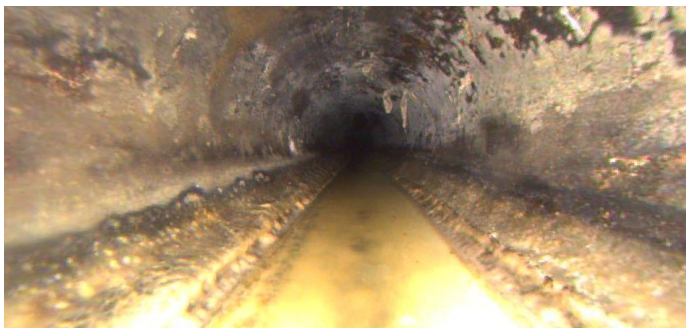
Code: **AMH**
Description: **Manhole**

Distance (ft): **.0**
Structural Grade: **0**
O&M Grade: **0**
Clock Start/From:
Clock To:
1st Value:
2nd Value:
Value Percent:
Continuous Index:
Within 8" of Joint: **NO**
Remarks: **M-802-012**

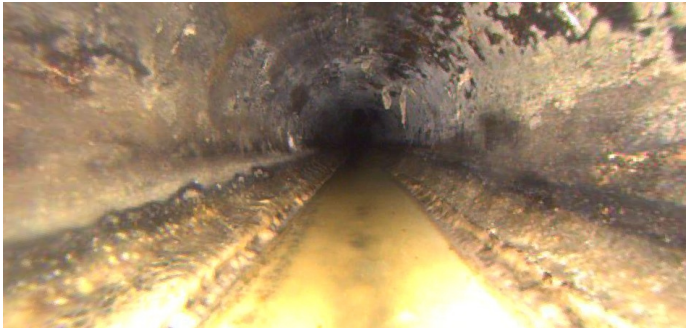
Code:	MWL
Description:	Water Level

Distance (ft):	.0
Structural Grade:	0
O&M Grade:	0
Clock Start/From:	
Clock To:	
1st Value:	
2nd Value:	
Value Percent:	10.000
Continuous Index:	
Within 8" of Joint:	NO
Remarks:

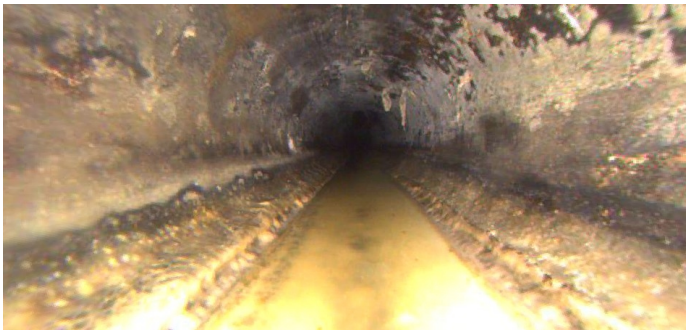
Code:	DAGS
Description:	Deposits Attached Grease

Distance (ft):	.0
Structural Grade:	0
O&M Grade:	2
Clock Start/From:	4
Clock To:	8
1st Value:	
2nd Value:	
Value Percent:	10.000
Continuous Index:	S01
Within 8" of Joint:	NO
Remarks:

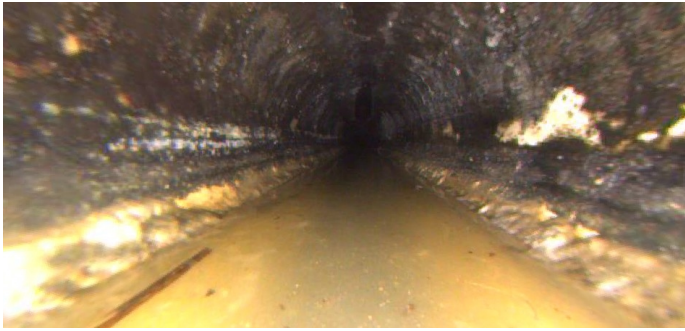
Code: **MWL**
Description: **Water Level**

Distance (ft): **39.8**
Structural Grade: **0**
O&M Grade: **0**
Clock Start/From:
Clock To:
1st Value:
2nd Value:
Value Percent: **25.000**
Continuous Index:
Within 8" of Joint: **NO**
Remarks:

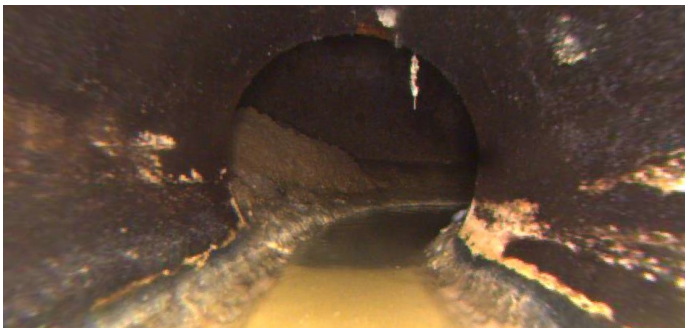
Code: **DAGS**
Description: **Deposits Attached Grease**

Distance (ft): **70.3**
Structural Grade: **0**
O&M Grade: **2**
Clock Start/From: **4**
Clock To: **8**
1st Value:
2nd Value:
Value Percent: **10.000**
Continuous Index: **F01**
Within 8" of Joint: **NO**
Remarks: **Clock positions vary**

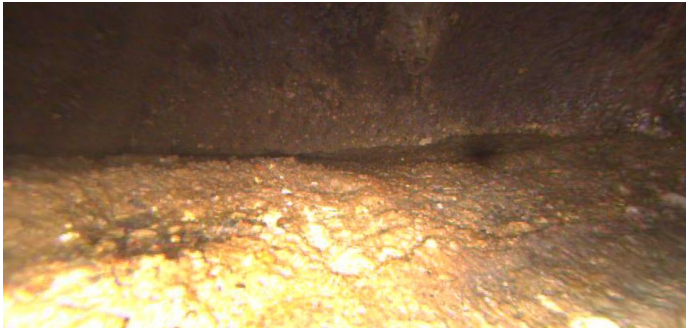
Code:	AMH
Description:	Manhole
Distance (ft):	73.0
Structural Grade:	0
O&M Grade:	0
Clock Start/From:	
Clock To:	
1st Value:	
2nd Value:	
Value Percent:	
Continuous Index:	
Within 8" of Joint:	NO
Remarks:	M-802-011
