## Profile/Photo Observation Report

Street:	<b>N Hobart Rd</b>	Flow Control:	<b>Not Controlled</b>
City:	<b>Hobart, IN</b>	Year Renewed:	
Location:	<b>Main Highway - Suburban/Rural</b>	Tape/Media #:	
Purpose:	<b>Resurvey</b>	Dia/Height:	<b>12"</b>
Use:	<b>Sanitary</b>	Material:	<b>PVC</b>
Drain Area:	<b>NA</b>	Lining:	
Category:	<b>NA</b>		
Comment:

Location Details:		Direction of Survey:	<b>Upstream</b>
US MH:	<b>M-802-011</b>	DS MH:	<b>M-802-020</b>
		Total Length Surveyed (ft):	<b>240.4</b>

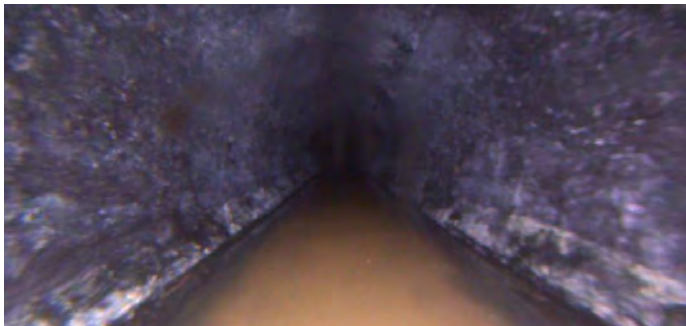
Code: **AMH**  
Description: **Manhole**

Distance (ft): **.0**  
Structural Grade: **0**  
O&M Grade: **0**  
Clock Start/From:  
Clock To:  
1st Value:  
2nd Value:  
Value Percent:  
Continuous Index:  
Within 8" of Joint: **NO**  
Remarks: **M-802-020**

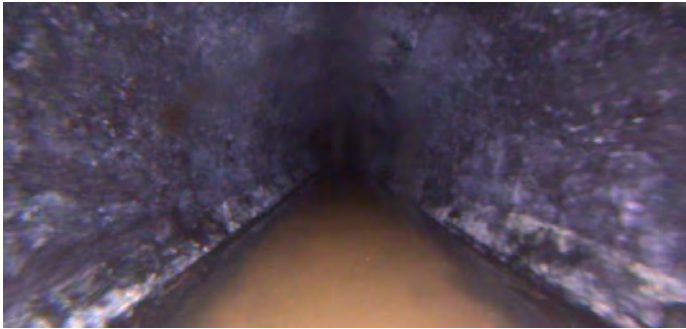
Code:	<b>MWL</b>
Description:	<b>Water Level</b>

Distance (ft):	<b>.0</b>
Structural Grade:	<b>0</b>
O&M Grade:	<b>0</b>
Clock Start/From:	
Clock To:	
1st Value:	
2nd Value:	
Value Percent:	<b>15.000</b>
Continuous Index:	
Within 8" of Joint:	<b>NO</b>
Remarks:

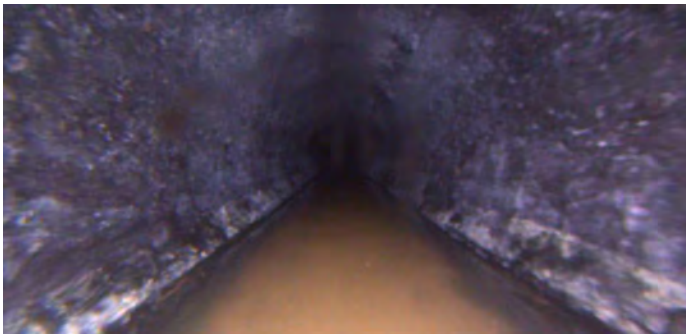
Code:	<b>DAGS</b>
Description:	<b>Deposits Attached Grease</b>

Distance (ft):	<b>.0</b>
Structural Grade:	<b>0</b>
O&M Grade:	<b>2</b>
Clock Start/From:	<b>8</b>
Clock To:	<b>4</b>
1st Value:	
2nd Value:	
Value Percent:	<b>5.000</b>
Continuous Index:	<b>S01</b>
Within 8" of Joint:	<b>NO</b>
Remarks:

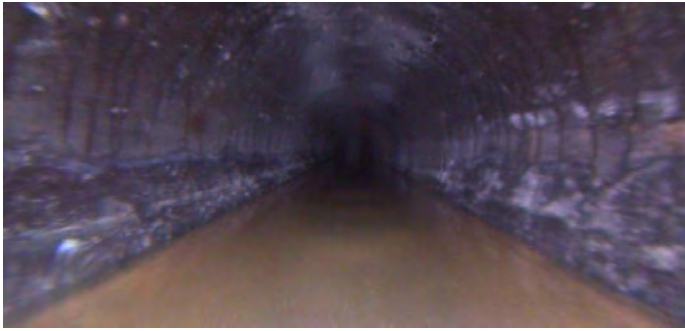
Code: **MWL**  
Description: **Water Level**

Distance (ft): **21.1**  
Structural Grade: **0**  
O&M Grade: **0**  
Clock Start/From:  
Clock To:  
1st Value:  
2nd Value:  
Value Percent: **25.000**  
Continuous Index:  
Within 8" of Joint: **NO**  
Remarks:

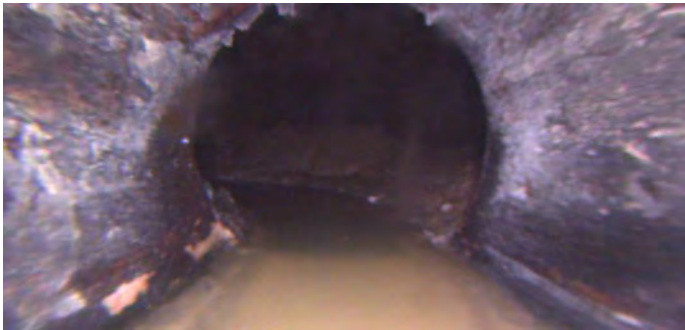
Code: **DAGS**  
Description: **Deposits Attached Grease**

Distance (ft): **238.9**  
Structural Grade: **0**  
O&M Grade: **2**  
Clock Start/From: **8**  
Clock To: **4**  
1st Value:  
2nd Value:  
Value Percent: **5.000**  
Continuous Index: **F01**  
Within 8" of Joint: **NO**  
Remarks:

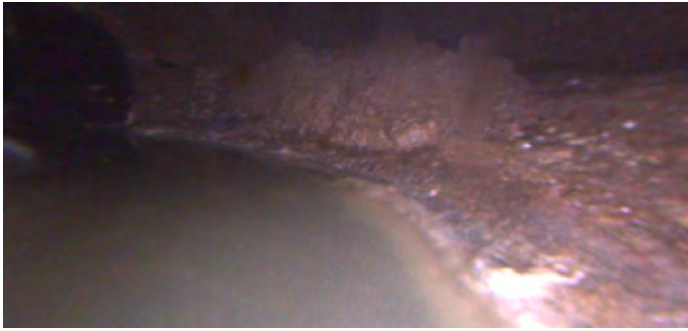
Code:	<b>AMH</b>
Description:	<b>Manhole</b>
Distance (ft):	<b>240.4</b>
Structural Grade:	<b>0</b>
O&M Grade:	<b>0</b>
Clock Start/From:	
Clock To:	
1st Value:	
2nd Value:	
Value Percent:	
Continuous Index:	
Within 8" of Joint:	<b>NO</b>
Remarks:	<b>M-802-011</b>
