## Profile/Photo Observation Report

| Street: | <b>N Hobart Rd</b> | Flow Control: | <b>Not Controlled</b> |

| US MH: | <b>M-802-011</b> | DS MH: | <b>M-802-020</b> |

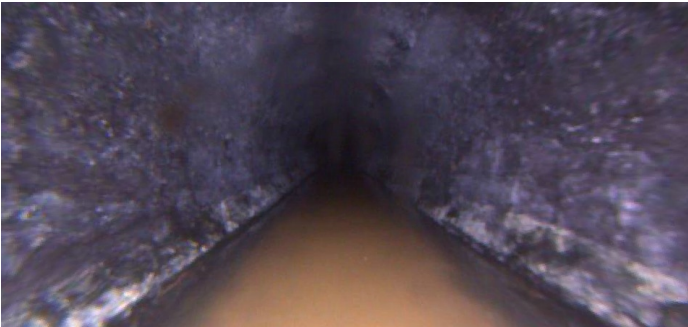
| | Position | Code | Observation | Video (sec) | Grade |
|--|---|---|---|---|---|
| <div> <div>Code:</div> <div>AMH</div> </div> <div> <div>Description:</div> <div>Manhole</div> </div> <div> </div> <div> <div>Distance (ft):</div> <div>.0</div> </div> <div> <div>Structural Grade:</div> <div>0</div> </div> <div> <div>O&amp;M Grade:</div> <div>0</div> </div> <div> <div>Clock Start/From:</div> <div></div> </div> <div> <div>Clock To:</div> <div></div> </div> <div> <div>1st Value:</div> <div></div> </div> <div> <div>2nd Value:</div> <div></div> </div> <div> <div>Value Percent:</div> <div></div> </div> <div> <div>Continuous Index:</div> <div></div> </div> <div> <div>Within 8" of Joint:</div> <div>NO</div> </div> <div> <div>Remarks:</div> <div>M-802-020</div> </div> | | | | | |

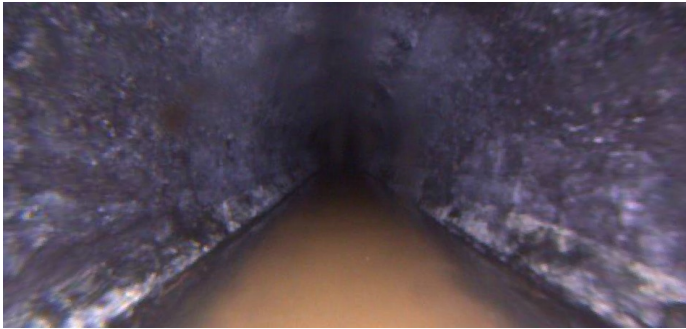
| Code: | <b>MWL</b> |
| Description: | <b>Water Level</b> |

| Distance (ft): | <b>.0</b> |
| Value Percent: | <b>15.000</b> |

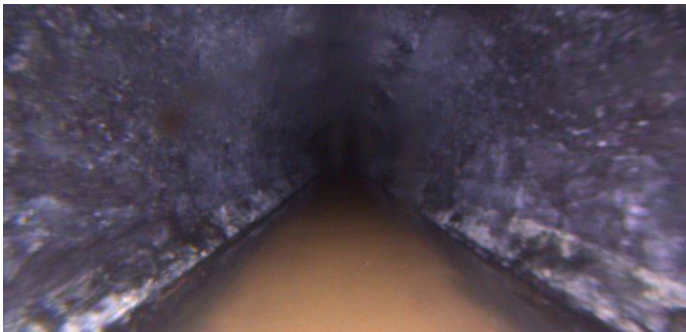
| Code: | <b>DAGS</b> |
| Description: | <b>Deposits Attached Grease</b> |

| Distance (ft): | <b>.0</b> |
| O&M Grade: | <b>2</b> |
| Clock Start/From: | <b>8</b> |
| Clock To: | <b>4</b> |
| Value Percent: | <b>5.000</b> |
| Continuous Index: | <b>S01</b> |

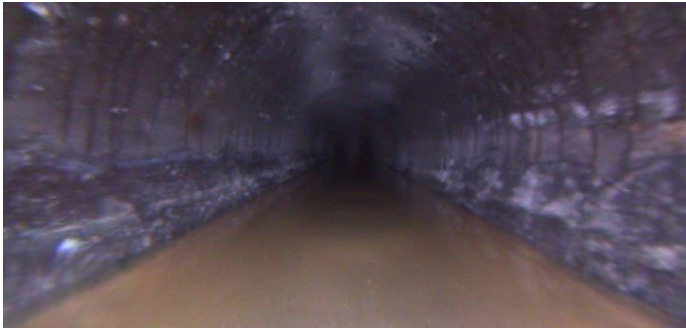
Code: **MWL**  
Description: **Water Level**

Distance (ft): **21.1**  
Structural Grade: **0**  
O&M Grade: **0**  
Clock Start/From:  
Clock To:  
1st Value:  
2nd Value:  
Value Percent: **25.000**  
Continuous Index:  
Within 8" of Joint: **NO**  
Remarks:

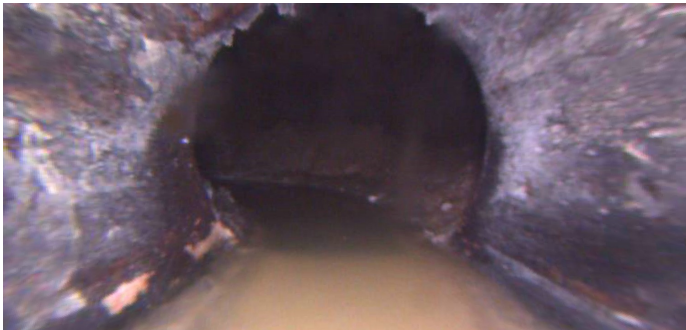
Code: **DAGS**  
Description: **Deposits Attached Grease**

Distance (ft): **238.9**  
Structural Grade: **0**  
O&M Grade: **2**  
Clock Start/From: **8**  
Clock To: **4**  
1st Value:  
2nd Value:  
Value Percent: **5.000**  
Continuous Index: **F01**  
Within 8" of Joint: **NO**  
Remarks:

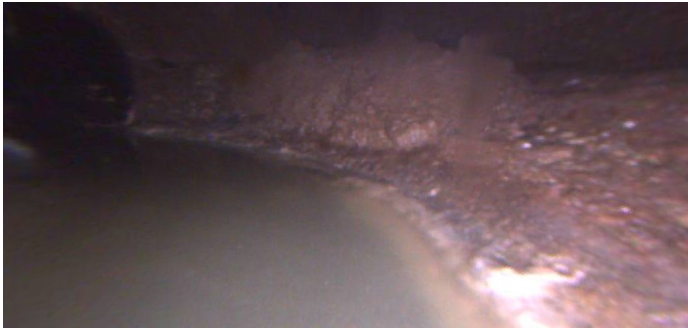
| Code: | <b>AMH</b> |
| Description: | <b>Manhole</b> |
| Distance (ft): | <b>240.4</b> |
| Remarks: | <b>M-802-011</b> |
