## Profile/Photo Observation Report

Street:	<b>OFF N HOBART RD</b>	Flow Control:	<b>Not Controlled</b>
City:	<b>Hobart, IN</b>	Year Renewed:	
Location:	<b>Main Highway - Suburban/Rural</b>	Tape/Media #:	
Purpose:	<b>Resurvey</b>	Dia/Height:	<b>10"</b>
Use:	<b>Sanitary</b>	Material:	<b>PVC</b>
Drain Area:	<b>NA</b>	Lining:	
Category:	<b>NA</b>		
Comment:

Location Details:		Direction of Survey:	<b>Downstream</b>
US MH:	<b>M-802-012</b>	DS MH:	<b>M-802-010</b>
		Total Length Surveyed (ft):	<b>233.2</b>

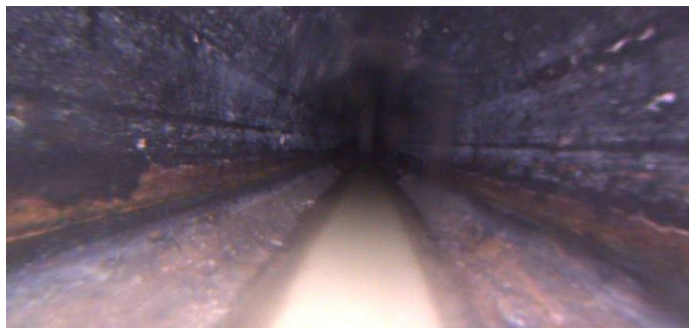
Code: **AMH**  
Description: **Manhole**

Distance (ft): **.0**  
Structural Grade: **0**  
O&M Grade: **0**  
Clock Start/From:  
Clock To:  
1st Value:  
2nd Value:  
Value Percent:  
Continuous Index:  
Within 8" of Joint: **NO**  
Remarks: **M-802-012**

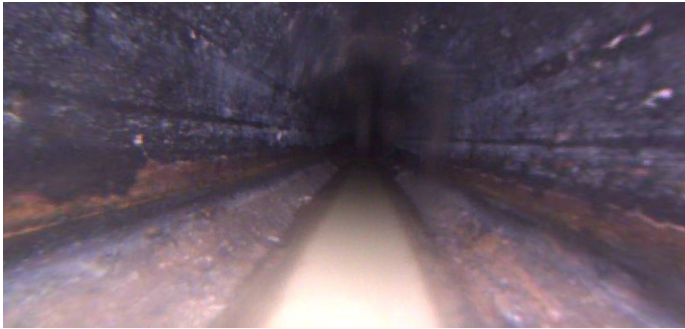
Code:	<b>MWL</b>
Description:	<b>Water Level</b>

Distance (ft):	<b>.0</b>
Structural Grade:	<b>0</b>
O&M Grade:	<b>0</b>
Clock Start/From:	
Clock To:	
1st Value:	
2nd Value:	
Value Percent:	<b>10.000</b>
Continuous Index:	
Within 8" of Joint:	<b>NO</b>
Remarks:

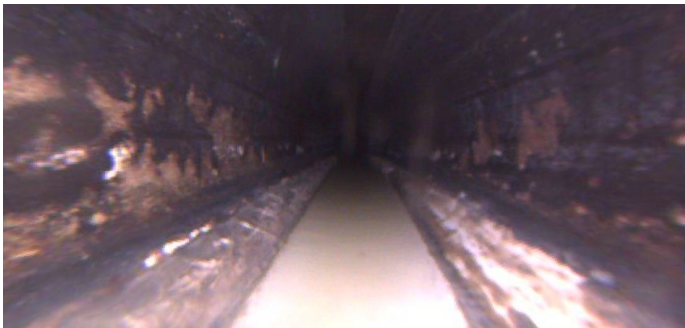
Code:	<b>DAGS</b>
Description:	<b>Deposits Attached Grease</b>

Distance (ft):	<b>8.0</b>
Structural Grade:	<b>0</b>
O&M Grade:	<b>2</b>
Clock Start/From:	<b>4</b>
Clock To:	<b>8</b>
1st Value:	
2nd Value:	
Value Percent:	<b>10.000</b>
Continuous Index:	<b>S01</b>
Within 8" of Joint:	<b>NO</b>
Remarks:

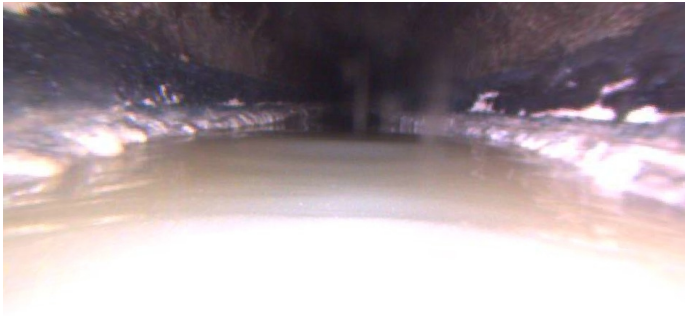
Code: **MWL**  
Description: **Water Level**

Distance (ft): **23.7**  
Structural Grade: **0**  
O&M Grade: **0**  
Clock Start/From:  
Clock To:  
1st Value:  
2nd Value:  
Value Percent: **30.000**  
Continuous Index:  
Within 8" of Joint: **NO**  
Remarks:

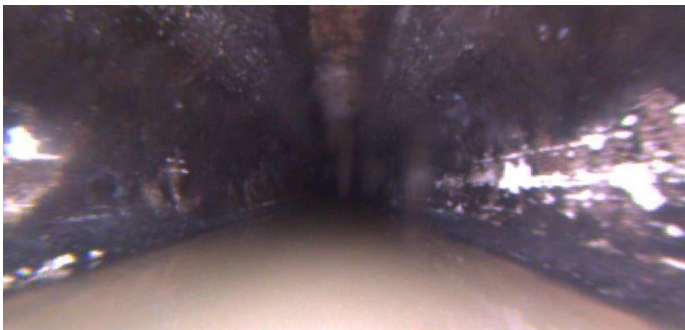
Code: **DAGS**  
Description: **Deposits Attached Grease**

Distance (ft): **35.2**  
Structural Grade: **0**  
O&M Grade: **2**  
Clock Start/From: **4**  
Clock To: **8**  
1st Value:  
2nd Value:  
Value Percent: **10.000**  
Continuous Index: **F01**  
Within 8" of Joint: **NO**  
Remarks: **Clock positions vary**

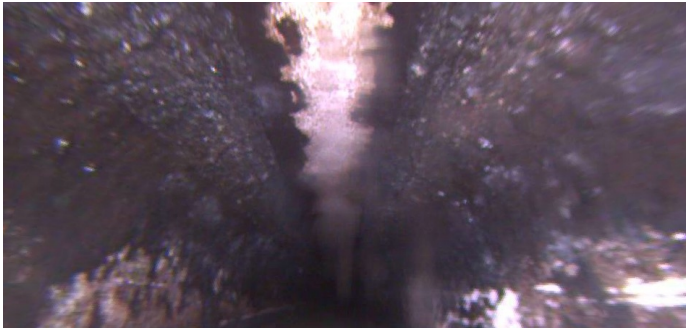
Code: **DAGS**  
Description: **Deposits Attached Grease**

Distance (ft): **36.1**  
Structural Grade: **0**  
O&M Grade: **2**  
Clock Start/From: **11**  
Clock To: **1**  
1st Value:  
2nd Value:  
Value Percent: **5.000**  
Continuous Index: **S02**  
Within 8" of Joint: **NO**  
Remarks:

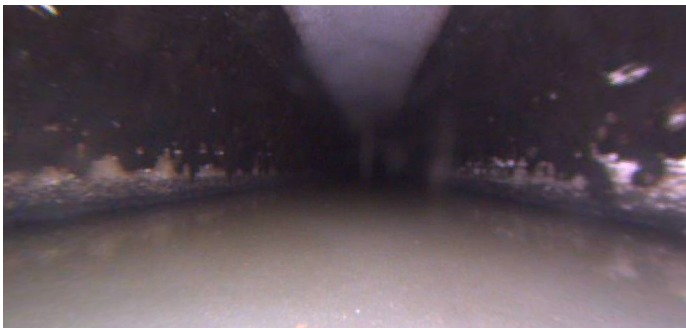
Code: **MWL**  
Description: **Water Level**

Distance (ft): **47.7**  
Structural Grade: **0**  
O&M Grade: **0**  
Clock Start/From:  
Clock To:  
1st Value:  
2nd Value:  
Value Percent: **40.000**  
Continuous Index:  
Within 8" of Joint: **NO**  
Remarks:
