## Profile/Photo Observation Report

| Street: | <b>N Hobart Rd</b> | Flow Control: | <b>Not Controlled</b> |
| City: | <b>Hobart, IN</b> | Year Renewed: | |

| US MH: | <b>M-802-012</b> | DS MH: | <b>M-802-010</b> |

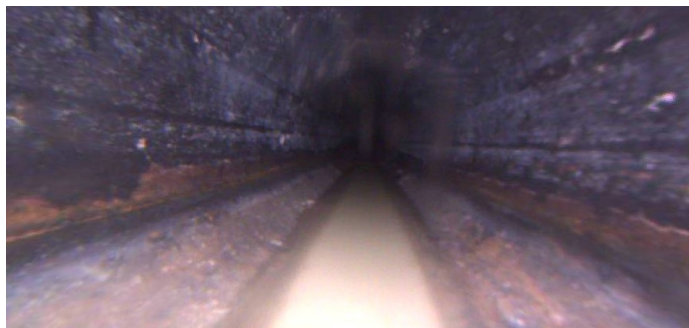
Code: **AMH**  
 Description: **Manhole**  
 Distance (ft): **.0**  
 Structural Grade: **0**  
 O&M Grade: **0**  
 Clock Start/From:  
 Clock To:  
 1st Value:  
 2nd Value:  
 Value Percent:  
 Continuous Index:  
 Within 8" of Joint: **NO**  
 Remarks: **M-802-012**

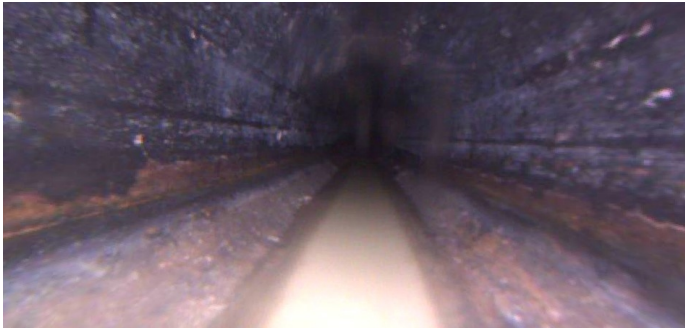
| Code: | <b>MWL</b> |
| Description: | <b>Water Level</b> |

| Distance (ft): | <b>.0</b> |
| Value Percent: | <b>10.000</b> |

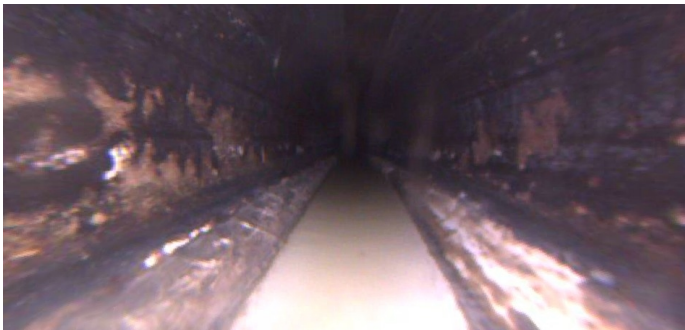
| Code: | <b>DAGS</b> |
| Description: | <b>Deposits Attached Grease</b> |

| Distance (ft): | <b>8.0</b> |
| O&M Grade: | <b>2</b> |
| Clock Start/From: | <b>4</b> |
| Clock To: | <b>8</b> |
| Value Percent: | <b>10.000</b> |

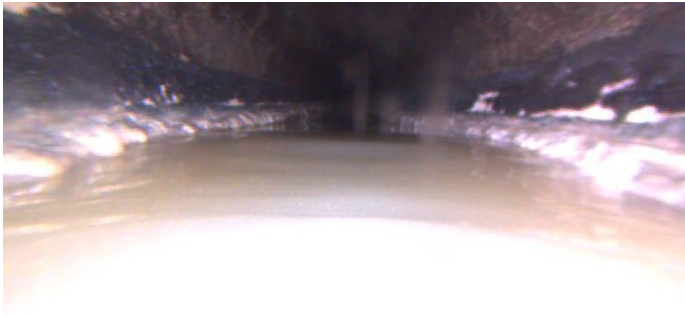
Code: **MWL**  
Description: **Water Level**

Distance (ft): **23.7**  
Structural Grade: **0**  
O&M Grade: **0**  
Clock Start/From:  
Clock To:  
1st Value:  
2nd Value:  
Value Percent: **30.000**  
Continuous Index:  
Within 8" of Joint: **NO**  
Remarks:

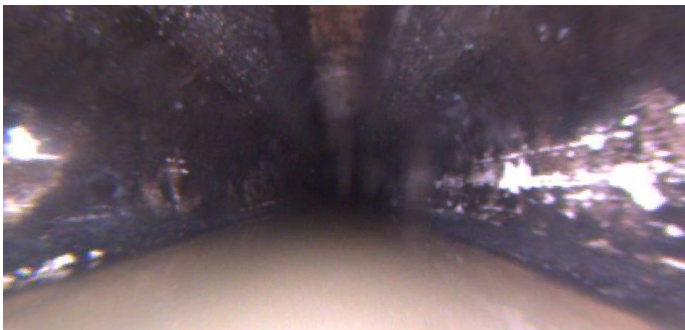
Code: **DAGS**  
Description: **Deposits Attached Grease**

Distance (ft): **35.2**  
Structural Grade: **0**  
O&M Grade: **2**  
Clock Start/From: **4**  
Clock To: **8**  
1st Value:  
2nd Value:  
Value Percent: **10.000**  
Continuous Index: **F01**  
Within 8" of Joint: **NO**  
Remarks: **Clock positions vary**

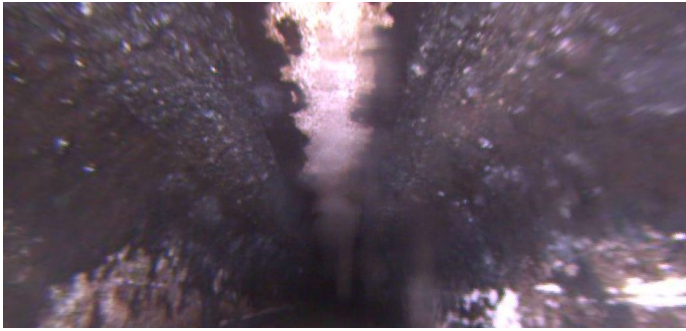
Code: **DAGS**  
Description: **Deposits Attached Grease**

Distance (ft): **36.1**  
Structural Grade: **0**  
O&M Grade: **2**  
Clock Start/From: **11**  
Clock To: **1**  
1st Value:  
2nd Value:  
Value Percent: **5.000**  
Continuous Index: **S02**  
Within 8" of Joint: **NO**  
Remarks:

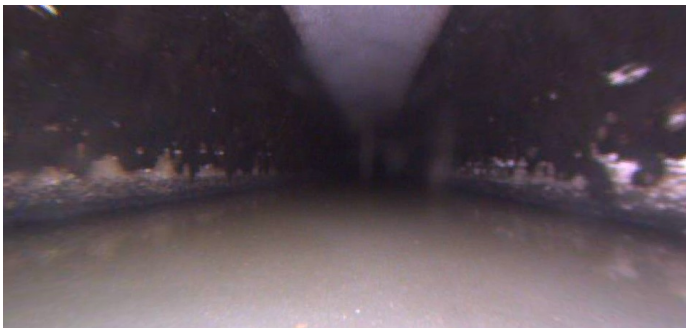
Code: **MWL**  
Description: **Water Level**

Distance (ft): **47.7**  
Structural Grade: **0**  
O&M Grade: **0**  
Clock Start/From:  
Clock To:  
1st Value:  
2nd Value:  
Value Percent: **40.000**  
Continuous Index:  
Within 8" of Joint: **NO**  
Remarks:
