Profile/Photo Observation Report

Street:	OFF N HOBART RD	Flow Control:	Not Controlled
City:	Hobart, IN	Year Renewed:	
Location:	Main Highway - Suburban/Rural	Tape/Media #:	
Purpose:	Resurvey	Dia/Height:	8"
Use:	Sanitary	Material:	PVC
Drain Area:	NA	Lining:	
Category:	NA		
Comment:

Location Details:		Direction of Survey:	Downstream
US MH:	M-802-015	DS MH:	M-802-012
		Total Length Surveyed (ft):	344.0

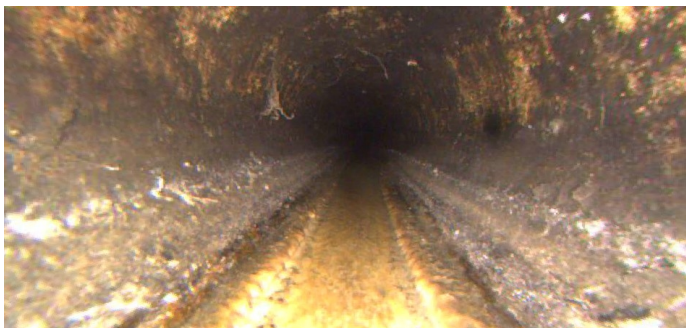
Code: **AMH**
Description: **Manhole**

Distance (ft): **.0**
Structural Grade: **0**
O&M Grade: **0**
Clock Start/From:
Clock To:
1st Value:
2nd Value:
Value Percent:
Continuous Index:
Within 8" of Joint: **NO**
Remarks: **M-802-015**

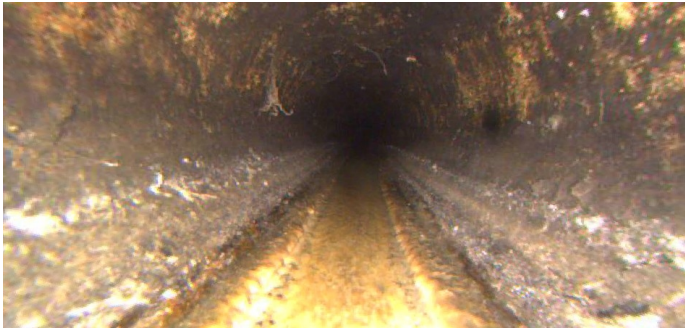
Code:	MWL
Description:	Water Level

Distance (ft):	.0
Structural Grade:	0
O&M Grade:	0
Clock Start/From:	
Clock To:	
1st Value:	
2nd Value:	
Value Percent:	5.000
Continuous Index:	
Within 8" of Joint:	NO
Remarks:

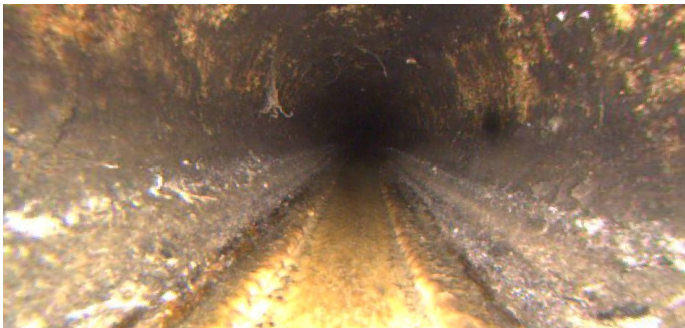
Code:	DAZ
Description:	Deposits Attached Other

Distance (ft):	.0
Structural Grade:	0
O&M Grade:	3
Clock Start/From:	7
Clock To:	5
1st Value:	
2nd Value:	
Value Percent:	15.000
Continuous Index:	S01
Within 8" of Joint:	NO
Remarks:	Mixed materials

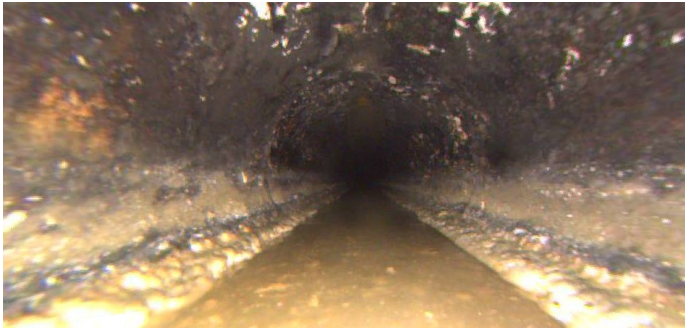
Code: **MWL**
Description: **Water Level**

Distance (ft): **24.3**
Structural Grade: **0**
O&M Grade: **0**
Clock Start/From:
Clock To:
1st Value:
2nd Value:
Value Percent: **15.000**
Continuous Index:
Within 8" of Joint: **NO**
Remarks:

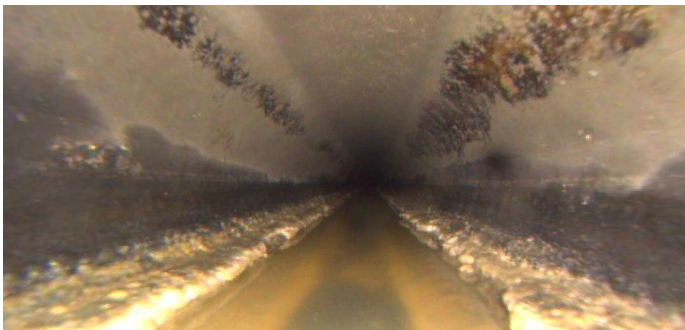
Code: **DAZ**
Description: **Deposits Attached Other**

Distance (ft): **90.4**
Structural Grade: **0**
O&M Grade: **3**
Clock Start/From: **7**
Clock To: **5**
1st Value:
2nd Value:
Value Percent: **15.000**
Continuous Index: **F01**
Within 8" of Joint: **NO**
Remarks: **Mixed materials / Clock positions vary**

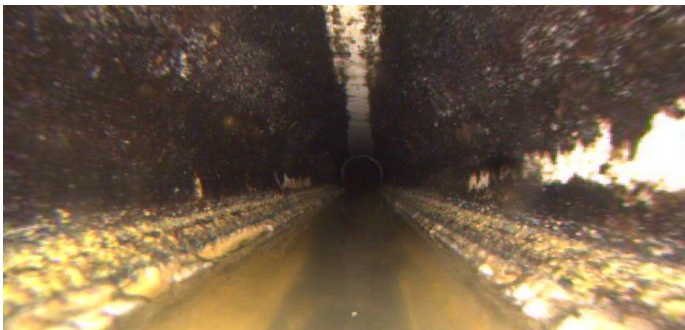
Code: **MWL**
Description: **Water Level**

Distance (ft): **234.4**
Structural Grade: **0**
O&M Grade: **0**
Clock Start/From:
Clock To:
1st Value:
2nd Value:
Value Percent: **25.000**
Continuous Index:
Within 8" of Joint: **NO**
Remarks:

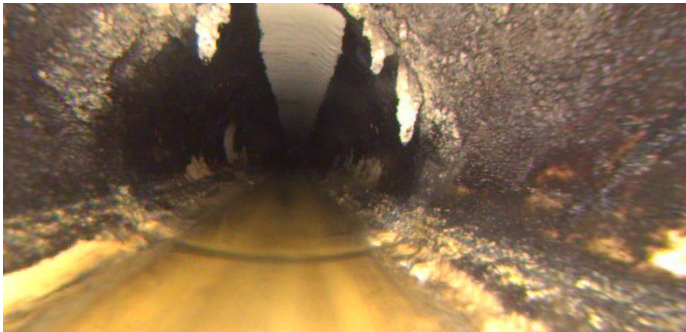
Code: ID
Description: Infil Dripper

Distance (ft): 303.3
Structural Grade: 0
O&M Grade: 3
Clock Start/From: 11
Clock To: 2
1st Value:
2nd Value:
Value Percent:
Continuous Index:
Within 8" of Joint: YES
Remarks:

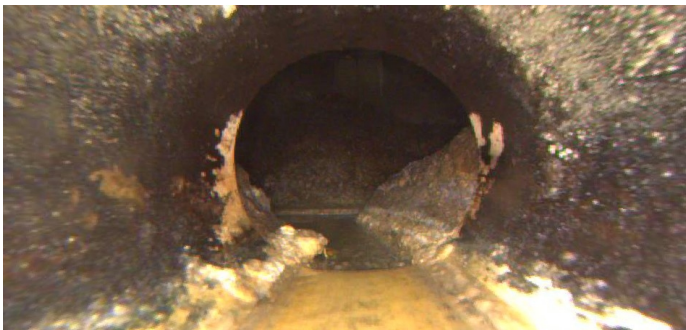
Code: **DAGS**
Description: **Deposits Attached Grease**

Distance (ft): **341.3**
Structural Grade: **0**
O&M Grade: **3**
Clock Start/From: **4**
Clock To: **8**
1st Value:
2nd Value:
Value Percent: **15.000**
Continuous Index: **F02**
Within 8" of Joint: **NO**
Remarks: **Clock positions vary**

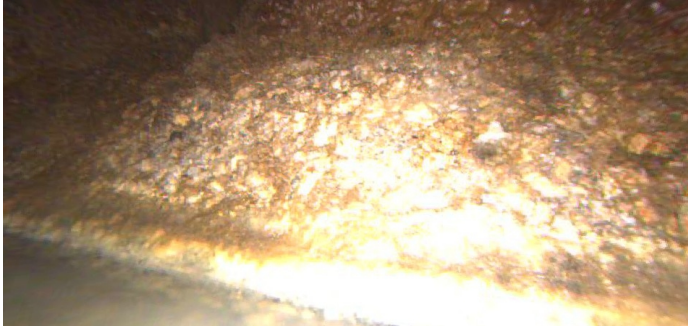
Code:	AMH
Description:	Manhole
Distance (ft):	344.0
Structural Grade:	0
O&M Grade:	0
Clock Start/From:	
Clock To:	
1st Value:	
2nd Value:	
Value Percent:	
Continuous Index:	
Within 8" of Joint:	NO
Remarks:	M-802-012
