Profile/Photo Observation Report

Date:	03/20/2018	Weather:		Coding:	PACP 6.0
Pipe Length (ft):	93.2	Owner:	NA	Pre Clean:	Not Known
P.O.#:		Surveyor:	John Kuglmaier	PSR:	P-802-014-015
Customer:		Clean Date:	01/01/1900	Shape:	C

Street:	OFF N HOBART RD	Flow Control:	Not Controlled
City:	Hobart, IN	Year Renewed:	
Location:	Main Highway - Suburban/Rural	Tape/Media #:	
Purpose:	Resurvey	Dia/Height:	8"
Use:	Sanitary	Material:	PVC
Drain Area:	NA	Lining:	
Category:	NA		
Comment:

Location Details:		Direction of Survey:	Downstream
US MH:	M-802-015	DS MH:	M-802-014
		Total Length Surveyed (ft):	23.6

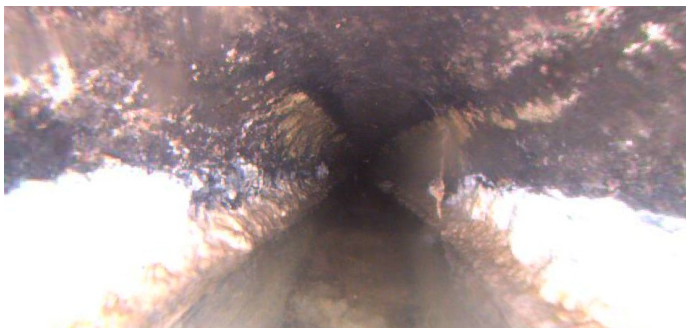
Code: **AMH**
Description: **Manhole**

Distance (ft): **.0**
Structural Grade: **0**
O&M Grade: **0**
Clock Start/From:
Clock To:
1st Value:
2nd Value:
Value Percent:
Continuous Index:
Within 8" of Joint: **NO**
Remarks: **M-802-015**

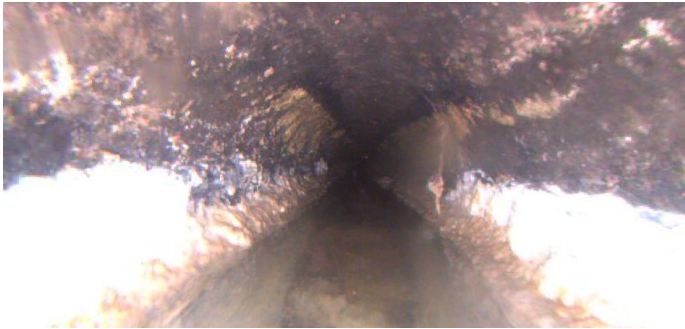
Code:	MWL
Description:	Water Level

Distance (ft):	.0
Structural Grade:	0
O&M Grade:	0
Clock Start/From:	
Clock To:	
1st Value:	
2nd Value:	
Value Percent:	25.000
Continuous Index:	
Within 8" of Joint:	NO
Remarks:

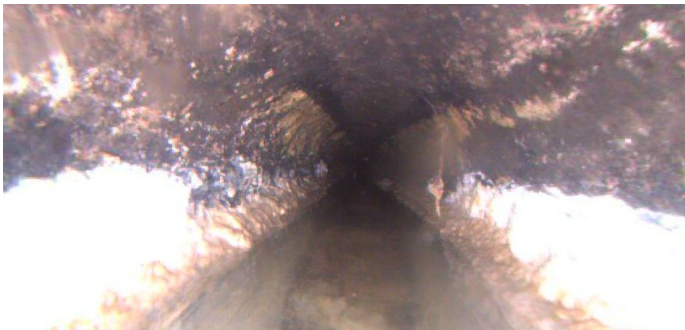
Code:	DAGS
Description:	Deposits Attached Grease

Distance (ft):	.0
Structural Grade:	0
O&M Grade:	3
Clock Start/From:	8
Clock To:	4
1st Value:	
2nd Value:	
Value Percent:	15.000
Continuous Index:	S01
Within 8" of Joint:	NO
Remarks:

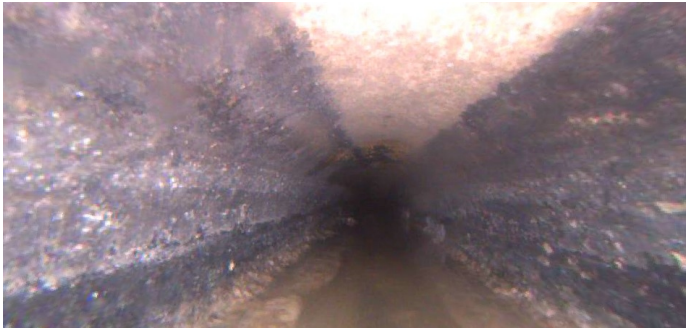
Code: **DAGS**
Description: **Deposits Attached Grease**

Distance (ft): **23.6**
Structural Grade: **0**
O&M Grade: **3**
Clock Start/From: **8**
Clock To: **4**
1st Value:
2nd Value:
Value Percent: **15.000**
Continuous Index: **F01**
Within 8" of Joint: **NO**
Remarks: **Clock positions vary**

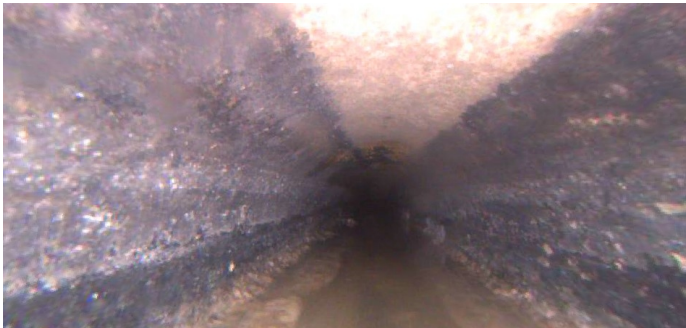
Code: **MSA**
Description: **Abandoned Survey**

Distance (ft): **23.6**
Structural Grade: **0**
O&M Grade: **0**
Clock Start/From:
Clock To:
1st Value:
2nd Value:
Value Percent:
Continuous Index:
Within 8" of Joint: **NO**
Remarks: **DAGS**
