Profile/Photo Observation Report

Street:	N Hobart Rd	Flow Control:	Not Controlled
City:	Hobart, IN	Year Renewed:	
Location:	Main Highway - Suburban/Rural	Tape/Media #:	
Purpose:	Resurvey	Dia/Height:	8"
Use:	Sanitary	Material:	PVC
Drain Area:	NA	Lining:	Cured in Place
Category:	NA		
Comment:

Location Details:		Direction of Survey:	Upstream
US MH:	M-802-015	DS MH:	M-802-014
		Total Length Surveyed (ft):	71.5

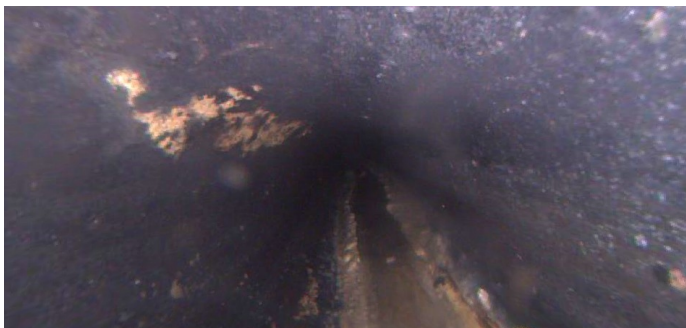
Code: **AMH**
Description: **Manhole**

Distance (ft): **.0**
Structural Grade: **0**
O&M Grade: **0**
Clock Start/From:
Clock To:
1st Value:
2nd Value:
Value Percent:
Continuous Index:
Within 8" of Joint: **NO**
Remarks: **M-802-014**

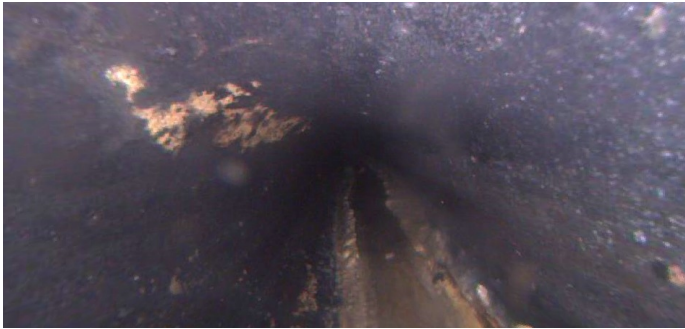
Code:	MWL
Description:	Water Level

Distance (ft):	.0
Structural Grade:	0
O&M Grade:	0
Clock Start/From:	
Clock To:	
1st Value:	
2nd Value:	
Value Percent:	5.000
Continuous Index:	
Within 8" of Joint:	NO
Remarks:

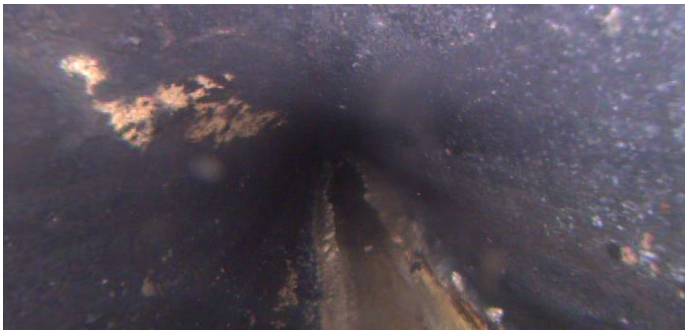
Code:	DAGS
Description:	Deposits Attached Grease

Distance (ft):	.0
Structural Grade:	0
O&M Grade:	2
Clock Start/From:	5
Clock To:	7
1st Value:	
2nd Value:	
Value Percent:	5.000
Continuous Index:	S01
Within 8" of Joint:	NO
Remarks:

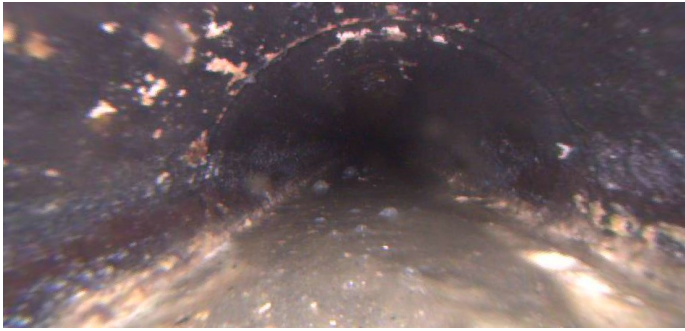
Code: **MWL**
Description: **Water Level**

Distance (ft): **28.7**
Structural Grade: **0**
O&M Grade: **0**
Clock Start/From:
Clock To:
1st Value:
2nd Value:
Value Percent: **30.000**
Continuous Index:
Within 8" of Joint: **NO**
Remarks:

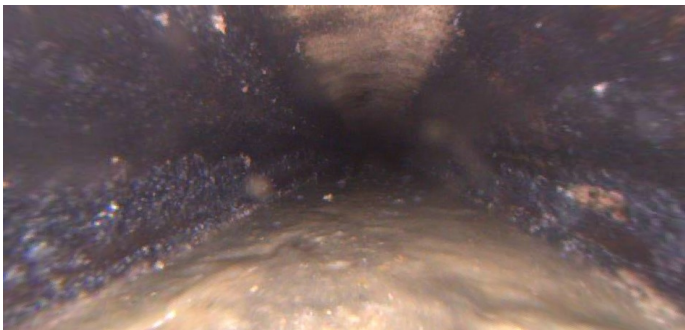
Code: **DAGS**
Description: **Deposits Attached Grease**

Distance (ft): **29.9**
Structural Grade: **0**
O&M Grade: **2**
Clock Start/From: **5**
Clock To: **7**
1st Value:
2nd Value:
Value Percent: **5.000**
Continuous Index: **F01**
Within 8" of Joint: **NO**
Remarks: **Clock positions vary**

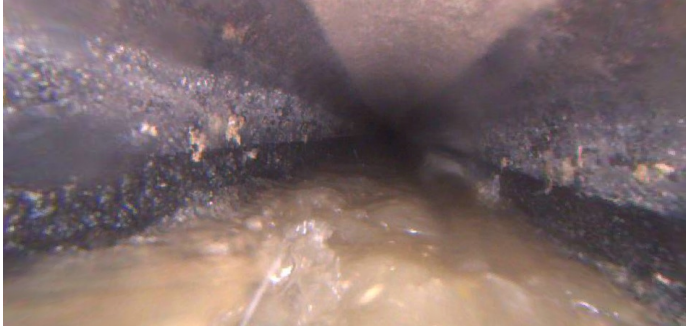
Code: **MSA**
Description: **Abandoned Survey**

Distance (ft): **71.5**
Structural Grade: **0**
O&M Grade: **0**
Clock Start/From:
Clock To:
1st Value:
2nd Value:
Value Percent:
Continuous Index:
Within 8" of Joint: **NO**
Remarks: **Unknown**
