## Profile/Photo Observation Report

Street:	<b>OFF N HOBART RD</b>	Flow Control:	<b>Not Controlled</b>
City:	<b>Hobart, IN</b>	Year Renewed:	
Location:	<b>Main Highway - Suburban/Rural</b>	Tape/Media #:	
Purpose:	<b>Resurvey</b>	Dia/Height:	<b>8"</b>
Use:	<b>Sanitary</b>	Material:	<b>PVC</b>
Drain Area:	<b>NA</b>	Lining:	
Category:	<b>NA</b>		
Comment:

Location Details:		Direction of Survey:	<b>Upstream</b>
US MH:	<b>M-802-017</b>	DS MH:	<b>M-802-015</b>
		Total Length Surveyed (ft):	<b>318.7</b>

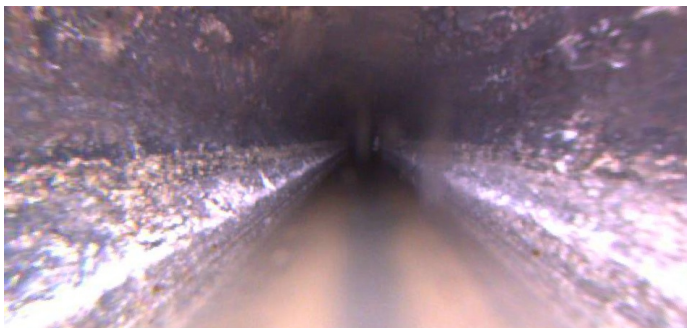
Code: **AMH**  
Description: **Manhole**

Distance (ft): **.0**  
Structural Grade: **0**  
O&M Grade: **0**  
Clock Start/From:  
Clock To:  
1st Value:  
2nd Value:  
Value Percent:  
Continuous Index:  
Within 8" of Joint: **NO**  
Remarks: **M-802-015**

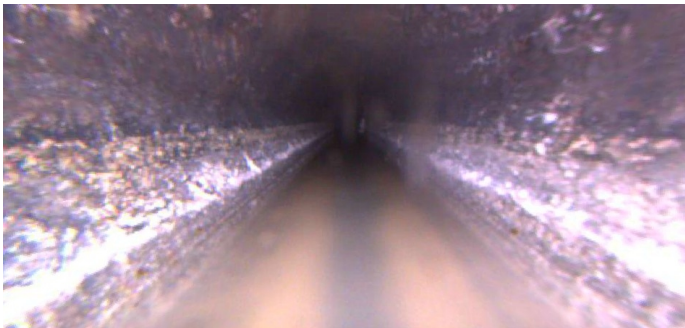
Code:	<b>DAGS</b>
Description:	<b>Deposits Attached Grease</b>

Distance (ft):	<b>.0</b>
Structural Grade:	<b>0</b>
O&M Grade:	<b>2</b>
Clock Start/From:	<b>3</b>
Clock To:	<b>9</b>
1st Value:	
2nd Value:	
Value Percent:	<b>5.000</b>
Continuous Index:	<b>S01</b>
Within 8" of Joint:	<b>NO</b>
Remarks:

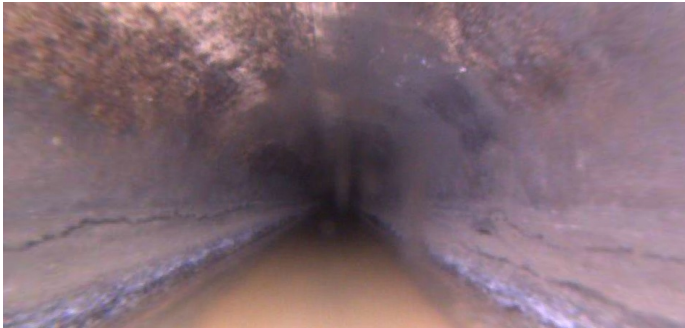
Code: **DAGS**  
Description: **Deposits Attached Grease**

Distance (ft): **41.2**  
Structural Grade: **0**  
O&M Grade: **2**  
Clock Start/From: **3**  
Clock To: **9**  
1st Value:  
2nd Value:  
Value Percent: **5.000**  
Continuous Index: **F01**  
Within 8" of Joint: **NO**  
Remarks: **Clock positions vary**

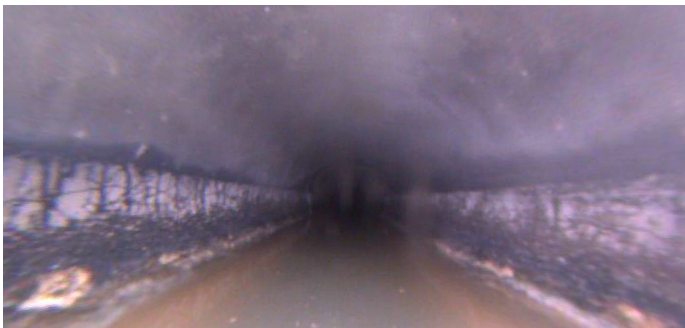
Code: **MWL**  
Description: **Water Level**

Distance (ft): **82.2**  
Structural Grade: **0**  
O&M Grade: **0**  
Clock Start/From:  
Clock To:  
1st Value:  
2nd Value:  
Value Percent: **30.000**  
Continuous Index:  
Within 8" of Joint: **NO**  
Remarks:

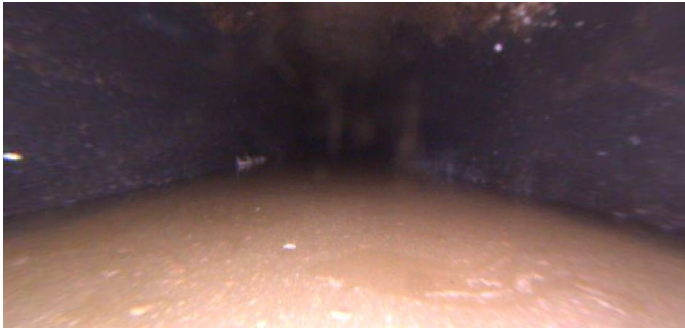
Code: **MWL**  
Description: **Water Level**

Distance (ft): **169.8**  
Structural Grade: **0**  
O&M Grade: **0**  
Clock Start/From:  
Clock To:  
1st Value:  
2nd Value:  
Value Percent: **40.000**  
Continuous Index:  
Within 8" of Joint: **NO**  
Remarks:

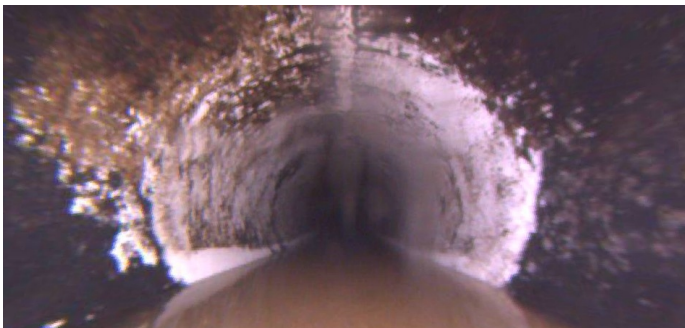
Code: **DAGS**  
Description: **Deposits Attached Grease**

Distance (ft): **225.5**  
Structural Grade: **0**  
O&M Grade: **2**  
Clock Start/From: **8**  
Clock To: **4**  
1st Value:  
2nd Value:  
Value Percent: **10.000**  
Continuous Index: **S02**  
Within 8" of Joint: **NO**  
Remarks:

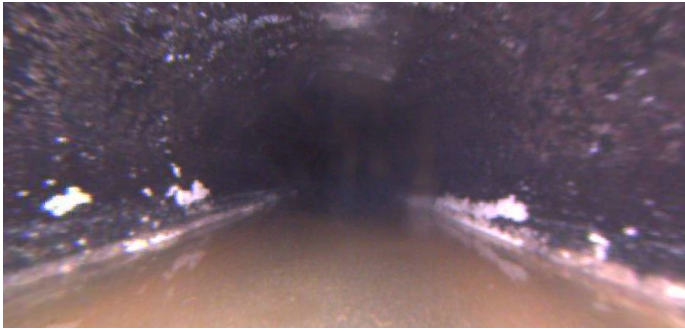
Code: **DAGS**  
Description: **Deposits Attached Grease**

Distance (ft): **266.6**  
Structural Grade: **0**  
O&M Grade: **2**  
Clock Start/From: **8**  
Clock To: **4**  
1st Value:  
2nd Value:  
Value Percent: **10.000**  
Continuous Index: **F02**  
Within 8" of Joint: **NO**  
Remarks: **Clock positions vary**

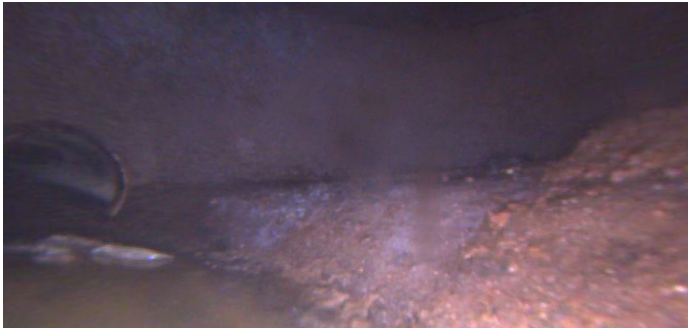
Code:	AMH
Description:	Manhole
Distance (ft):	318.7
Structural Grade:	0
O&M Grade:	0
Clock Start/From:	
Clock To:	
1st Value:	
2nd Value:	
Value Percent:	
Continuous Index:	
Within 8" of Joint:	NO
Remarks:	M-802-017
