Profile/Photo Observation Report

Street:	Randolph Pl	Flow Control:	Not Controlled
City:	Hobart, IN	Year Renewed:	
Location:	Main Highway - Suburban/Rural	Tape/Media #:	
Purpose:	Resurvey	Dia/Height:	8"
Use:	Sanitary	Material:	PVC
Drain Area:	NA	Lining:	
Category:	NA		
Comment:

Location Details:		Direction of Survey:	Upstream
US MH:	M-802-017	DS MH:	M-802-015
		Total Length Surveyed (ft):	318.7

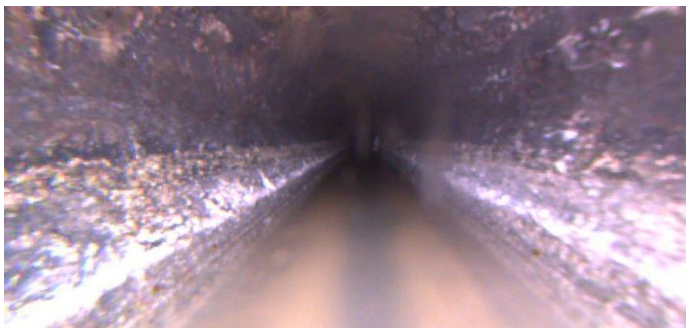
Code: **AMH**
Description: **Manhole**

Distance (ft): **.0**
Structural Grade: **0**
O&M Grade: **0**
Clock Start/From:
Clock To:
1st Value:
2nd Value:
Value Percent:
Continuous Index:
Within 8" of Joint: **NO**
Remarks: **M-802-015**

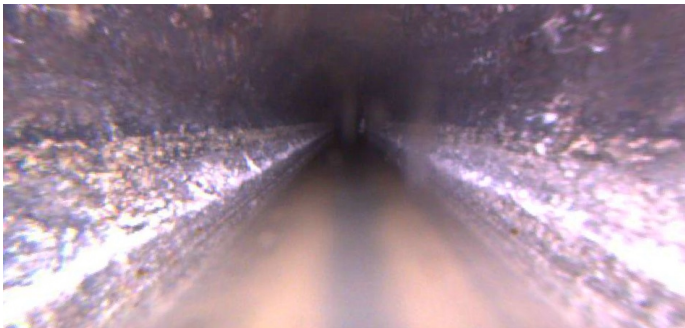
Code:	DAGS
Description:	Deposits Attached Grease

Distance (ft):	.0
Structural Grade:	0
O&M Grade:	2
Clock Start/From:	3
Clock To:	9
1st Value:	
2nd Value:	
Value Percent:	5.000
Continuous Index:	S01
Within 8" of Joint:	NO
Remarks:

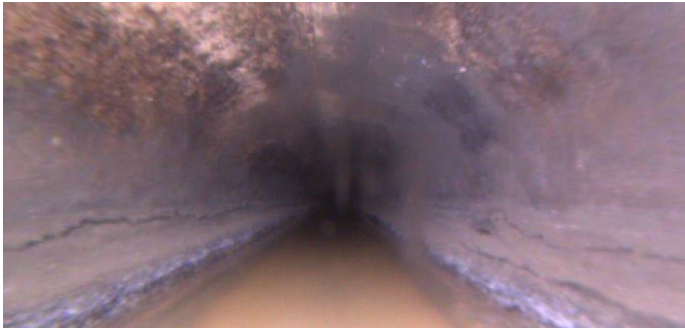
Code: **DAGS**
Description: **Deposits Attached Grease**

Distance (ft): **41.2**
Structural Grade: **0**
O&M Grade: **2**
Clock Start/From: **3**
Clock To: **9**
1st Value:
2nd Value:
Value Percent: **5.000**
Continuous Index: **F01**
Within 8" of Joint: **NO**
Remarks: **Clock positions vary**

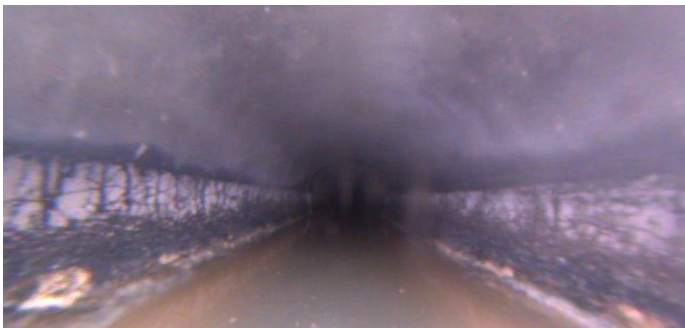
Code: **MWL**
Description: **Water Level**

Distance (ft): **82.2**
Structural Grade: **0**
O&M Grade: **0**
Clock Start/From:
Clock To:
1st Value:
2nd Value:
Value Percent: **30.000**
Continuous Index:
Within 8" of Joint: **NO**
Remarks:

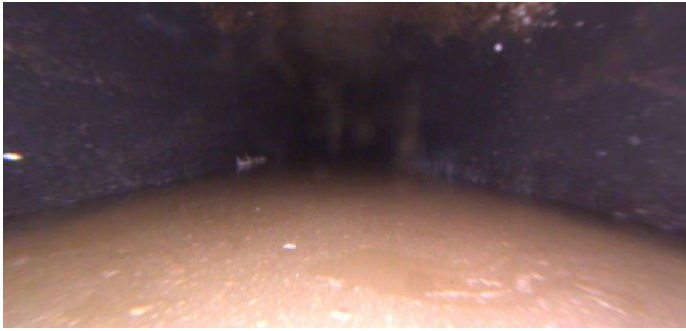
Code: **MWL**
Description: **Water Level**

Distance (ft): **169.8**
Structural Grade: **0**
O&M Grade: **0**
Clock Start/From:
Clock To:
1st Value:
2nd Value:
Value Percent: **40.000**
Continuous Index:
Within 8" of Joint: **NO**
Remarks:

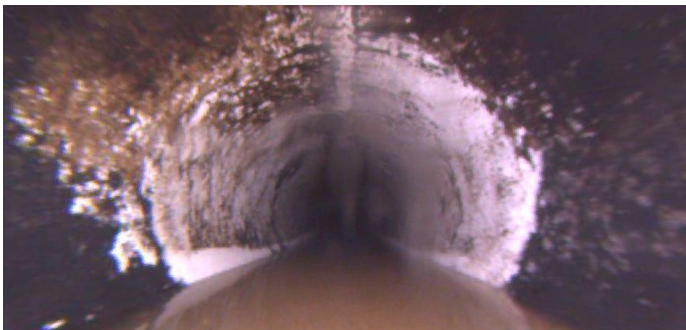
Code: **DAGS**
Description: **Deposits Attached Grease**

Distance (ft): **225.5**
Structural Grade: **0**
O&M Grade: **2**
Clock Start/From: **8**
Clock To: **4**
1st Value:
2nd Value:
Value Percent: **10.000**
Continuous Index: **S02**
Within 8" of Joint: **NO**
Remarks:

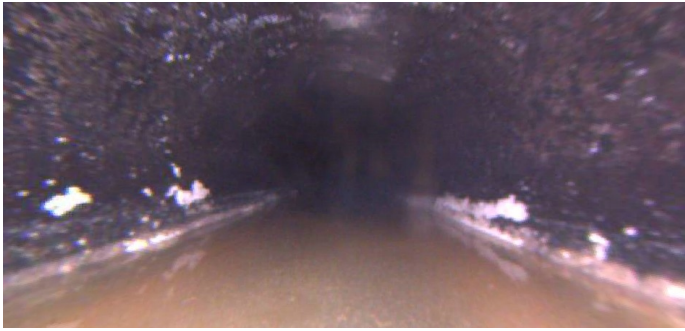
Code: **DAGS**
Description: **Deposits Attached Grease**

Distance (ft): **266.6**
Structural Grade: **0**
O&M Grade: **2**
Clock Start/From: **8**
Clock To: **4**
1st Value:
2nd Value:
Value Percent: **10.000**
Continuous Index: **F02**
Within 8" of Joint: **NO**
Remarks: **Clock positions vary**

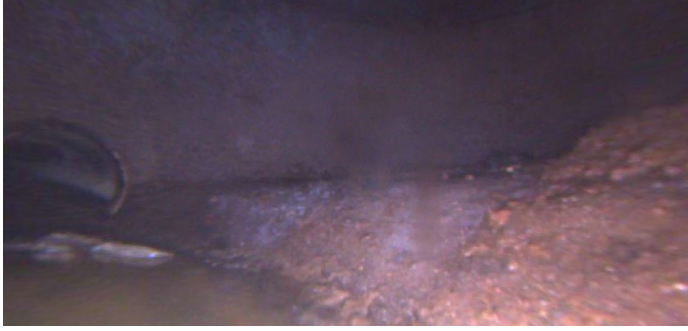
Code:	AMH
Description:	Manhole
Distance (ft):	318.7
Structural Grade:	0
O&M Grade:	0
Clock Start/From:	
Clock To:	
1st Value:	
2nd Value:	
Value Percent:	
Continuous Index:	
Within 8" of Joint:	NO
Remarks:	M-802-017
