Profile/Photo Observation Report

Date:	03/22/2018	Weather:		Coding:	PACP 6.0
Pipe Length (ft):	244.0	Owner:	NA	Pre Clean:	Not Known
P.O.#:		Surveyor:	Selasie Honu	PSR:	P-802-018-019
Customer:		Clean Date:	01/01/1900	Shape:	C

Street:	OFF E 37TH AVE	Flow Control:	Not Controlled
City:	Hobart, IN	Year Renewed:	
Location:	Other	Tape/Media #:	
Purpose:	Not Known	Dia/Height:	10"
Use:	Sanitary	Material:	PVC
Drain Area:	NA	Lining:	
Category:	NA		
Comment:			
Location Details:		Direction of Survey:	Upstream
US MH:	M-802-018	DS MH:	M-802-019
		Total Length Surveyed (ft):	237.2

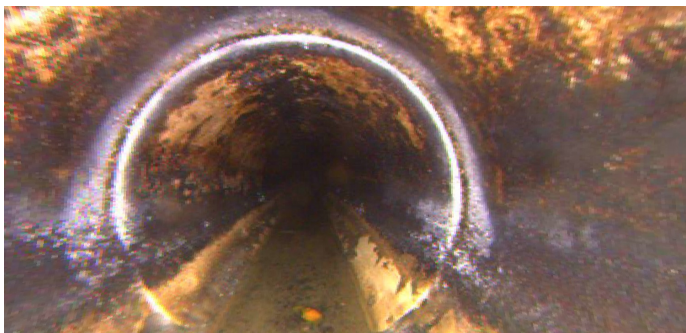
Code: **AMH**
 Description: **Manhole**
 Distance (ft): **.0**
 Structural Grade: **0**
 O&M Grade: **0**
 Clock Start/From:
 Clock To:
 1st Value:
 2nd Value:
 Value Percent:
 Continuous Index:
 Within 8" of Joint: **NO**
 Remarks: **M-802-019**

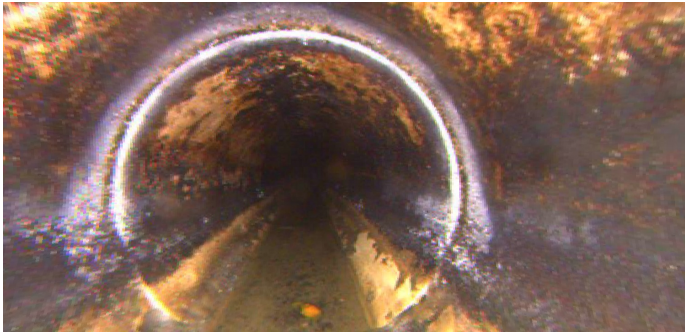
Code:	MWL
Description:	Water Level

Distance (ft):	.0
Structural Grade:	0
O&M Grade:	0
Clock Start/From:	
Clock To:	
1st Value:	
2nd Value:	
Value Percent:	5.000
Continuous Index:	
Within 8" of Joint:	NO
Remarks:

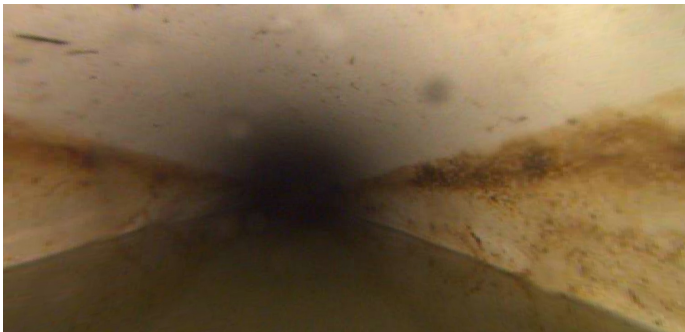
Code:	MWLS
Description:	Water Level Sag

Distance (ft):	224.9
Structural Grade:	2
O&M Grade:	3
Clock Start/From:	
Clock To:	
1st Value:	
2nd Value:	
Value Percent:	5.000
Continuous Index:	S01
Within 8" of Joint:	NO
Remarks:

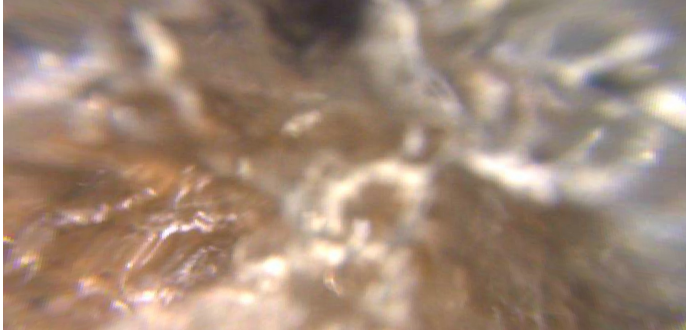
Code: **MWLS**
Description: **Water Level Sag**

Distance (ft): **237.2**
Structural Grade: **2**
O&M Grade: **3**
Clock Start/From:
Clock To:
1st Value:
2nd Value:
Value Percent: **5.000**
Continuous Index: **F01**
Within 8" of Joint: **NO**
Remarks:

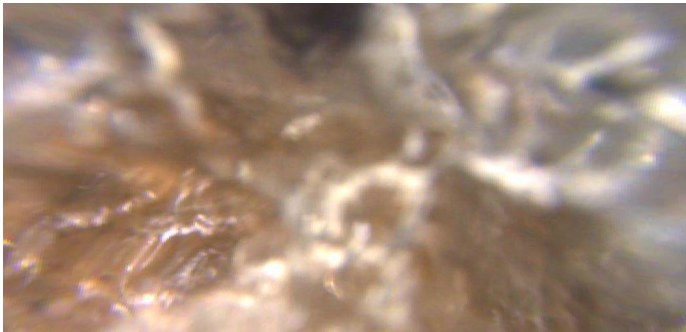
Code: **AMH**
Description: **Manhole**

Distance (ft): **237.2**
Structural Grade: **0**
O&M Grade: **0**
Clock Start/From:
Clock To:
1st Value:
2nd Value:
Value Percent:
Continuous Index:
Within 8" of Joint: **NO**
Remarks: **M-802-018**
