## Profile/Photo Observation Report

Street:	<b>e 37th st</b>	Flow Control:	<b>Not Controlled</b>
City:	<b>Hobart, IN</b>	Year Renewed:	
Location:	<b>Other</b>	Tape/Media #:	
Purpose:	<b>Not Known</b>	Dia/Height:	<b>10"</b>
Use:	<b>Sanitary</b>	Material:	<b>PVC</b>
Drain Area:	<b>NA</b>	Lining:	
Category:	<b>NA</b>		
Comment:

Location Details:		Direction of Survey:	<b>Upstream</b>
US MH:	<b>M-802-018</b>	DS MH:	<b>M-802-019</b>
		Total Length Surveyed (ft):	<b>237.2</b>

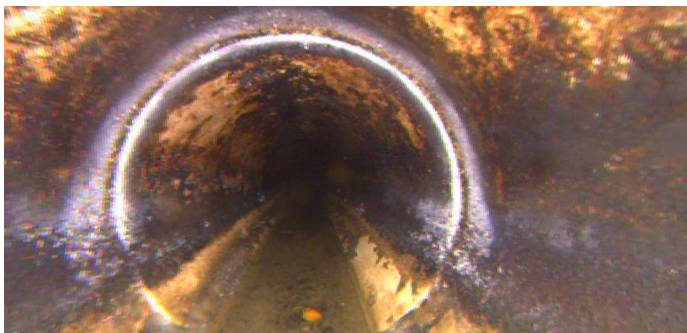
Code: **AMH**  
Description: **Manhole**

Distance (ft): **.0**  
Structural Grade: **0**  
O&M Grade: **0**  
Clock Start/From:  
Clock To:  
1st Value:  
2nd Value:  
Value Percent:  
Continuous Index:  
Within 8" of Joint: **NO**  
Remarks: **M-802-019**

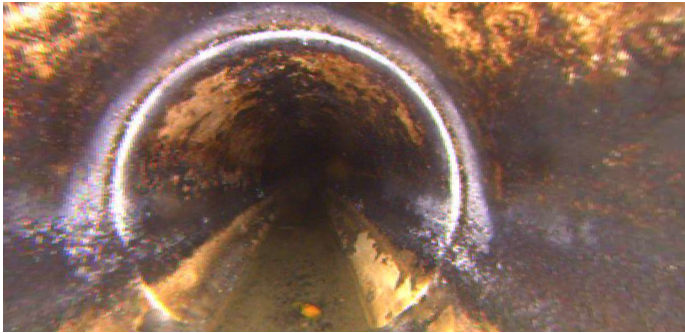
Code:	<b>MWL</b>
Description:	<b>Water Level</b>

Distance (ft):	<b>.0</b>
Structural Grade:	<b>0</b>
O&M Grade:	<b>0</b>
Clock Start/From:	
Clock To:	
1st Value:	
2nd Value:	
Value Percent:	<b>5.000</b>
Continuous Index:	
Within 8" of Joint:	<b>NO</b>
Remarks:

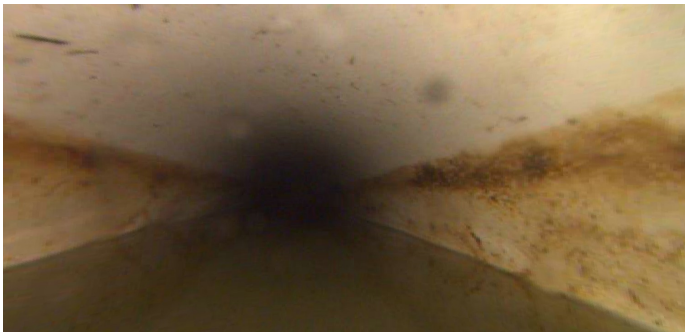
Code:	<b>MWLS</b>
Description:	<b>Water Level Sag</b>

Distance (ft):	<b>224.9</b>
Structural Grade:	<b>2</b>
O&M Grade:	<b>3</b>
Clock Start/From:	
Clock To:	
1st Value:	
2nd Value:	
Value Percent:	<b>5.000</b>
Continuous Index:	<b>S01</b>
Within 8" of Joint:	<b>NO</b>
Remarks:

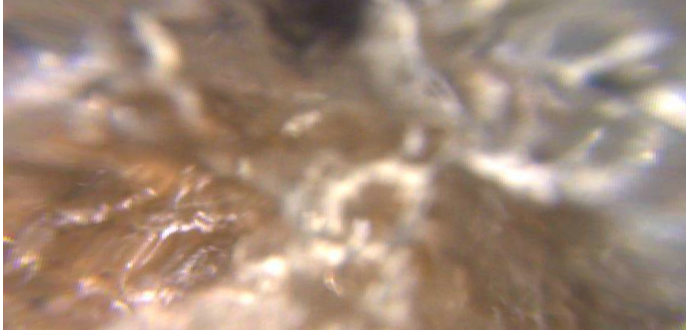
Code: **MWLS**  
Description: **Water Level Sag**

Distance (ft): **237.2**  
Structural Grade: **2**  
O&M Grade: **3**  
Clock Start/From:  
Clock To:  
1st Value:  
2nd Value:  
Value Percent: **5.000**  
Continuous Index: **F01**  
Within 8" of Joint: **NO**  
Remarks:

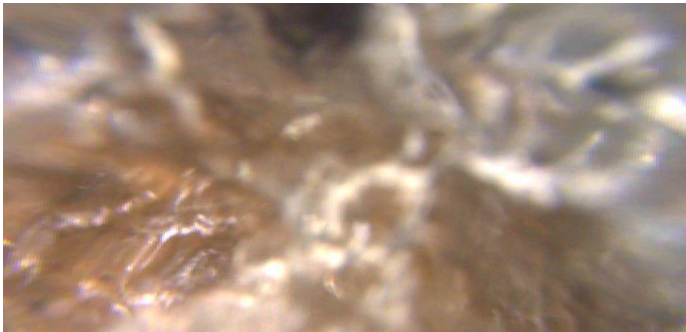
Code: **AMH**  
Description: **Manhole**

Distance (ft): **237.2**  
Structural Grade: **0**  
O&M Grade: **0**  
Clock Start/From:  
Clock To:  
1st Value:  
2nd Value:  
Value Percent:  
Continuous Index:  
Within 8" of Joint: **NO**  
Remarks: **M-802-018**
