Profile/Photo Observation Report

Street: East Ridge Road Flow Control: Not Controlled
City: Hobart, IN Year Renewed:

Purpose:Routine AssessmentDia/Height:8"Use:Sanitary Sewage PipeMaterial:PVCDrain Area:Lining:None

US MH: M-802-019 DS MH: LS015 Total Length Surveyed (ft): 285.4

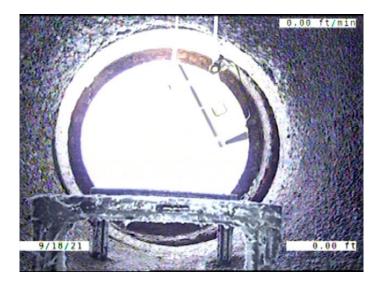
Code: AMH Description: Manhole

Distance (ft): .0 Structural Grade: 0 0 O&M Grade:

Remarks: M-802-019

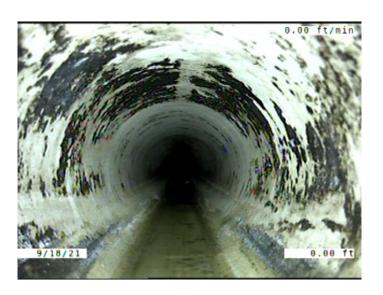
MWL Code:

Description: **Miscellaneous Water Level**

Distance (ft): .0 Structural Grade: 0 O&M Grade: 0

Value Percent: 5.000

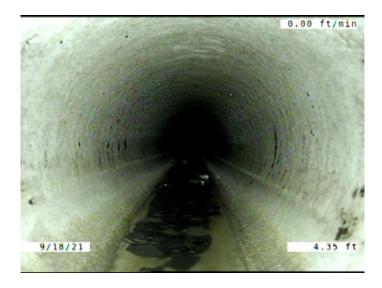
Code: **DSF**

Description: **Deposits Settled Fine**

Distance (ft): 4.3 Structural Grade: 0 2 O&M Grade: Clock Start/From: 5 Clock To: 7

5.000 Value Percent: Continuous Index: **S01** Within 8" of Joint: YES

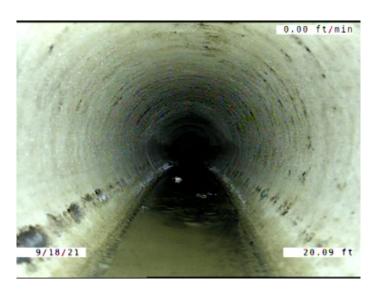
Code: **MWLS**

Description: **Miscellaneous Water Level Sag**

20.1 Distance (ft): Structural Grade: 2 O&M Grade: 0

Value Percent: 5.000

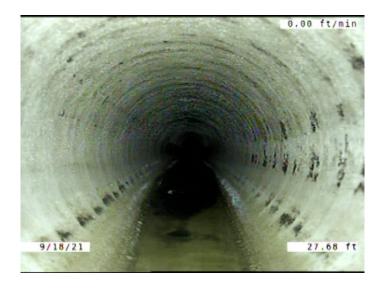
Description: Miscellaneous Water Level Sag

Distance (ft): 27.7
Structural Grade: 2
O&M Grade: 0

Value Percent: 5.000
Continuous Index: S02
Within 8" of Joint: NO

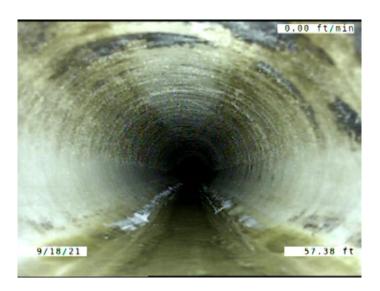
Code: MWLS

Description: Miscellaneous Water Level Sag

Distance (ft): 57.4
Structural Grade: 2
O&M Grade: 0

Value Percent: 5.000
Continuous Index: F02
Within 8" of Joint: NO

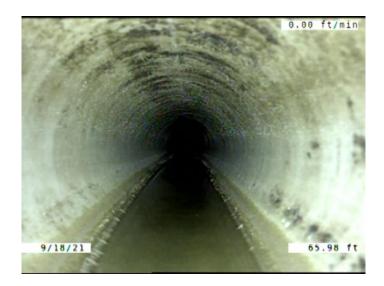
Description: **Miscellaneous Water Level Sag**

Distance (ft): 66.0 Structural Grade: 2 0 O&M Grade:

Value Percent: 5.000 Continuous Index: **S03** Within 8" of Joint: NO

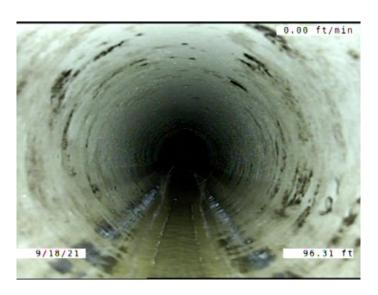
Code: **MWLS**

Description: **Miscellaneous Water Level Sag**

Distance (ft): 96.3 Structural Grade: 2 O&M Grade: 0

Value Percent: 5.000 Continuous Index: F03 Within 8" of Joint: NO

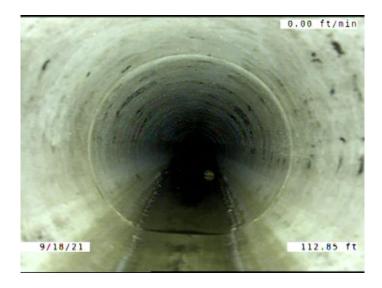
Description: **Miscellaneous Water Level Sag**

Distance (ft): 112.9 Structural Grade: 2 0 O&M Grade:

Value Percent: 5.000 Continuous Index: **S04** Within 8" of Joint: NO

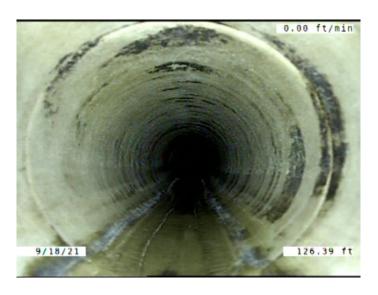
Code: **MWLS**

Description: **Miscellaneous Water Level Sag**

Distance (ft): 126.4 Structural Grade: 2 O&M Grade: 0

Value Percent: 5.000 Continuous Index: F04 Within 8" of Joint: NO

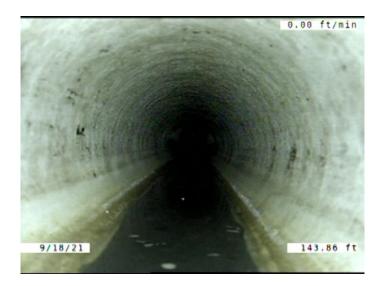
Description: **Miscellaneous Water Level Sag**

Distance (ft): 143.9 Structural Grade: 2 0 O&M Grade:

Value Percent: 5.000 **S05** Continuous Index: Within 8" of Joint: NO

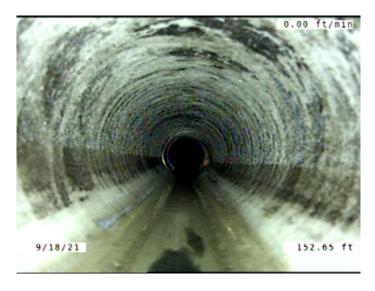
Code: **MWLS**

Description: **Miscellaneous Water Level Sag**

Distance (ft): 152.7 Structural Grade: 2 O&M Grade: 0

Value Percent: 5.000 Continuous Index: F05 Within 8" of Joint: NO

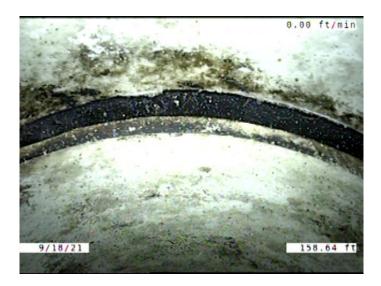
Code: **JOM**

Description: Joint Offset Medium

Distance (ft): 158.6
Structural Grade: 3
O&M Grade: 0

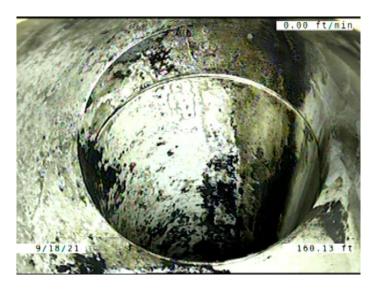
Code: TFA

Description: Tap Factory Activity

Distance (ft): 160.1
Structural Grade: 0
O&M Grade: 0
Clock Start/From: 3

1st Value: **6.000**

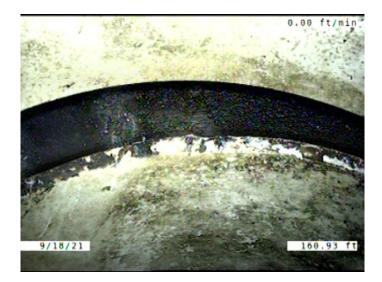
Code: JOL

Description: **Joint Offset Large**

Distance (ft): 160.9 Structural Grade: 4 0 O&M Grade:

1st Value: 1.000

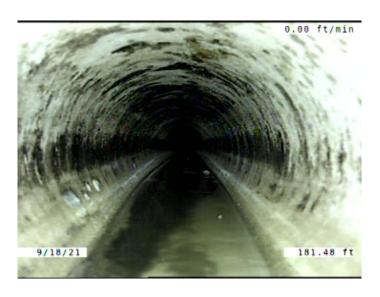
Code: **MWLS**

Description: **Miscellaneous Water Level Sag**

Distance (ft): 181.5 Structural Grade: 2 O&M Grade: 0

5.000 Value Percent: Continuous Index: **S06** Within 8" of Joint: NO

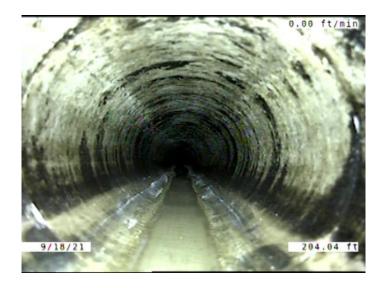
Description: **Miscellaneous Water Level Sag**

204.0 Distance (ft): Structural Grade: 2 0 O&M Grade:

Value Percent: 5.000 F06 Continuous Index: Within 8" of Joint: NO

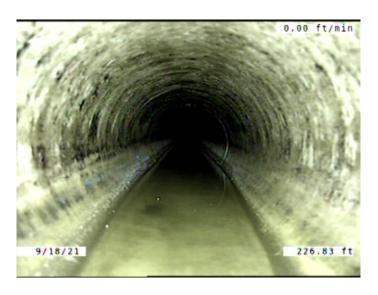
Code: **MWLS**

Description: **Miscellaneous Water Level Sag**

Distance (ft): 226.8 Structural Grade: 2 O&M Grade: 0

Value Percent: 5.000 Continuous Index: **S07** Within 8" of Joint: NO

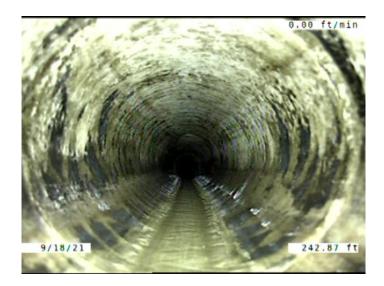
Description: Miscellaneous Water Level Sag

Distance (ft): 242.9
Structural Grade: 2
O&M Grade: 0

Value Percent: 5.000
Continuous Index: F07
Within 8" of Joint: NO

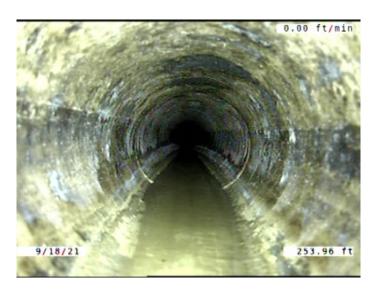
Code: MWLS

Description: Miscellaneous Water Level Sag

Distance (ft): 254.0
Structural Grade: 2
O&M Grade: 0

Value Percent: 5.000
Continuous Index: S08
Within 8" of Joint: NO

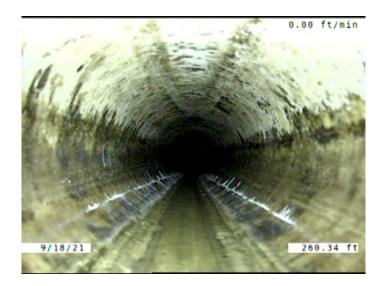
Description: **Miscellaneous Water Level Sag**

260.3 Distance (ft): Structural Grade: 2 0 O&M Grade:

Value Percent: 5.000 Continuous Index: F08 Within 8" of Joint: NO

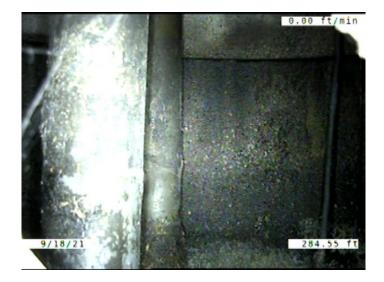
Description: Miscellaneous Water Level Sag

Distance (ft): 284.5
Structural Grade: 2
O&M Grade: 0

Value Percent: 10.000
Continuous Index: F09
Within 8" of Joint: NO

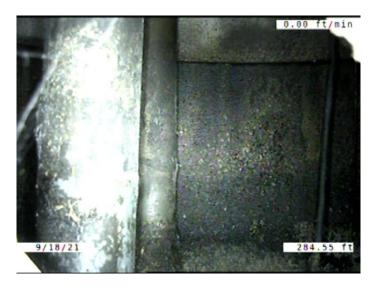
Code: **DSF**

Description: Deposits Settled Fine

Distance (ft): 284.5
Structural Grade: 0
O&M Grade: 2
Clock Start/From: 5
Clock To: 7
1st Value:

Value Percent: 5.000
Continuous Index: F01
Within 8" of Joint: YES

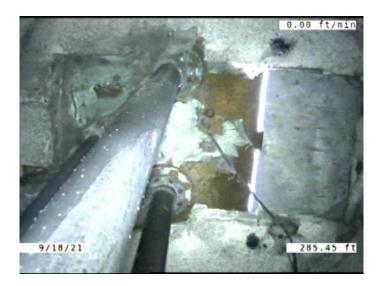
Code: AWW

Description: Access Point Wet Well

Distance (ft): 285.4
Structural Grade: 0

Within 8" of Joint: NO
Remarks: LS015
