Date:	09/18/2021	Weather:		Coding:	PACP 7.0
Pipe Length (ft)	: 285.4	Owner:	City of Hobart	Pre Clean:	Light Cleaning
P.O.#:	YES502259	Surveyor:	S. Bucklin	PSR:	P-802-019-LS015
Customer:	City of Hobart	Clean Date:	08/25/2021	Shape:	С
Street:	East Ridge Road		Flow Control:	Not Controlled	
City:	Hobart, IN		Year Renewed:		
Location:	Easement/Right o	f Way	Tape/Media #:		
Purpose:	Routine Assessme	nt	Dia/Height:	8"	
Use:	Sanitary Sewage P	Pipe	Material:	PVC	
Drain Area:			Lining:	None	
Category:	NA				
Comment:					
Location Details	S: NE CORNER OF KF	C PARKING LOT. IN	I Direction of Survey	2: Downstream	
US MH:	M-802-019	DS MH:	LS015	Total Length Surveyed (ft)	: <b>285.4</b>
0&M Index:	2.00	O&M Quick:	2J00	O&M Rating:	112.00
tructural Index:	2.10	Structural Qui	ck: 4131	Structural Rating:	63.00
Overall Index:	2.03	Overall Quick:	44.24	Overall Rating:	175.00

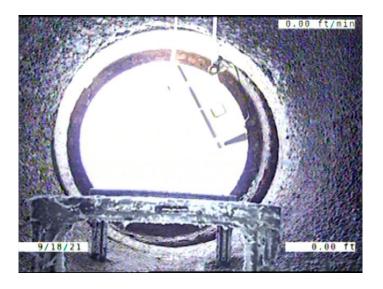
Code:	AMH Markala
Description:	Manhole
Distance (ft):	.0
Structural Grade:	0
O&M Grade:	0
Clock Start/From:	
Clock To:	
1st Value:	
2nd Value:	
Value Percent:	
Continuous Index:	
Within 8" of Joint:	NO
Remarks:	M-802-019

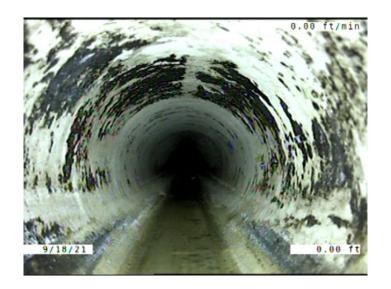
Code: Description:	MWL Miscellaneous Water Level
Distance (ft):	.0
Structural Grade:	0
O&M Grade:	0
Clock Start/From:	
Clock To:	
1st Value:	
2nd Value:	
Value Percent:	5.000
Continuous Index:	
Within 8" of Joint:	NO
Remarks:

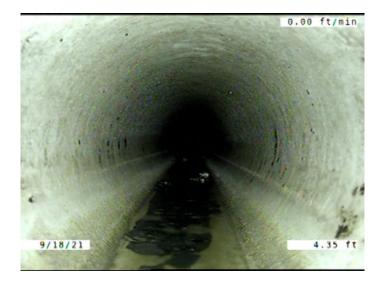
Code: Description:	DSF Deposits Settled Fine
Description	
Distance (ft):	4.3
Structural Grade:	0
O&M Grade:	2
Clock Start/From:	5
Clock To:	7
1st Value:	
2nd Value:	
Value Percent:	5.000
Continuous Index:	S01
Within 8" of Joint:	YES
Remarks:

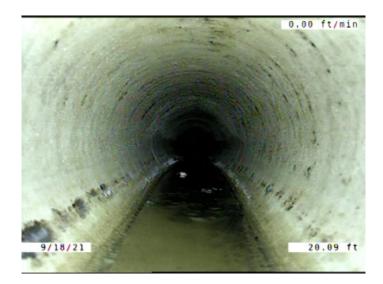
Code: Description:	MWLS Miscellaneous Water Level Sag
Distance (ft):	20.1
Structural Grade:	2
O&M Grade:	0
Clock Start/From:	
Clock To:	
1st Value:	
2nd Value:	
Value Percent:	5.000
Continuous Index:	
Within 8" of Joint:	NO
Remarks:

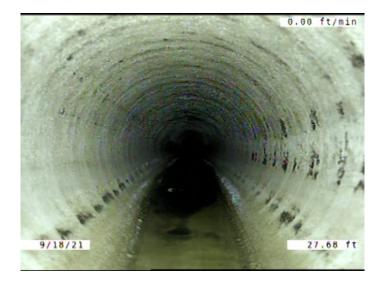
MWLS Miscellaneous Water Level Sag
27.7
2
0
5.000
S02
NO

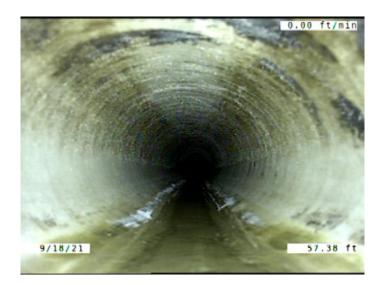
Code: Description:	MWLS Miscellaneous Water Level Sag
Distance (ft): Structural Grade: O&M Grade: Clock Start/From: Clock To:	57.4 2 0
1st Value: 2nd Value: Value Percent: Continuous Index: Within 8" of Joint: Remarks:	5.000 F02 NO

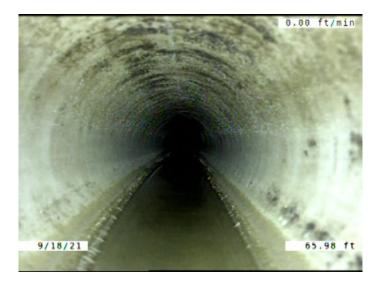
Code: Description:	MWLS Miscellaneous Water Level Sag
Distance (ft):	66.0
Structural Grade:	2
O&M Grade:	0
Clock Start/From:	
Clock To:	
1st Value:	
2nd Value:	
Value Percent:	5.000
Continuous Index:	S03
Within 8" of Joint:	NO
Remarks:

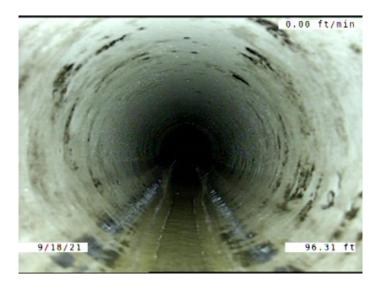
Code: Description:	MWLS Miscellaneous Water Level Sag
Distance (ft): Structural Grade: O&M Grade: Clock Start/From:	96.3 2 0
Clock To: 1st Value: 2nd Value:	
Value Percent: Continuous Index:	5.000 F03
Within 8" of Joint: Remarks:	NO

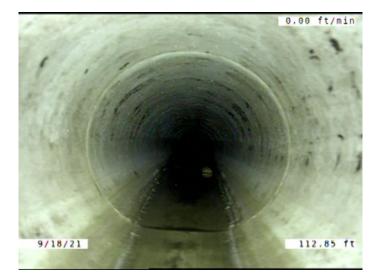
Code: Description:	MWLS Miscellaneous Water Level Sag
Distance (ft):	112.9
Structural Grade:	2
O&M Grade:	0
Clock Start/From:	
Clock To:	
1st Value:	
2nd Value:	
Value Percent:	5.000
Continuous Index:	S04
Within 8" of Joint:	NO
Remarks:

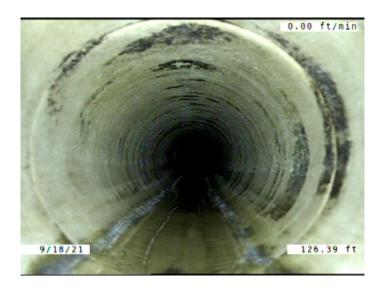
Code: Description:	MWLS Miscellaneous Water Level Sag
Distance (ft):	126.4
Structural Grade:	2
O&M Grade:	0
Clock Start/From:	
Clock To:	
1st Value:	
2nd Value:	
Value Percent:	5.000
Continuous Index:	F04
Within 8" of Joint:	NO
Remarks:

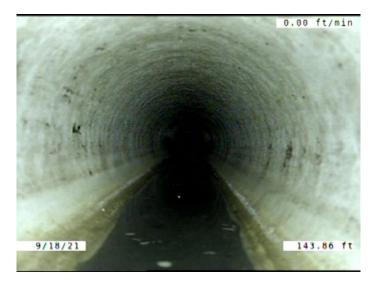
Code: Description:	MWLS Miscellaneous Water Level Sag
Distance (ft):	143.9
Structural Grade:	2
O&M Grade:	0
Clock Start/From:	
Clock To:	
1st Value:	
2nd Value:	
Value Percent:	5.000
Continuous Index:	S05
Within 8" of Joint:	NO
Remarks:

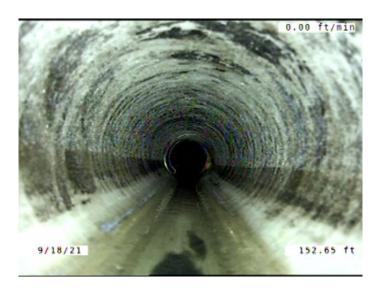
Code: Description:	MWLS Miscellaneous Water Level Sag
Distance (ft):	152.7
Structural Grade:	2
O&M Grade:	0
Clock Start/From:	
Clock To:	
1st Value:	
2nd Value:	
Value Percent:	5.000
Continuous Index:	F05
Within 8" of Joint:	NO
Remarks:

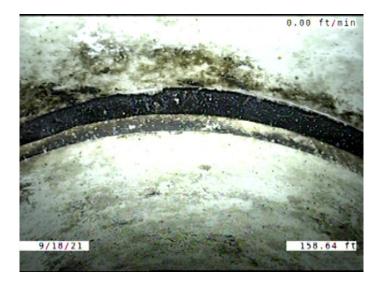
Code: Description:	JOM Joint Offset Medium
Distance (ft):	158.6
Structural Grade:	3
O&M Grade:	0
Clock Start/From:	
Clock To:	
1st Value:	
2nd Value:	
Value Percent:	
Continuous Index:	
Within 8" of Joint:	NO
Remarks:

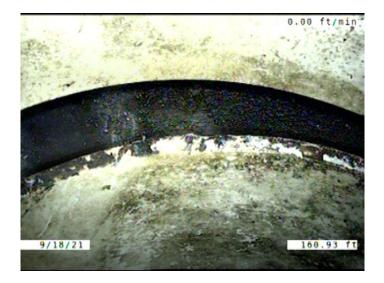
Code: Description:	JOL Joint Offset Large
Distance (ft):	160.9
Structural Grade:	4
O&M Grade:	0
Clock Start/From:	
Clock To:	
1st Value:	1.000
2nd Value:	
Value Percent:	
Continuous Index:	
Within 8" of Joint:	NO
Remarks:

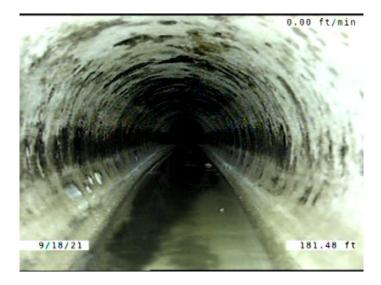
Code: Description:	MWLS Miscellaneous Water Level Sag
Distance (ft): Structural Grade: O&M Grade: Clock Start/From: Clock To: 1st Value: 2nd Value: Value Percent: Continuous Index:	181.5 2 0 5.000 S06
Within 8" of Joint: Remarks:	NO

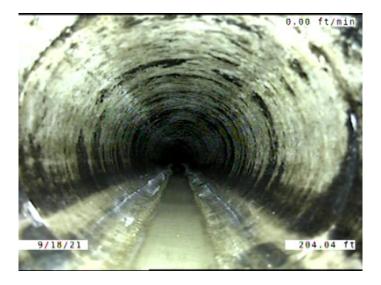
Code: Description:	MWLS Miscellaneous Water Level Sag
Distance (ft):	204.0
Structural Grade:	2
O&M Grade:	0
Clock Start/From:	
Clock To:	
1st Value:	
2nd Value:	
Value Percent:	5.000
Continuous Index:	F06
Within 8" of Joint:	NO
Remarks:

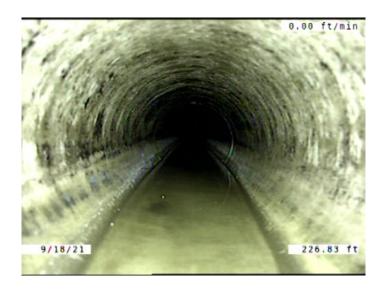
Code: Description:	MWLS Miscellaneous Water Level Sag
Distance (ft):	226.8
Structural Grade:	2
O&M Grade:	0
Clock Start/From:	
Clock To:	
1st Value:	
2nd Value:	
Value Percent:	5.000
Continuous Index:	S07
Within 8" of Joint:	NO
Remarks:

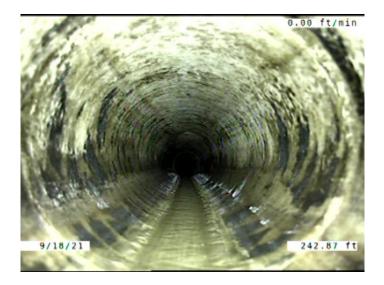
Code: Description:	MWLS Miscellaneous Water Level Sag
Distance (ft):	242.9
Structural Grade:	2
O&M Grade:	0
Clock Start/From:	
Clock To:	
1st Value:	
2nd Value:	
Value Percent:	5.000
Continuous Index:	F07
Within 8" of Joint:	NO
Remarks:

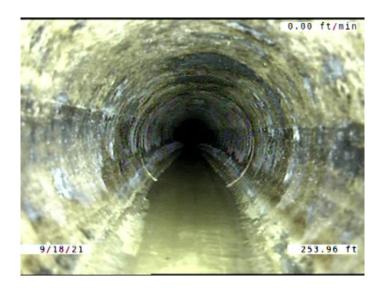
Code: Description:	MWLS Miscellaneous Water Level Sag
Distance (ft):	254.0
Structural Grade:	2
O&M Grade:	0
Clock Start/From:	
Clock To:	
1st Value:	
2nd Value:	
Value Percent:	5.000
Continuous Index:	S08
Within 8" of Joint:	NO
Remarks:

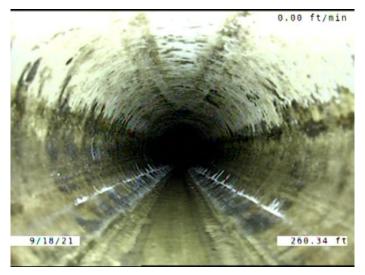
Code: Description:	MWLS Miscellaneous Water Level Sag
Distance (ft):	260.3
Structural Grade:	2
O&M Grade:	0
Clock Start/From:	
Clock To:	
1st Value:	
2nd Value:	
Value Percent:	5.000
Continuous Index:	F08
Within 8" of Joint:	NO
Remarks:

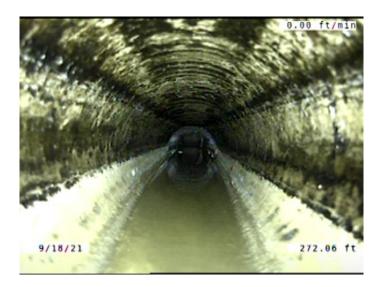
Code: Description:	MWLS Miscellaneous Water Level Sag
Distance (ft):	272.1
Structural Grade:	2
O&M Grade:	0
Clock Start/From:	
Clock To:	
1st Value:	
2nd Value:	
Value Percent:	10.000
Continuous Index:	S09
Within 8" of Joint:	NO
Remarks:

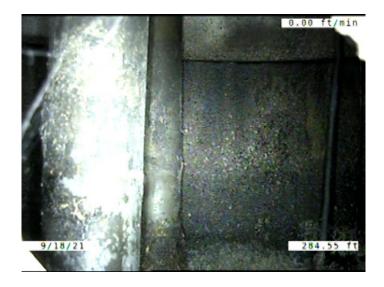
Code: Description:	MWLS Miscellaneous Water Level Sag
Distance (ft):	284.5
Structural Grade:	2
O&M Grade:	0
Clock Start/From:	
Clock To:	
1st Value:	
2nd Value:	
Value Percent:	10.000
Continuous Index:	F09
Within 8" of Joint:	NO

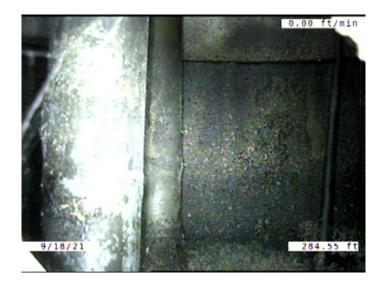
Code: Description:	DSF Deposits Settled Fine
Distance (ft): Structural Grade: O&M Grade: Clock Start/From: Clock To: 1st Value: 2nd Value: Value Percent: Continuous Index: Within 8" of Joint: Remarks:	284.5 0 2 5 7 5.000 F01 YES

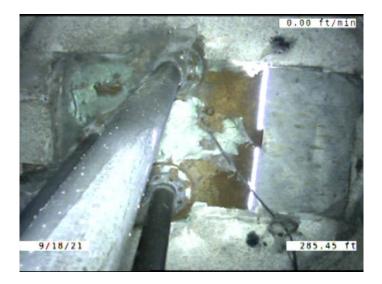
Code: AWW Description: Access Point Wet Well Distance (ft): 285.4 Structural Grade: 0 O&M Grade: 0 Clock Start/From: Clock To: 1st Value: 2nd Value: Value Percent: Continuous Index: Within 8" of Joint: NO LS015 Remarks:
