Profile/Photo Observation Report

Street:	7770 E Ridge Rd	Flow Control:	Not Controlled
City:	Hobart In	Year Renewed:	
Location:	Parking Lot	Tape/Media #:	Deliverable 1
Purpose:	Routine Assessment	Dia/Height:	6"
Use:	Sanitary	Material:	PVC
Drain Area:	Northeast	Lining:	
Category:	NA		
Comment:	428-1		
Location Details:	KFC parking lot	Direction of Survey:	Downstream
US MH:	M-802-25	DS MH:	M-802-019
		Total Length Surveyed (ft):	78.9

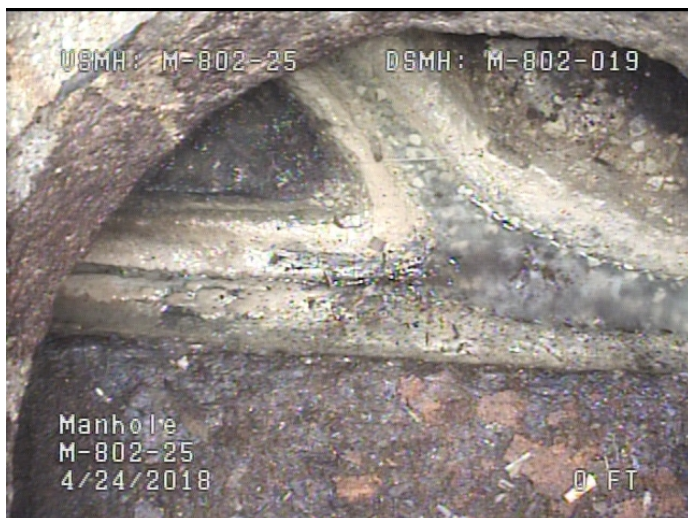
Code: **AMH**
 Description: **Manhole**

Distance (ft): **.0**
 Structural Grade: **0**
 O&M Grade: **0**
 Clock Start/From:
 Clock To:
 1st Value:
 2nd Value:
 Value Percent:
 Continuous Index:
 Within 8" of Joint: **NO**
 Remarks: **M-802-25**

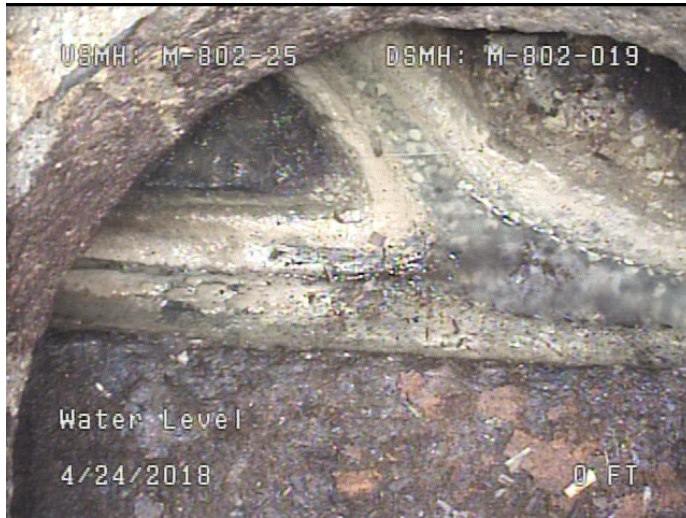
Code:	MWL
Description:	Water Level
Distance (ft):	.0
Structural Grade:	0
O&M Grade:	0
Clock Start/From:	
Clock To:	
1st Value:	
2nd Value:	
Value Percent:	5.000
Continuous Index:	
Within 8" of Joint:	NO
Remarks:

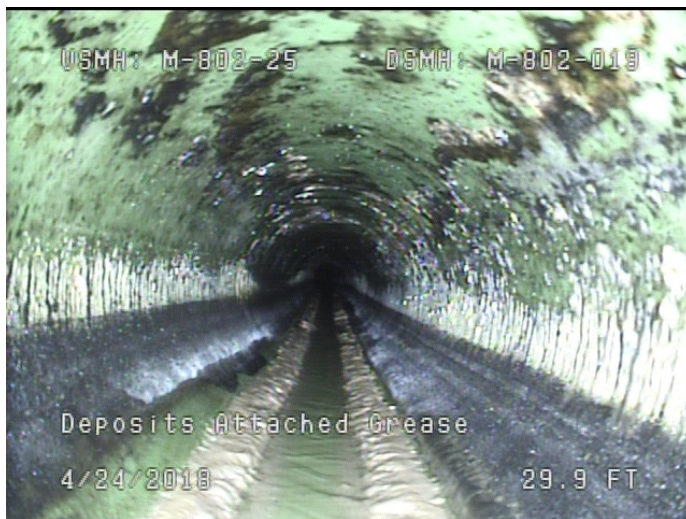
Code:	DAGS
Description:	Deposits Attached Grease
Distance (ft):	29.9
Structural Grade:	0
O&M Grade:	2
Clock Start/From:	12
Clock To:	12
1st Value:	
2nd Value:	
Value Percent:	5.000
Continuous Index:	S01
Within 8" of Joint:	NO
Remarks:

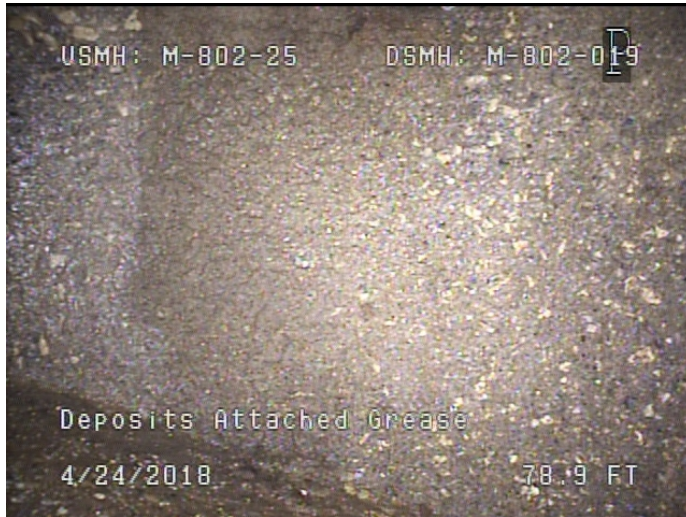
Code:	DAGS
Description:	Deposits Attached Grease
Distance (ft):	78.9
Structural Grade:	0
O&M Grade:	2
Clock Start/From:	12
Clock To:	12
1st Value:	
2nd Value:	
Value Percent:	5.000
Continuous Index:	F01
Within 8" of Joint:	NO
Remarks:

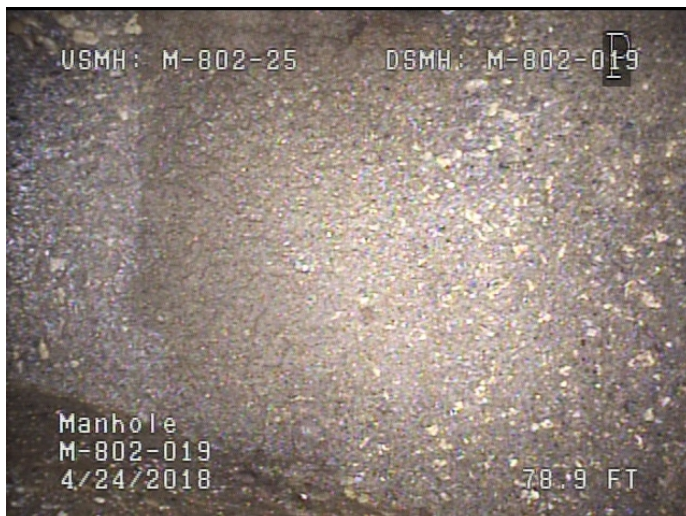
Code:	AMH
Description:	Manhole
Distance (ft):	78.9
Structural Grade:	0
O&M Grade:	0
Clock Start/From:	
Clock To:	
1st Value:	
2nd Value:	
Value Percent:	
Continuous Index:	
Within 8" of Joint:	NO
Remarks:	M-802-019
