Profile/Photo Observation Report

Street:	HIGH ST	Flow Control:	Not Controlled
City:	Hobart, IN	Year Renewed:	
Location:	Other	Tape/Media #:	
Purpose:	Not Known	Dia/Height:	10"
Use:	Sanitary	Material:	VCP
Drain Area:	NA	Lining:	
Category:	NA		
Comment:

Location Details:		Direction of Survey:	Upstream
US MH:	M-803-001	DS MH:	M-804-041
		Total Length Surveyed (ft):	7.3

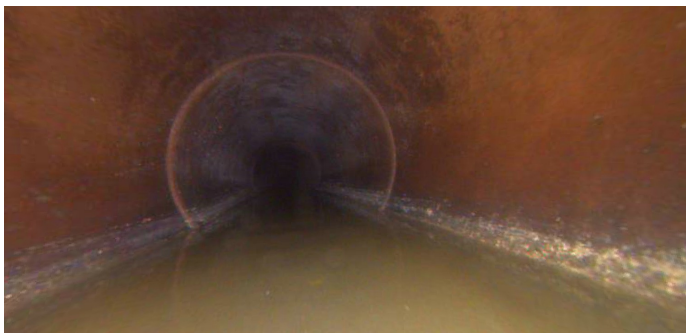
Code: **AMH**
Description: **Manhole**

Distance (ft): **.0**
Structural Grade: **0**
O&M Grade: **0**
Clock Start/From:
Clock To:
1st Value:
2nd Value:
Value Percent:
Continuous Index:
Within 8" of Joint: **NO**
Remarks: **M-804-041**

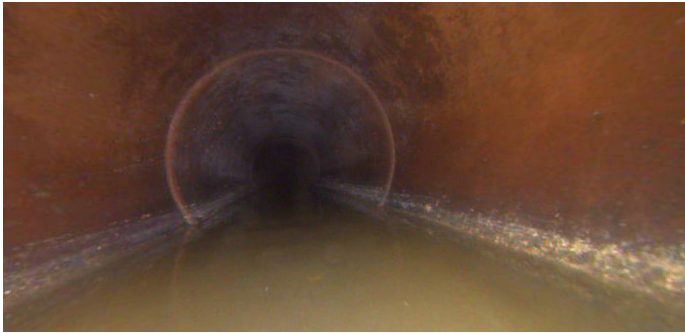
Code:	MWL
Description:	Water Level

Distance (ft):	.0
Structural Grade:	0
O&M Grade:	0
Clock Start/From:	
Clock To:	
1st Value:	
2nd Value:	
Value Percent:	30.000
Continuous Index:	
Within 8" of Joint:	NO
Remarks:

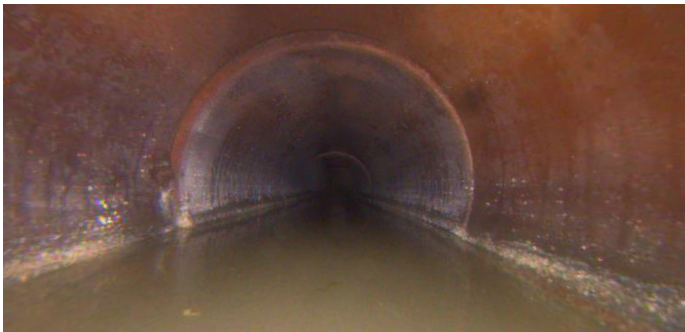
Code:	MSA
Description:	Abandoned Survey

Distance (ft):	7.3
Structural Grade:	0
O&M Grade:	0
Clock Start/From:	
Clock To:	
1st Value:	
2nd Value:	
Value Percent:	
Continuous Index:	
Within 8" of Joint:	NO
Remarks:	unknown
