Profile/Photo Observation Report

Street:	HIGH ST	Flow Control:	Not Controlled
City:	Hobart, IN	Year Renewed:	
Location:	Light Highway	Tape/Media #:	
Purpose:	Routine Assessment	Dia/Height:	12"
Use:	Sanitary	Material:	VCP
Drain Area:	NA	Lining:	
Category:	NA		
Comment:

Location Details:		Direction of Survey:	Upstream
US MH:	M-803-001	DS MH:	M-804-041
		Total Length Surveyed (ft):	7.7

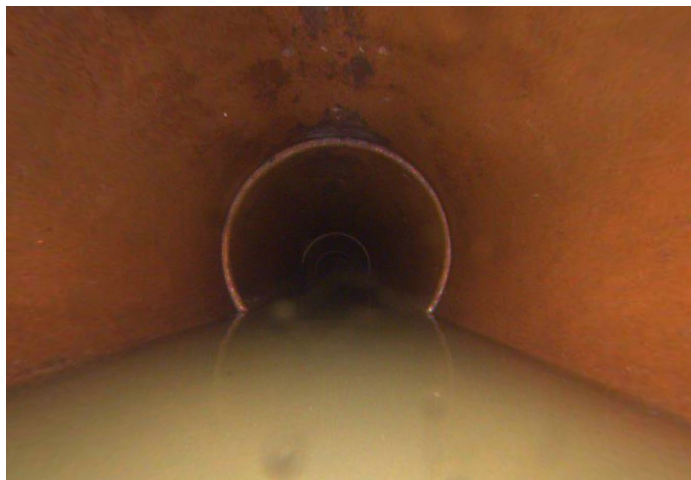
Code: **AMH**
 Description: **Manhole**

Distance (ft): **.0**
 Structural Grade: **0**
 O&M Grade: **0**
 Clock Start/From:
 Clock To:
 1st Value:
 2nd Value:
 Value Percent:
 Continuous Index:
 Within 8" of Joint: **NO**
 Remarks: **M-804-041**

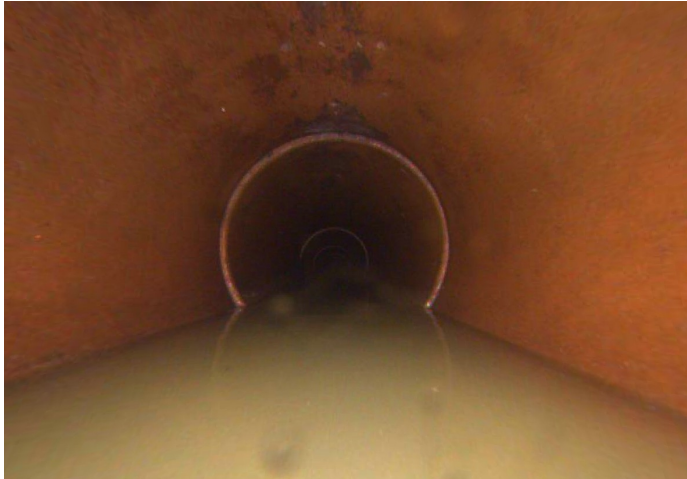
Code: **MWL**
Description: **Water Level**

Distance (ft): **.0**
Structural Grade: **0**
O&M Grade: **0**
Clock Start/From:
Clock To:
1st Value:
2nd Value:
Value Percent: **20.000**
Continuous Index:
Within 8" of Joint: **NO**
Remarks:

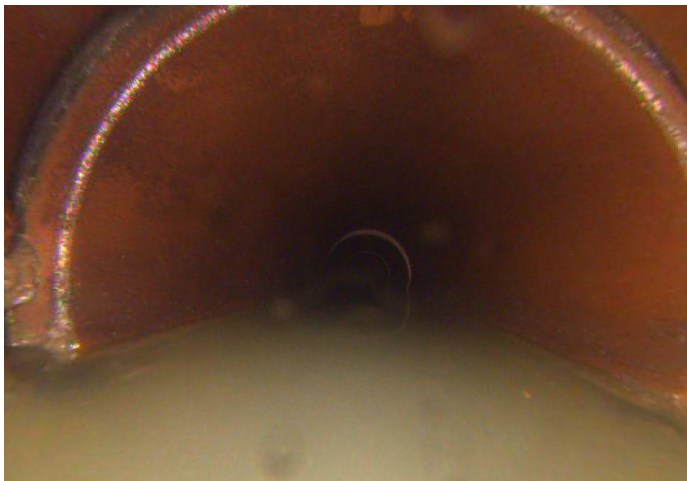
Code: **MSA**
Description: **Abandoned Survey**

Distance (ft): **7.7**
Structural Grade: **0**
O&M Grade: **0**
Clock Start/From:
Clock To:
1st Value:
2nd Value:
Value Percent:
Continuous Index:
Within 8" of Joint: **NO**
Remarks: **Unknown**
