Profile/Photo Observation Report

Street:	HIGH ST	Flow Control:	Not Controlled
City:	Hobart, IN	Year Renewed:	
Location:	Other	Tape/Media #:	
Purpose:	Not Known	Dia/Height:	10"
Use:	Sanitary	Material:	VCP
Drain Area:	NA	Lining:	
Category:	NA		
Comment:

Location Details:		Direction of Survey:	Downstream
US MH:	M-803-002	DS MH:	M-803-001
		Total Length Surveyed (ft):	38.7

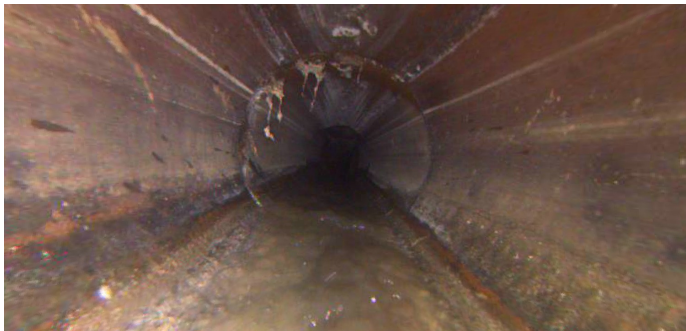
Code: **AMH**
Description: **Manhole**

Distance (ft): **.0**
Structural Grade: **0**
O&M Grade: **0**
Clock Start/From:
Clock To:
1st Value:
2nd Value:
Value Percent:
Continuous Index:
Within 8" of Joint: **NO**
Remarks: **M-803-002**

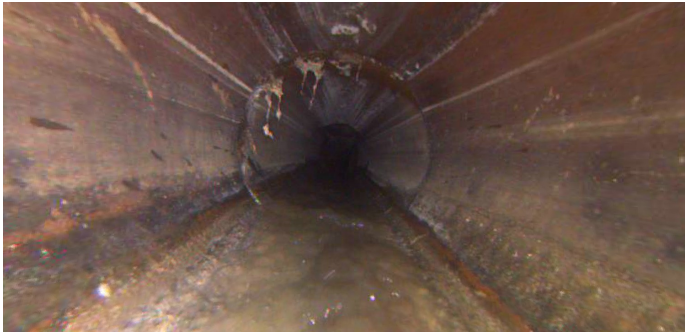
Code:	MWL
Description:	Water Level

Distance (ft):	.0
Structural Grade:	0
O&M Grade:	0
Clock Start/From:	
Clock To:	
1st Value:	
2nd Value:	
Value Percent:	5.000
Continuous Index:	
Within 8" of Joint:	NO
Remarks:

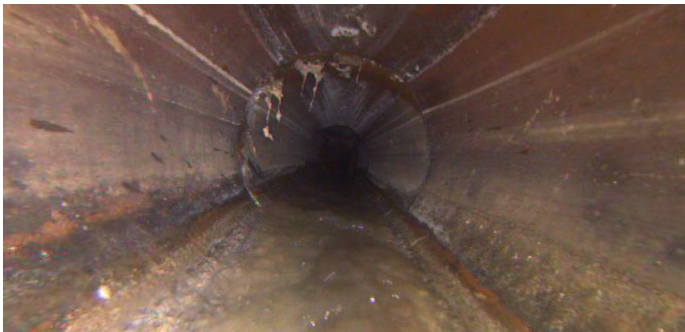
Code:	DAGS
Description:	Deposits Attached Grease

Distance (ft):	.0
Structural Grade:	0
O&M Grade:	2
Clock Start/From:	8
Clock To:	4
1st Value:	
2nd Value:	
Value Percent:	5.000
Continuous Index:	S01
Within 8" of Joint:	NO
Remarks:

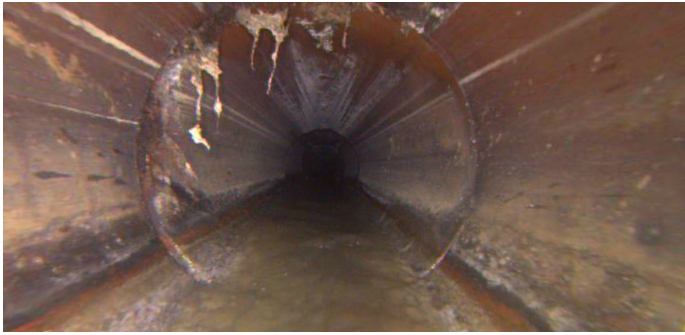
Code: **RFJ**
Description: **Roots Fine Joint**

Distance (ft): **1.6**
Structural Grade: **0**
O&M Grade: **1**
Clock Start/From: **8**
Clock To: **4**
1st Value:
2nd Value:
Value Percent:
Continuous Index:
Within 8" of Joint: **YES**
Remarks:

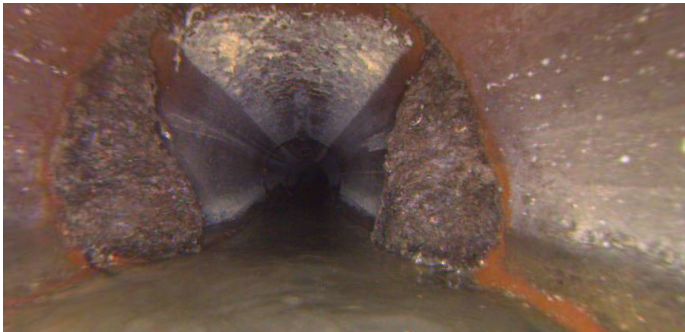
Code: **RMJ**
Description: **Roots Medium Joint**

Distance (ft): **7.8**
Structural Grade: **0**
O&M Grade: **3**
Clock Start/From: **8**
Clock To: **4**
1st Value:
2nd Value:
Value Percent: **10.000**
Continuous Index:
Within 8" of Joint: **YES**
Remarks:

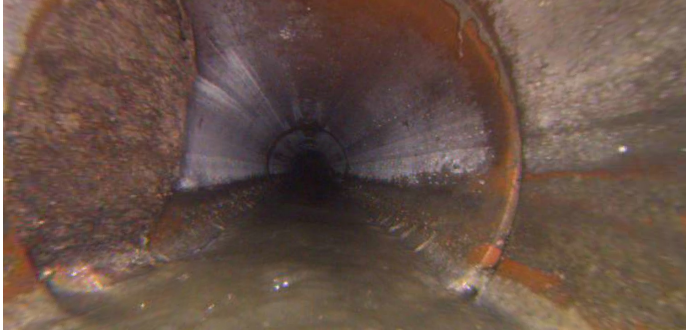
Code: **DAZ**
Description: **Deposits Attached Other**

Distance (ft): **16.8**
Structural Grade: **0**
O&M Grade: **3**
Clock Start/From: **7**
Clock To: **10**
1st Value:
2nd Value:
Value Percent: **15.000**
Continuous Index:
Within 8" of Joint: **YES**
Remarks:

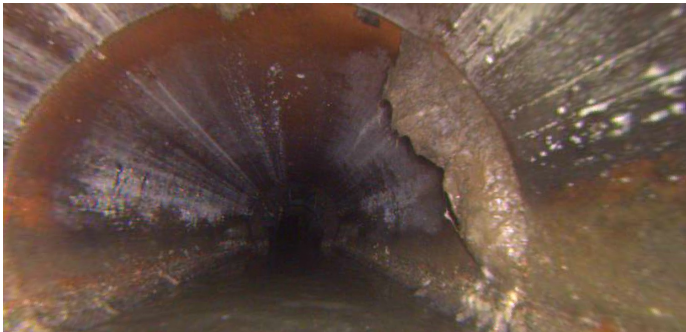
Code: **DAZ**
Description: **Deposits Attached Other**

Distance (ft): **22.7**
Structural Grade: **0**
O&M Grade: **2**
Clock Start/From: **1**
Clock To: **4**
1st Value:
2nd Value:
Value Percent: **10.000**
Continuous Index:
Within 8" of Joint: **YES**
Remarks:

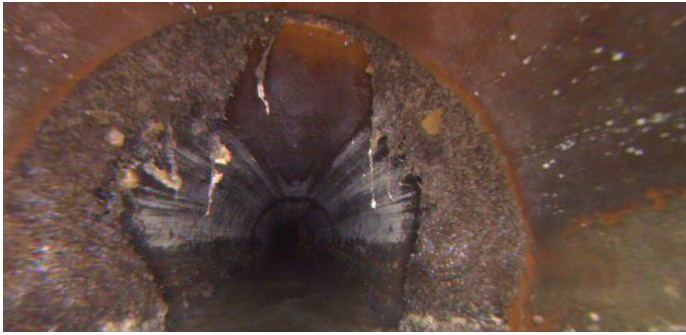
Code: **RMJ**
Description: **Roots Medium Joint**

Distance (ft): **25.7**
Structural Grade: **0**
O&M Grade: **3**
Clock Start/From: **8**
Clock To: **4**
1st Value:
2nd Value:
Value Percent: **20.000**
Continuous Index:
Within 8" of Joint: **YES**
Remarks:

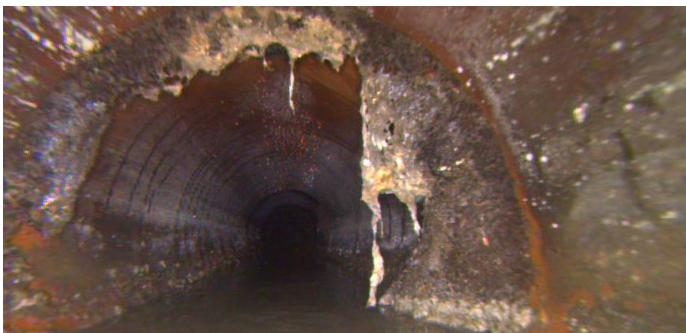
Code: **RMJ**
Description: **Roots Medium Joint**

Distance (ft): **31.7**
Structural Grade: **0**
O&M Grade: **3**
Clock Start/From: **8**
Clock To: **4**
1st Value:
2nd Value:
Value Percent: **10.000**
Continuous Index:
Within 8" of Joint: **YES**
Remarks:

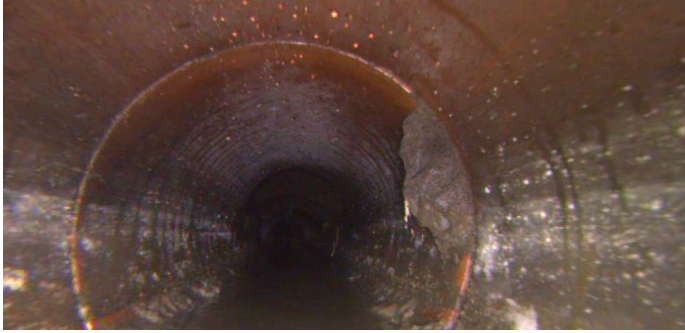
Code: **DAZ**
Description: **Deposits Attached Other**

Distance (ft): **34.5**
Structural Grade: **0**
O&M Grade: **2**
Clock Start/From: **2**
Clock To: **3**
1st Value:
2nd Value:
Value Percent: **5.000**
Continuous Index:
Within 8" of Joint: **YES**
Remarks:

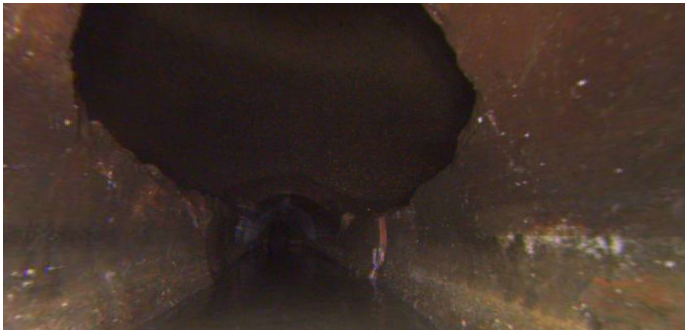
Code: **DAGS**
Description: **Deposits Attached Grease**

Distance (ft): **36.5**
Structural Grade: **0**
O&M Grade: **2**
Clock Start/From: **8**
Clock To: **4**
1st Value:
2nd Value:
Value Percent: **5.000**
Continuous Index: **F01**
Within 8" of Joint: **NO**
Remarks:

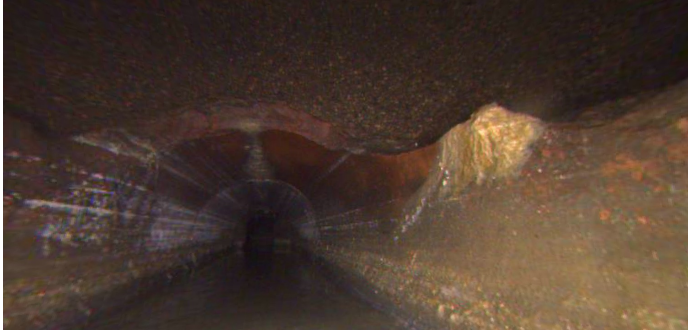
Code:	AMH
Description:	Manhole
Distance (ft):	38.7
Structural Grade:	0
O&M Grade:	0
Clock Start/From:	
Clock To:	
1st Value:	
2nd Value:	
Value Percent:	
Continuous Index:	
Within 8" of Joint:	NO
Remarks:	M-803-001
