## Profile/Photo Observation Report

Street:	<b>HI9GH ST</b>	Flow Control:	<b>Not Controlled</b>
City:	<b>Hobart, IN</b>	Year Renewed:	
Location:	<b>Other</b>	Tape/Media #:	
Purpose:	<b>Not Known</b>	Dia/Height:	<b>10"</b>
Use:	<b>Sanitary</b>	Material:	<b>VCP</b>
Drain Area:	<b>NA</b>	Lining:	
Category:	<b>NA</b>		
Comment:

Location Details:		Direction of Survey:	<b>Downstream</b>
US MH:	<b>M-803-002</b>	DS MH:	<b>M-803-001</b>
		Total Length Surveyed (ft):	<b>38.7</b>

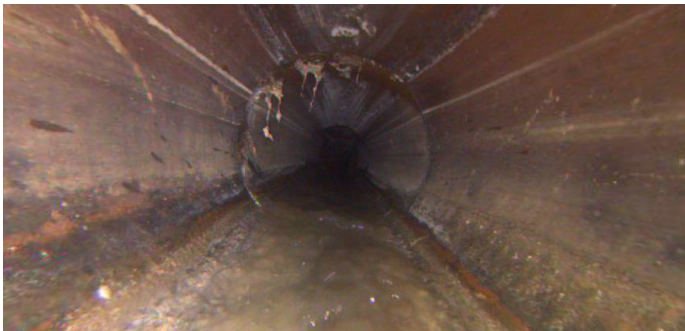
Code: **AMH**  
Description: **Manhole**

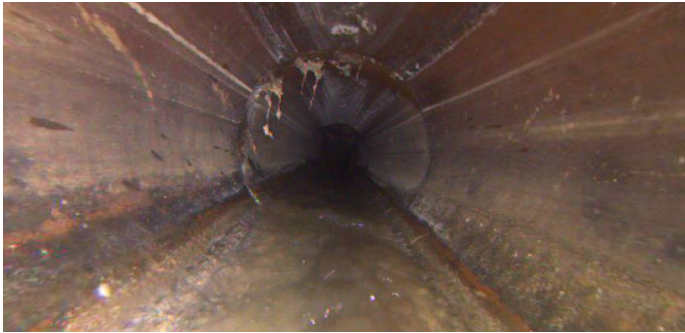
Code:	<b>MWL</b>
Description:	<b>Water Level</b>

Distance (ft):	<b>.0</b>
Structural Grade:	<b>0</b>
O&M Grade:	<b>0</b>
Clock Start/From:	
Clock To:	
1st Value:	
2nd Value:	
Value Percent:	<b>5.000</b>
Continuous Index:	
Within 8" of Joint:	<b>NO</b>
Remarks:

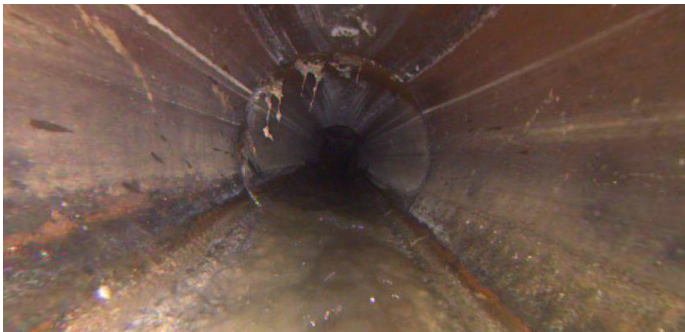
Code:	<b>DAGS</b>
Description:	<b>Deposits Attached Grease</b>

Distance (ft):	<b>.0</b>
Structural Grade:	<b>0</b>
O&M Grade:	<b>2</b>
Clock Start/From:	<b>8</b>
Clock To:	<b>4</b>
1st Value:	
2nd Value:	
Value Percent:	<b>5.000</b>
Continuous Index:	<b>S01</b>
Within 8" of Joint:	<b>NO</b>
Remarks:

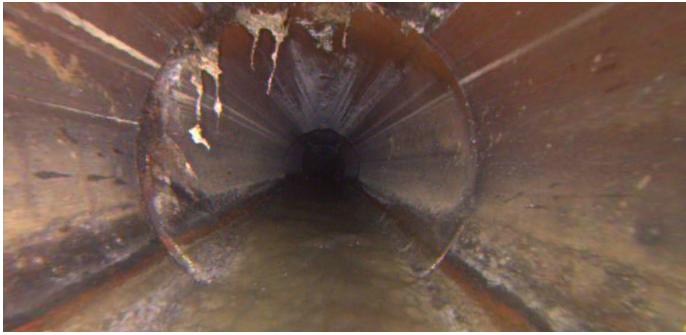
Code: **RFJ**  
Description: **Roots Fine Joint**

Distance (ft): **1.6**  
Structural Grade: **0**  
O&M Grade: **1**  
Clock Start/From: **8**  
Clock To: **4**  
1st Value:  
2nd Value:  
Value Percent:  
Continuous Index:  
Within 8" of Joint: **YES**  
Remarks:

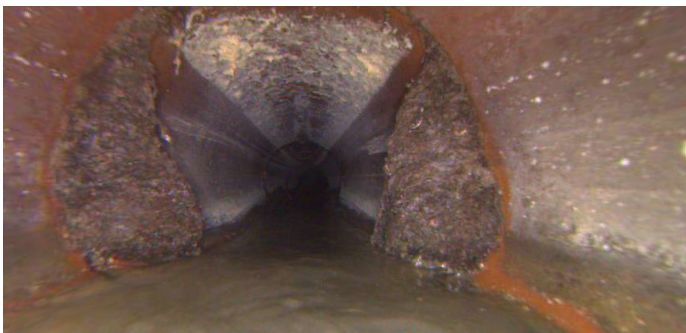
Code: **RMJ**  
Description: **Roots Medium Joint**

Distance (ft): **7.8**  
Structural Grade: **0**  
O&M Grade: **3**  
Clock Start/From: **8**  
Clock To: **4**  
1st Value:  
2nd Value:  
Value Percent: **10.000**  
Continuous Index:  
Within 8" of Joint: **YES**  
Remarks:

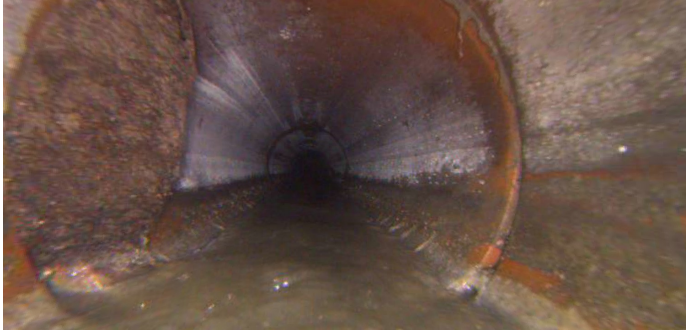
Code: **DAZ**  
Description: **Deposits Attached Other**

Distance (ft): **16.8**  
Structural Grade: **0**  
O&M Grade: **3**  
Clock Start/From: **7**  
Clock To: **10**  
1st Value:  
2nd Value:  
Value Percent: **15.000**  
Continuous Index:  
Within 8" of Joint: **YES**  
Remarks:

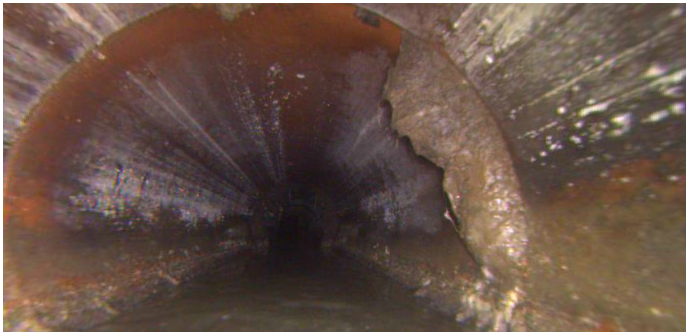
Code: **DAZ**  
Description: **Deposits Attached Other**

Distance (ft): **22.7**  
Structural Grade: **0**  
O&M Grade: **2**  
Clock Start/From: **1**  
Clock To: **4**  
1st Value:  
2nd Value:  
Value Percent: **10.000**  
Continuous Index:  
Within 8" of Joint: **YES**  
Remarks:

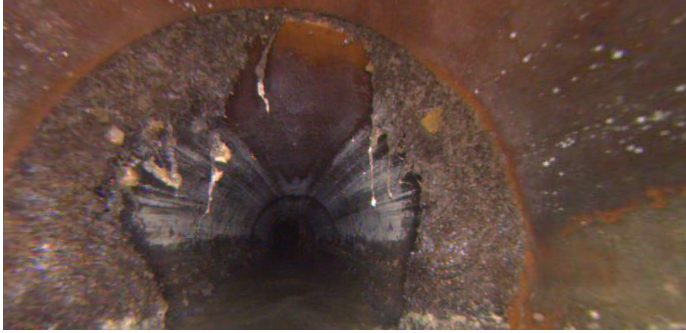
Code: **RMJ**  
Description: **Roots Medium Joint**

Distance (ft): **25.7**  
Structural Grade: **0**  
O&M Grade: **3**  
Clock Start/From: **8**  
Clock To: **4**  
1st Value:  
2nd Value:  
Value Percent: **20.000**  
Continuous Index:  
Within 8" of Joint: **YES**  
Remarks:

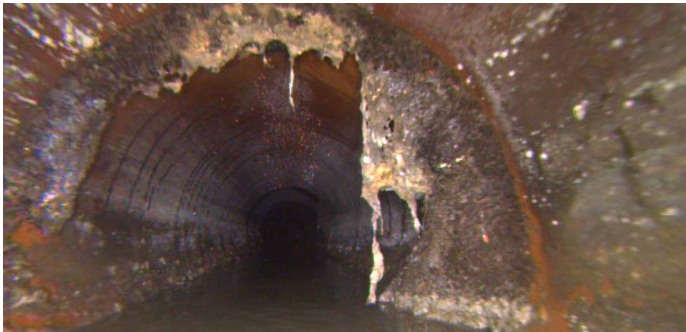
Code: **RMJ**  
Description: **Roots Medium Joint**

Distance (ft): **31.7**  
Structural Grade: **0**  
O&M Grade: **3**  
Clock Start/From: **8**  
Clock To: **4**  
1st Value:  
2nd Value:  
Value Percent: **10.000**  
Continuous Index:  
Within 8" of Joint: **YES**  
Remarks:

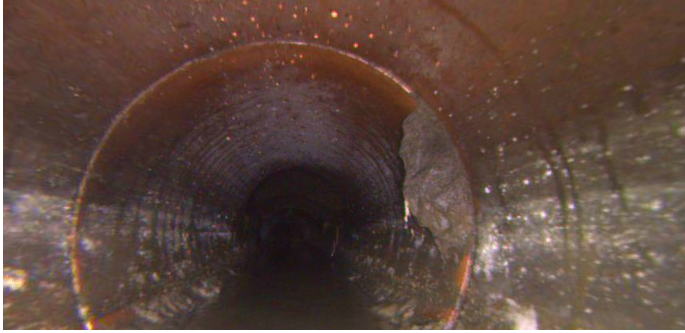
Code: **DAZ**  
Description: **Deposits Attached Other**

Distance (ft): **34.5**  
Structural Grade: **0**  
O&M Grade: **2**  
Clock Start/From: **2**  
Clock To: **3**  
1st Value:  
2nd Value:  
Value Percent: **5.000**  
Continuous Index:  
Within 8" of Joint: **YES**  
Remarks:

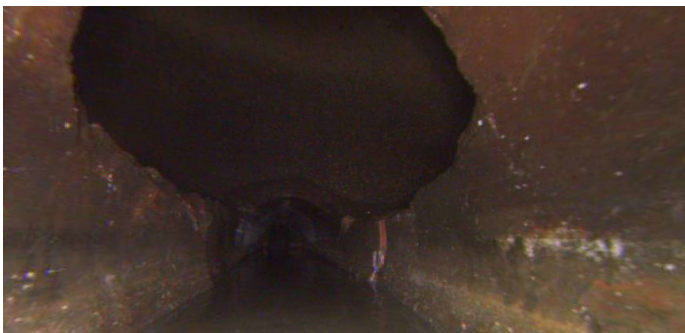
Code: **DAGS**  
Description: **Deposits Attached Grease**

Distance (ft): **36.5**  
Structural Grade: **0**  
O&M Grade: **2**  
Clock Start/From: **8**  
Clock To: **4**  
1st Value:  
2nd Value:  
Value Percent: **5.000**  
Continuous Index: **F01**  
Within 8" of Joint: **NO**  
Remarks:

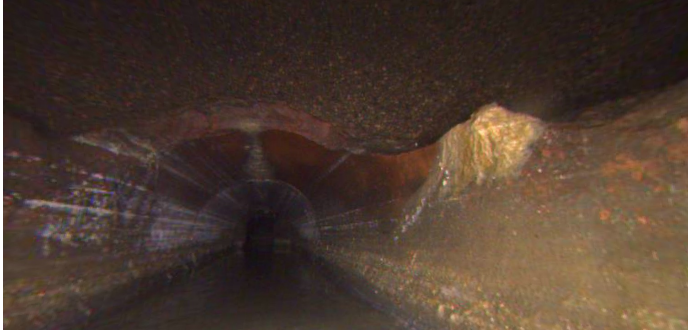
Code:	<b>AMH</b>
Description:	<b>Manhole</b>
Distance (ft):	<b>38.7</b>
Structural Grade:	<b>0</b>
O&M Grade:	<b>0</b>
Clock Start/From:	
Clock To:	
1st Value:	
2nd Value:	
Value Percent:	
Continuous Index:	
Within 8" of Joint:	<b>NO</b>
Remarks:	<b>M-803-001</b>
