Profile/Photo Observation Report

Date:	10/01/2018	Weather:		Coding:	PACP 6.0
Pipe Length (ft):	169.1	Owner:	NA	Pre Clean:	Not Known
P.O.#:		Surveyor:	Justin Gonzales	PSR:	P-803-004-003
Customer:		Clean Date:	01/01/1900	Shape:	C

Street:	ALLEY BETWEEN HIGH ST & E NORT	Flow Control:	Not Controlled
City:	Hobart, IN	Year Renewed:	
Location:	Light Highway	Tape/Media #:	
Purpose:	Routine Assessment	Dia/Height:	12"
Use:	Sanitary	Material:	VCP
Drain Area:	NA	Lining:	
Category:	NA		
Comment:

Location Details:		Direction of Survey:	Upstream
US MH:	M-803-003	DS MH:	M-803-004
		Total Length Surveyed (ft):	72.9

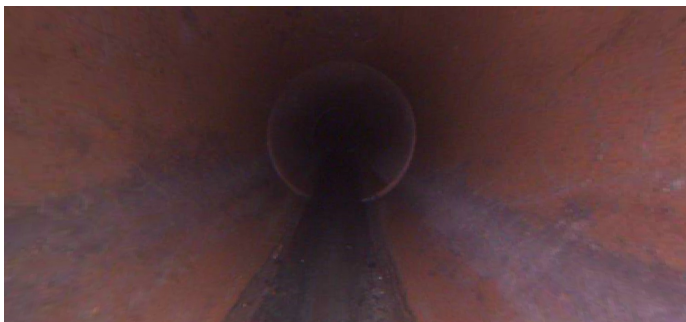
Code: **AMH**
Description: **Manhole**

Distance (ft): **.0**
Structural Grade: **0**
O&M Grade: **0**
Clock Start/From:
Clock To:
1st Value:
2nd Value:
Value Percent:
Continuous Index:
Within 8" of Joint: **NO**
Remarks: **M-803-004**

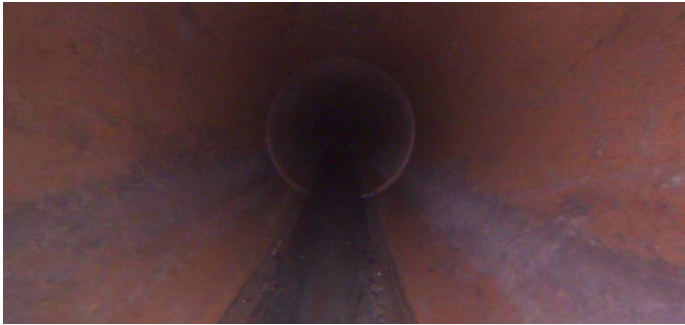
Code:	MWL
Description:	Water Level

Distance (ft):	.0
Structural Grade:	0
O&M Grade:	0
Clock Start/From:	
Clock To:	
1st Value:	
2nd Value:	
Value Percent:	5.000
Continuous Index:	
Within 8" of Joint:	NO
Remarks:

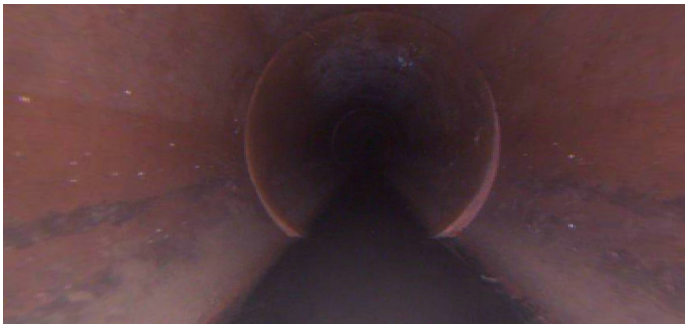
Code:	DAGS
Description:	Deposits Attached Grease

Distance (ft):	7.7
Structural Grade:	0
O&M Grade:	2
Clock Start/From:	7
Clock To:	5
1st Value:	
2nd Value:	
Value Percent:	5.000
Continuous Index:	S01
Within 8" of Joint:	YES
Remarks:	WANDER

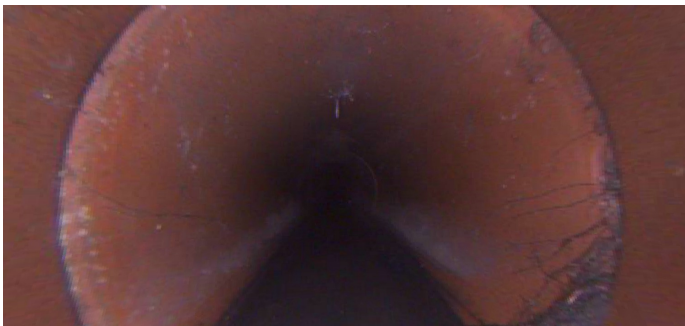
Code: **RFJ**
Description: **Roots Fine Joint**

Distance (ft): **17.3**
Structural Grade: **0**
O&M Grade: **1**
Clock Start/From: **7**
Clock To: **5**
1st Value:
2nd Value:
Value Percent:
Continuous Index:
Within 8" of Joint: **YES**
Remarks:

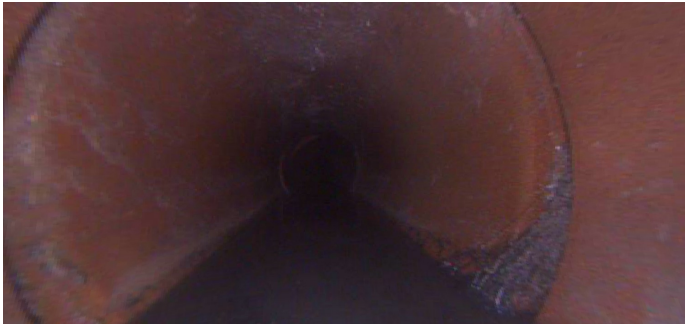
Code: **RFJ**
Description: **Roots Fine Joint**

Distance (ft): **23.4**
Structural Grade: **0**
O&M Grade: **1**
Clock Start/From: **4**
Clock To: **5**
1st Value:
2nd Value:
Value Percent:
Continuous Index:
Within 8" of Joint: **YES**
Remarks:

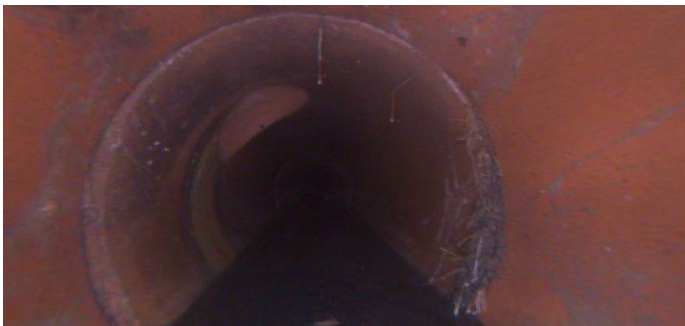
Code: **RFJ**
Description: **Roots Fine Joint**

Distance (ft): **26.3**
Structural Grade: **0**
O&M Grade: **1**
Clock Start/From: **3**
Clock To: **5**
1st Value:
2nd Value:
Value Percent:
Continuous Index:
Within 8" of Joint: **YES**
Remarks:

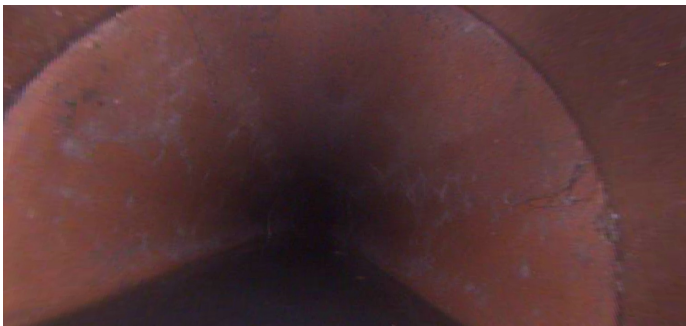
Code: **RFJ**
Description: **Roots Fine Joint**

Distance (ft): **29.4**
Structural Grade: **0**
O&M Grade: **1**
Clock Start/From: **3**
Clock To:
1st Value:
2nd Value:
Value Percent:
Continuous Index:
Within 8" of Joint: **YES**
Remarks:

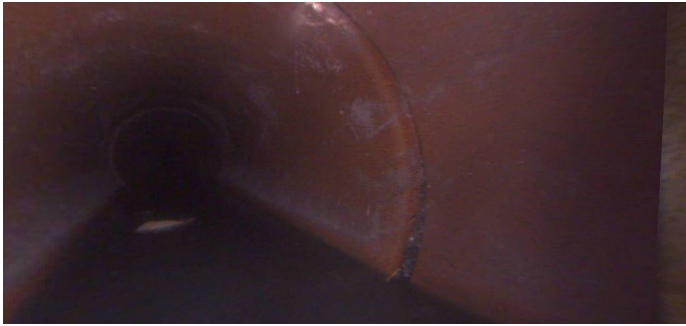
Code: **RFJ**
Description: **Roots Fine Joint**

Distance (ft): **32.3**
Structural Grade: **0**
O&M Grade: **1**
Clock Start/From: **5**
Clock To:
1st Value:
2nd Value:
Value Percent:
Continuous Index:
Within 8" of Joint: **YES**
Remarks:

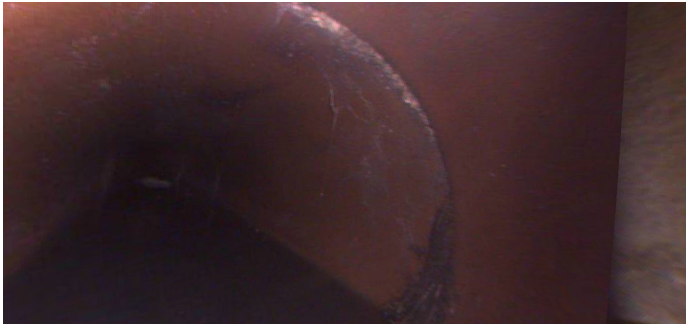
Code: **RFJ**
Description: **Roots Fine Joint**

Distance (ft): **38.5**
Structural Grade: **0**
O&M Grade: **1**
Clock Start/From: **12**
Clock To: **5**
1st Value:
2nd Value:
Value Percent:
Continuous Index:
Within 8" of Joint: **YES**
Remarks:

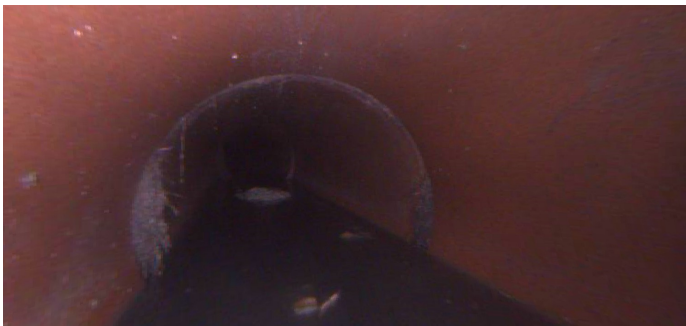
Code: **RFJ**
Description: **Roots Fine Joint**

Distance (ft): **41.0**
Structural Grade: **0**
O&M Grade: **1**
Clock Start/From: **7**
Clock To: **5**
1st Value:
2nd Value:
Value Percent:
Continuous Index:
Within 8" of Joint: **YES**
Remarks:

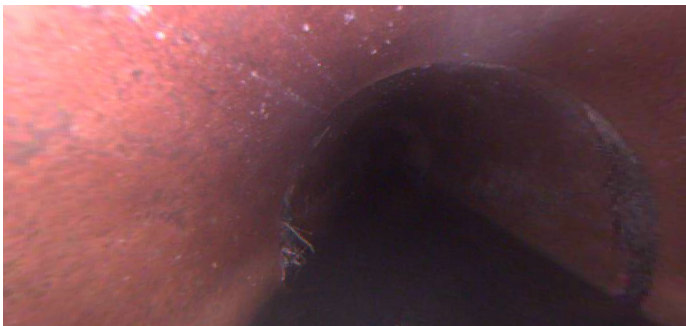
Code: **RFJ**
Description: **Roots Fine Joint**

Distance (ft): **53.3**
Structural Grade: **0**
O&M Grade: **1**
Clock Start/From: **7**
Clock To: **5**
1st Value:
2nd Value:
Value Percent:
Continuous Index:
Within 8" of Joint: **YES**
Remarks:

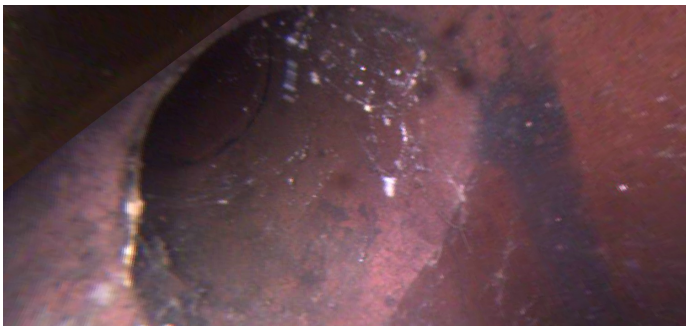
Code: **TF**
Description: **Tap Factory**

Distance (ft): **69.8**
Structural Grade: **0**
O&M Grade: **0**
Clock Start/From: **10**
Clock To:
1st Value: **4.000**
2nd Value:
Value Percent:
Continuous Index:
Within 8" of Joint:
Remarks:

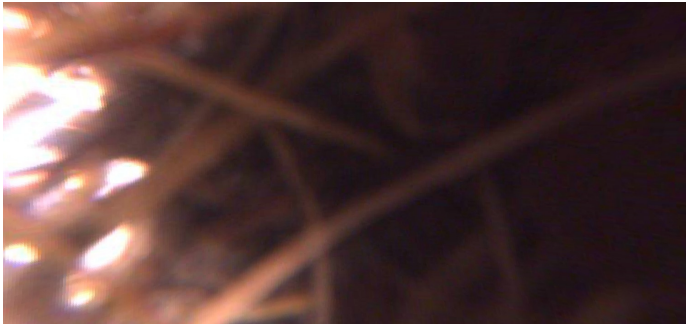
Code: **RFJ**
Description: **Roots Fine Joint**

Distance (ft): **72.9**
Structural Grade: **0**
O&M Grade: **1**
Clock Start/From: **7**
Clock To: **5**
1st Value:
2nd Value:
Value Percent:
Continuous Index: **F02**
Within 8" of Joint: **YES**
Remarks: **WANDER**
