Profile/Photo Observation Report

Date:	03/29/2018	Weather:		Coding:	PACP 6.0
Pipe Length (ft):	164.8	Owner:	NA	Pre Clean:	Not Known
P.O.#:		Surveyor:	Jen Costello	PSR:	P-803-005-004
Customer:		Clean Date:	01/01/1900	Shape:	C

Street:	ALLEY BETWEEN HIGH ST & E NORT	Flow Control:	Not Controlled
City:	Hobart, IN	Year Renewed:	
Location:	Other	Tape/Media #:	
Purpose:	Not Known	Dia/Height:	10"
Use:	Sanitary	Material:	VCP
Drain Area:	NA	Lining:	
Category:	NA		
Comment:

Location Details:		Direction of Survey:	Upstream
US MH:	M-803-004	DS MH:	M-803-005
		Total Length Surveyed (ft):	16.2

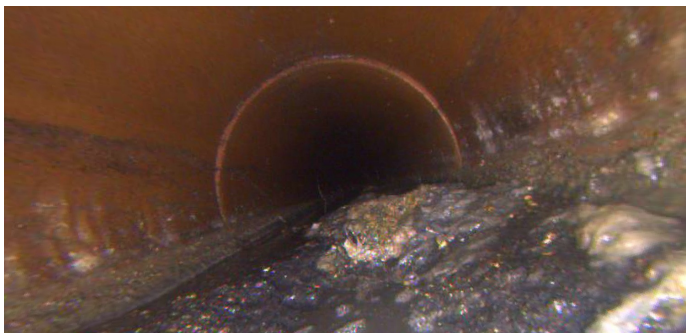
Code: **AMH**
Description: **Manhole**

Distance (ft): **.0**
Structural Grade: **0**
O&M Grade: **0**
Clock Start/From:
Clock To:
1st Value:
2nd Value:
Value Percent:
Continuous Index:
Within 8" of Joint: **NO**
Remarks: **M-803-005**

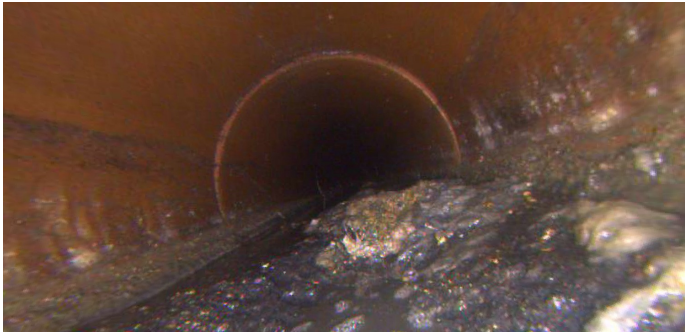
Code:	MWL
Description:	Water Level

Distance (ft):	.0
Structural Grade:	0
O&M Grade:	0
Clock Start/From:	
Clock To:	
1st Value:	
2nd Value:	
Value Percent:	40.000
Continuous Index:	
Within 8" of Joint:	NO
Remarks:

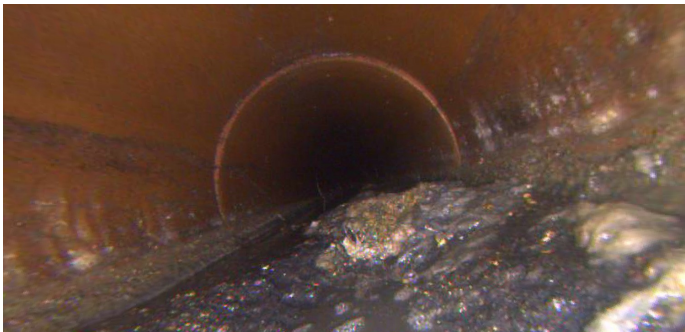
Code:	DSF
Description:	Deposits Settled Fine

Distance (ft):	.0
Structural Grade:	0
O&M Grade:	5
Clock Start/From:	4
Clock To:	8
1st Value:	
2nd Value:	
Value Percent:	40.000
Continuous Index:	
Within 8" of Joint:	NO
Remarks:

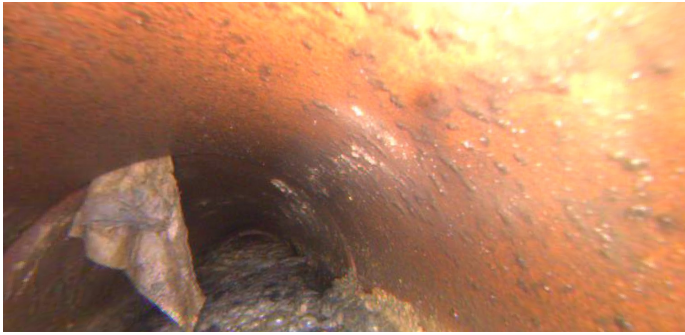
Code: **DAR**
Description: **Deposits Attached Ragging**

Distance (ft): **14.6**
Structural Grade: **0**
O&M Grade: **3**
Clock Start/From: **11**
Clock To: **12**
1st Value:
2nd Value:
Value Percent: **20.000**
Continuous Index:
Within 8" of Joint: **YES**
Remarks:

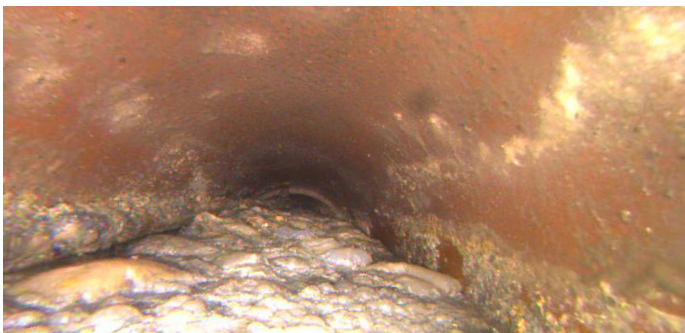
Code: **DSZ**
Description: **Deposits Settled Other**

Distance (ft): **16.2**
Structural Grade: **0**
O&M Grade: **5**
Clock Start/From: **3**
Clock To: **9**
1st Value:
2nd Value:
Value Percent: **40.000**
Continuous Index:
Within 8" of Joint: **NO**
Remarks: **misc**

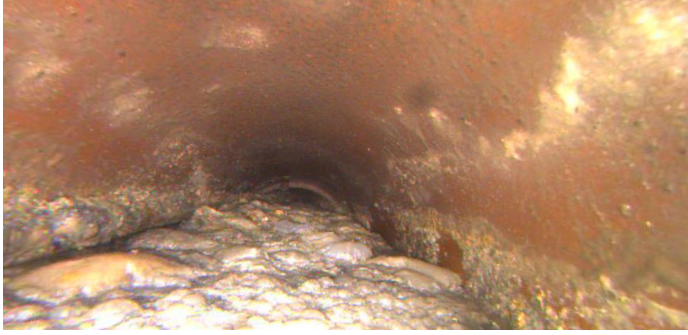
Code:	MSA
Description:	Abandoned Survey
Distance (ft):	16.2
Structural Grade:	0
O&M Grade:	0
Clock Start/From:	
Clock To:	
1st Value:	
2nd Value:	
Value Percent:	
Continuous Index:	
Within 8" of Joint:	NO
Remarks:	DSZ
