Profile/Photo Observation Report

Date:	03/29/2018	Weather:		Coding:	PACP 6.0
Pipe Length (ft):	164.8	Owner:	NA	Pre Clean:	Not Known
P.O.#:		Surveyor:	Jen Costello	PSR:	P-803-005-004
Customer:		Clean Date:	01/01/1900	Shape:	C

Location Details:		Direction of Survey:	Upstream
US MH:	M-803-004	DS MH:	M-803-005
		Total Length Surveyed (ft):	16.2

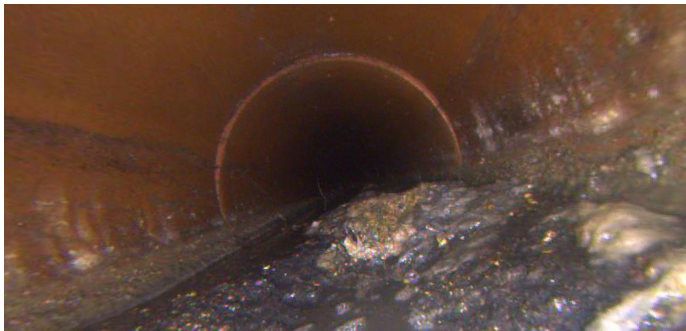
Code: **AMH**
Description: **Manhole**

Distance (ft): **.0**
Structural Grade: **0**
O&M Grade: **0**
Clock Start/From:
Clock To:
1st Value:
2nd Value:
Value Percent:
Continuous Index:
Within 8" of Joint: **NO**
Remarks: **M-803-005**

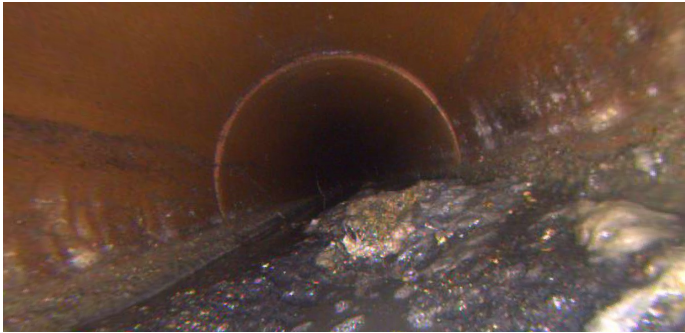
Code:	MWL
Description:	Water Level

Distance (ft):	.0
Structural Grade:	0
O&M Grade:	0
Clock Start/From:	
Clock To:	
1st Value:	
2nd Value:	
Value Percent:	40.000
Continuous Index:	
Within 8" of Joint:	NO
Remarks:

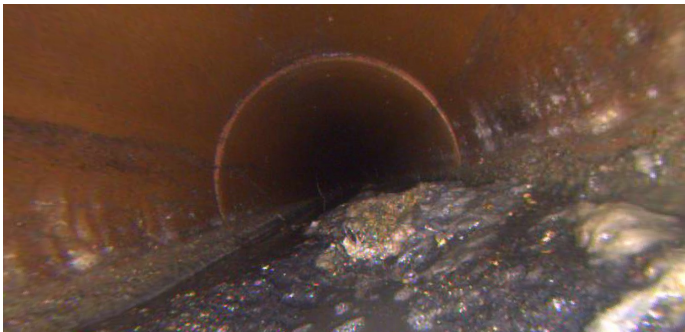
Code:	DSF
Description:	Deposits Settled Fine

Distance (ft):	.0
Structural Grade:	0
O&M Grade:	5
Clock Start/From:	4
Clock To:	8
1st Value:	
2nd Value:	
Value Percent:	40.000
Continuous Index:	
Within 8" of Joint:	NO
Remarks:

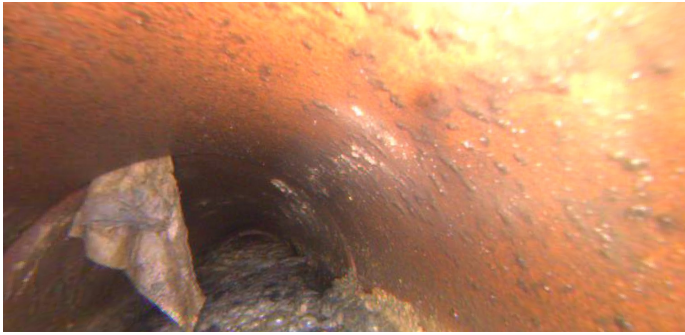
Code: **DAR**
Description: **Deposits Attached Ragging**

Distance (ft): **14.6**
Structural Grade: **0**
O&M Grade: **3**
Clock Start/From: **11**
Clock To: **12**
1st Value:
2nd Value:
Value Percent: **20.000**
Continuous Index:
Within 8" of Joint: **YES**
Remarks:

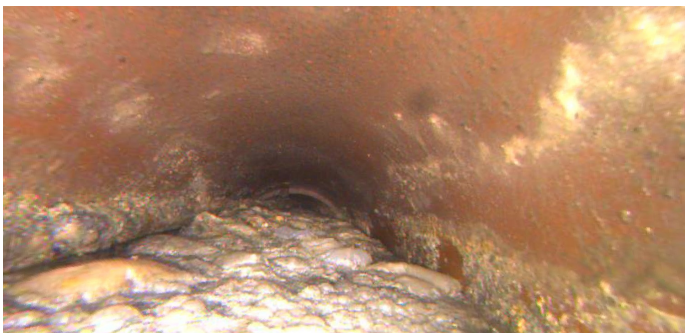
Code: **DSZ**
Description: **Deposits Settled Other**

Distance (ft): **16.2**
Structural Grade: **0**
O&M Grade: **5**
Clock Start/From: **3**
Clock To: **9**
1st Value:
2nd Value:
Value Percent: **40.000**
Continuous Index:
Within 8" of Joint: **NO**
Remarks: **misc**

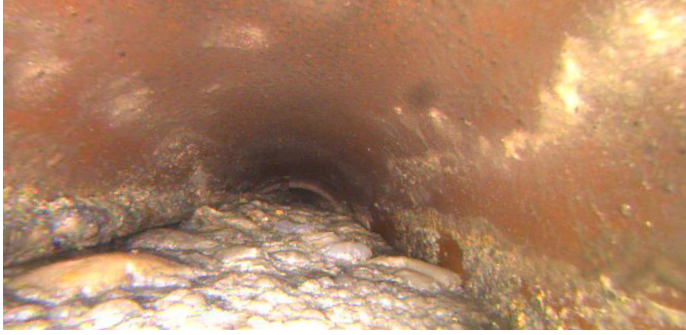
Code:	MSA
Description:	Abandoned Survey
Distance (ft):	16.2
Structural Grade:	0
O&M Grade:	0
Clock Start/From:	
Clock To:	
1st Value:	
2nd Value:	
Value Percent:	
Continuous Index:	
Within 8" of Joint:	NO
Remarks:	DSZ
