## Profile/Photo Observation Report

Street:	<b>ALLEY BETWEEN HIGH ST &amp; E NORT</b>	Flow Control:	<b>Not Controlled</b>
City:	<b>Hobart, IN</b>	Year Renewed:	
Location:	<b>Other</b>	Tape/Media #:	
Purpose:	<b>Not Known</b>	Dia/Height:	<b>10"</b>
Use:	<b>Sanitary</b>	Material:	<b>VCP</b>
Drain Area:	<b>NA</b>	Lining:	
Category:	<b>NA</b>		
Comment:

Location Details:		Direction of Survey:	<b>Downstream</b>
US MH:	<b>M-803-005</b>	DS MH:	<b>M-803-006</b>
		Total Length Surveyed (ft):	<b>96.0</b>

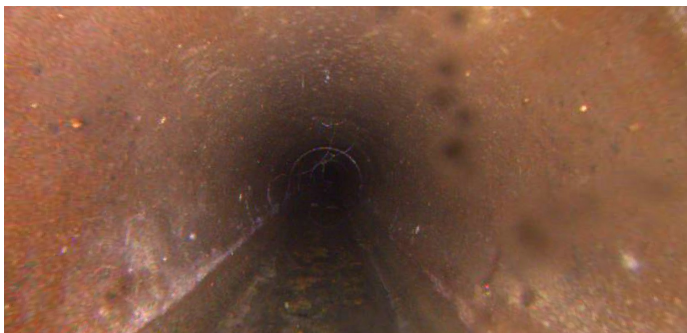
96.0	AMH	Manhole	410	NA
<div> <div>Code:</div> <div>Description:</div> </div> <div> <div>Distance (ft):</div> <div>Structural Grade:</div> <div>O&amp;M Grade:</div> <div>Clock Start/From:</div> <div>Clock To:</div> <div>1st Value:</div> <div>2nd Value:</div> <div>Value Percent:</div> <div>Continuous Index:</div> <div>Within 8" of Joint:</div> <div>Remarks:</div> </div> <div> <div>AMH</div> <div>Manhole</div> <div>.0</div> <div>0</div> <div>0</div> <div></div> <div></div> <div></div> <div></div> <div></div> <div>NO</div> <div>M-803-005</div> </div>

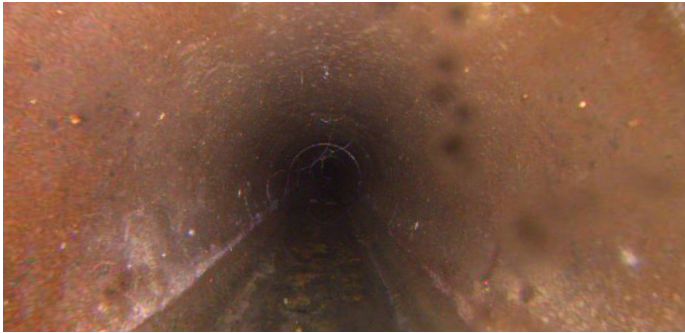
Code:	<b>MWL</b>
Description:	<b>Water Level</b>

Distance (ft):	<b>.0</b>
Structural Grade:	<b>0</b>
O&M Grade:	<b>0</b>
Clock Start/From:	
Clock To:	
1st Value:	
2nd Value:	
Value Percent:	<b>5.000</b>
Continuous Index:	
Within 8" of Joint:	<b>NO</b>
Remarks:

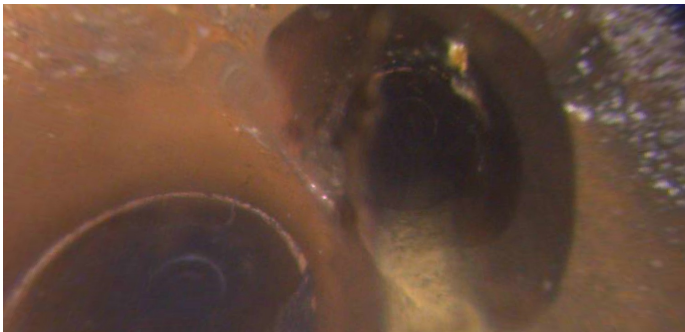
Code:	<b>TFA</b>
Description:	<b>Tap Factory Active</b>

Distance (ft):	<b>29.5</b>
Structural Grade:	<b>0</b>
O&M Grade:	<b>0</b>
Clock Start/From:	<b>2</b>
Clock To:	
1st Value:	<b>4.000</b>
2nd Value:	
Value Percent:	
Continuous Index:	
Within 8" of Joint:	
Remarks:

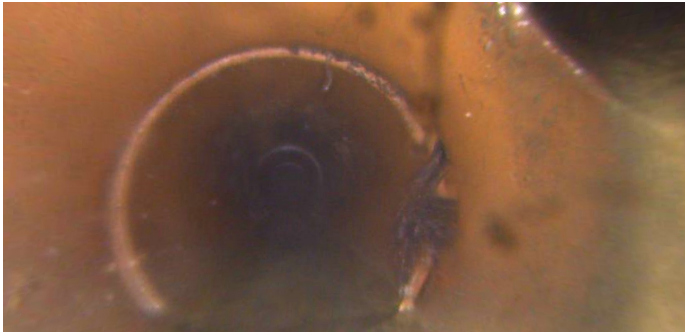
Code: **RFJ**  
Description: **Roots Fine Joint**

Distance (ft): **29.8**  
Structural Grade: **0**  
O&M Grade: **1**  
Clock Start/From: **8**  
Clock To: **4**  
1st Value:  
2nd Value:  
Value Percent:  
Continuous Index: **S01**  
Within 8" of Joint: **YES**  
Remarks:

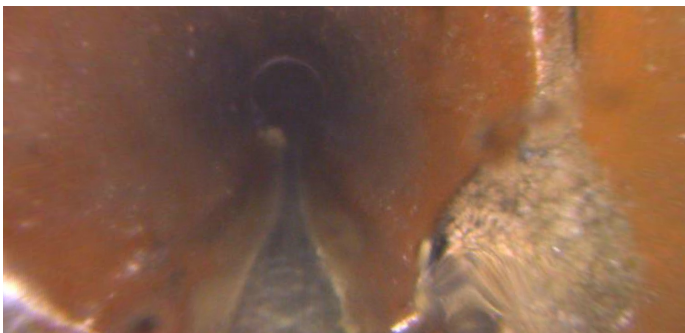
Code: **DAE**  
Description: **Deposits Attached Encrustation**

Distance (ft): **42.2**  
Structural Grade: **0**  
O&M Grade: **2**  
Clock Start/From: **3**  
Clock To: **5**  
1st Value:  
2nd Value:  
Value Percent: **5.000**  
Continuous Index:  
Within 8" of Joint: **YES**  
Remarks:

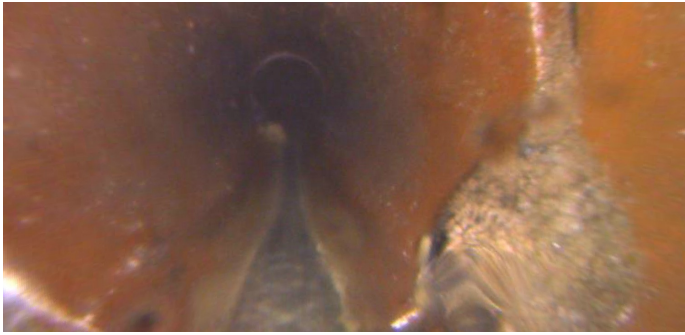
Code: **RFJ**  
Description: **Roots Fine Joint**

Distance (ft): **42.2**  
Structural Grade: **0**  
O&M Grade: **1**  
Clock Start/From: **8**  
Clock To: **4**  
1st Value:  
2nd Value:  
Value Percent:  
Continuous Index: **F01**  
Within 8" of Joint: **YES**  
Remarks:

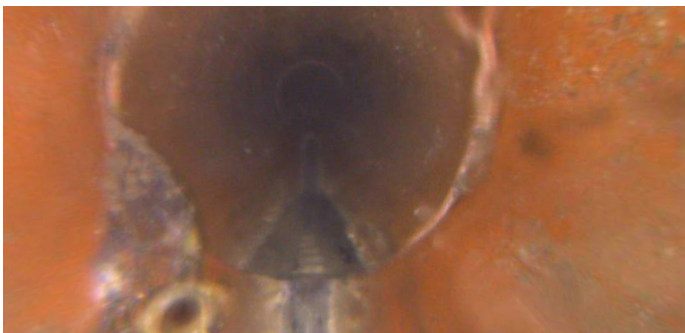
Code: **RMJ**  
Description: **Roots Medium Joint**

Distance (ft): **44.9**  
Structural Grade: **0**  
O&M Grade: **3**  
Clock Start/From: **8**  
Clock To: **9**  
1st Value:  
2nd Value:  
Value Percent: **5.000**  
Continuous Index:  
Within 8" of Joint: **YES**  
Remarks:

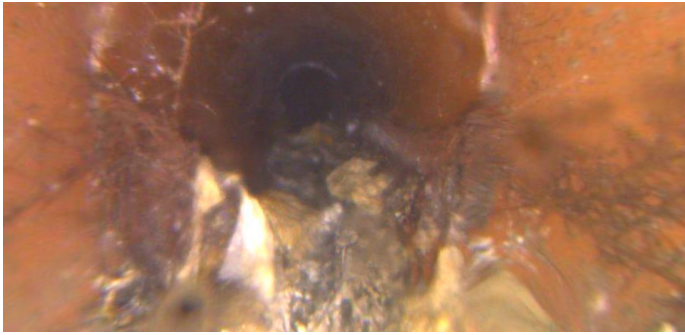
Code: **RMJ**  
Description: **Roots Medium Joint**

Distance (ft): **50.8**  
Structural Grade: **0**  
O&M Grade: **3**  
Clock Start/From: **3**  
Clock To: **9**  
1st Value:  
2nd Value:  
Value Percent: **30.000**  
Continuous Index:  
Within 8" of Joint: **YES**  
Remarks:

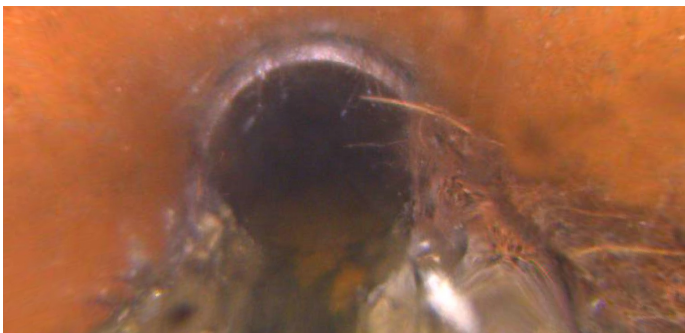
Code: **RMJ**  
Description: **Roots Medium Joint**

Distance (ft): **53.6**  
Structural Grade: **0**  
O&M Grade: **3**  
Clock Start/From: **8**  
Clock To: **4**  
1st Value:  
2nd Value:  
Value Percent: **20.000**  
Continuous Index:  
Within 8" of Joint: **YES**  
Remarks:

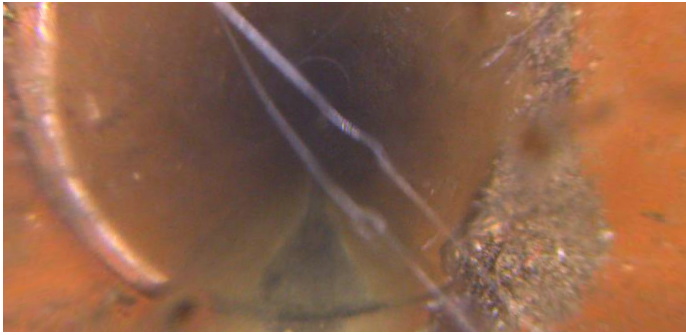
Code: **RMJ**  
Description: **Roots Medium Joint**

Distance (ft): **59.9**  
Structural Grade: **0**  
O&M Grade: **3**  
Clock Start/From: **2**  
Clock To: **4**  
1st Value:  
2nd Value:  
Value Percent: **5.000**  
Continuous Index:  
Within 8" of Joint: **YES**  
Remarks:

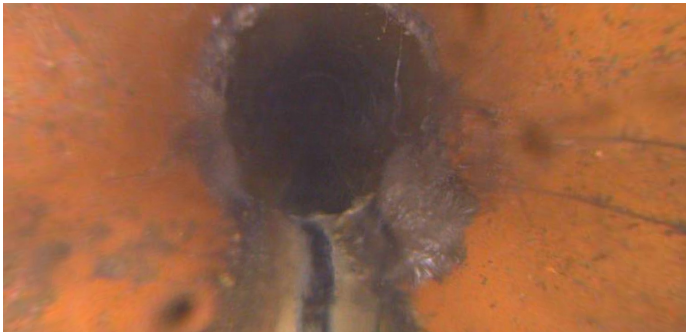
Code: **RMJ**  
Description: **Roots Medium Joint**

Distance (ft): **65.4**  
Structural Grade: **0**  
O&M Grade: **3**  
Clock Start/From: **8**  
Clock To: **4**  
1st Value:  
2nd Value:  
Value Percent: **10.000**  
Continuous Index:  
Within 8" of Joint: **YES**  
Remarks:

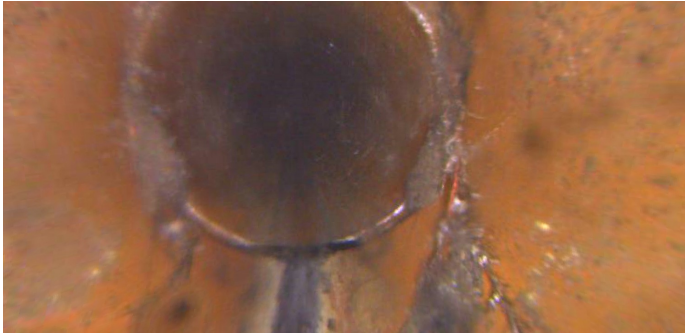
Code: **RFJ**  
Description: **Roots Fine Joint**

Distance (ft): **71.6**  
Structural Grade: **0**  
O&M Grade: **1**  
Clock Start/From: **8**  
Clock To: **4**  
1st Value:  
2nd Value:  
Value Percent:  
Continuous Index:  
Within 8" of Joint: **YES**  
Remarks:

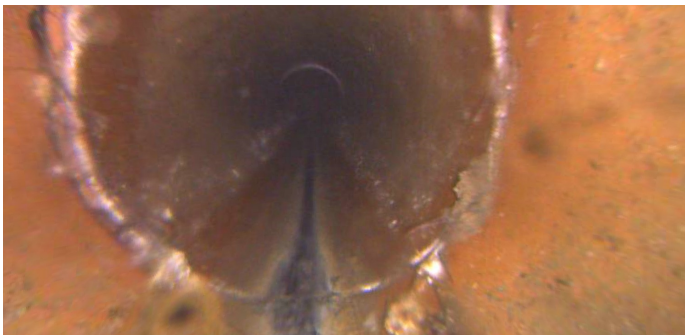
Code: **RFJ**  
Description: **Roots Fine Joint**

Distance (ft): **77.7**  
Structural Grade: **0**  
O&M Grade: **1**  
Clock Start/From: **8**  
Clock To: **4**  
1st Value:  
2nd Value:  
Value Percent:  
Continuous Index:  
Within 8" of Joint: **YES**  
Remarks:

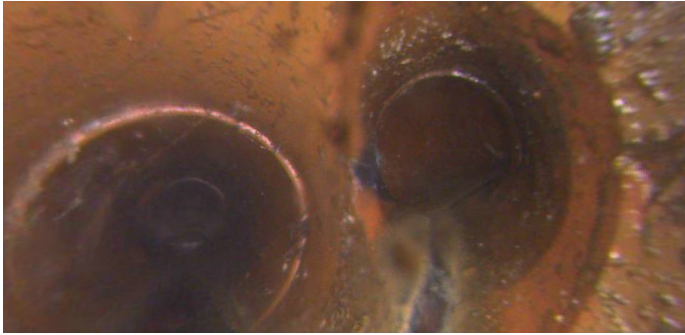
Code: **TF**  
Description: **Tap Factory**

Distance (ft): **86.0**  
Structural Grade: **0**  
O&M Grade: **0**  
Clock Start/From: **3**  
Clock To:  
1st Value: **4.000**  
2nd Value:  
Value Percent:  
Continuous Index:  
Within 8" of Joint:  
Remarks:

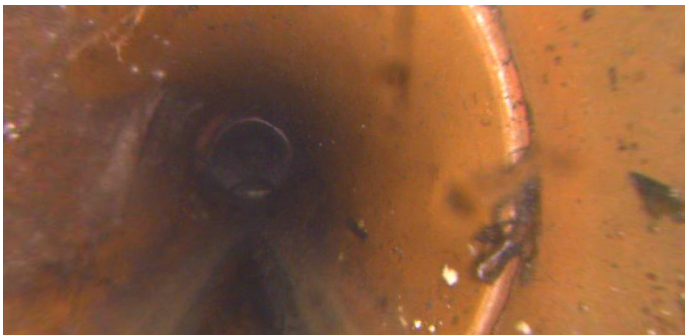
Code: **RFJ**  
Description: **Roots Fine Joint**

Distance (ft): **86.8**  
Structural Grade: **0**  
O&M Grade: **1**  
Clock Start/From: **8**  
Clock To: **4**  
1st Value:  
2nd Value:  
Value Percent:  
Continuous Index:  
Within 8" of Joint: **YES**  
Remarks:

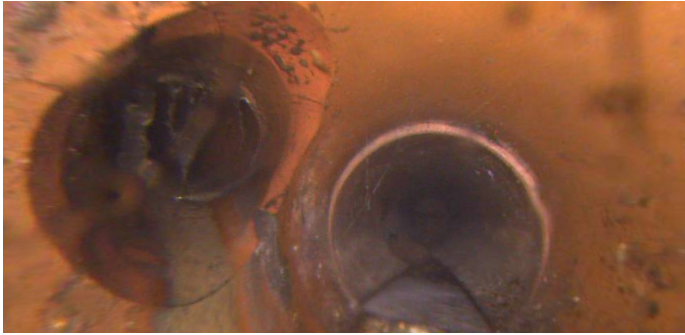
Code: **TFD**  
Description: **Tap Factory Defective**

Distance (ft): **88.8**  
Structural Grade: **0**  
O&M Grade: **2**  
Clock Start/From: **10**  
Clock To:  
1st Value: **4.000**  
2nd Value:  
Value Percent:  
Continuous Index:  
Within 8" of Joint:  
Remarks: **ROOTS**

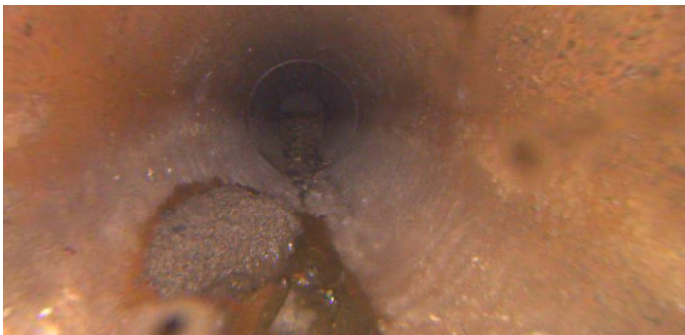
Code: **DSF**  
Description: **Deposits Settled Fine**

Distance (ft): **90.8**  
Structural Grade: **0**  
O&M Grade: **2**  
Clock Start/From: **6**  
Clock To: **7**  
1st Value:  
2nd Value:  
Value Percent: **5.000**  
Continuous Index:  
Within 8" of Joint: **NO**  
Remarks:

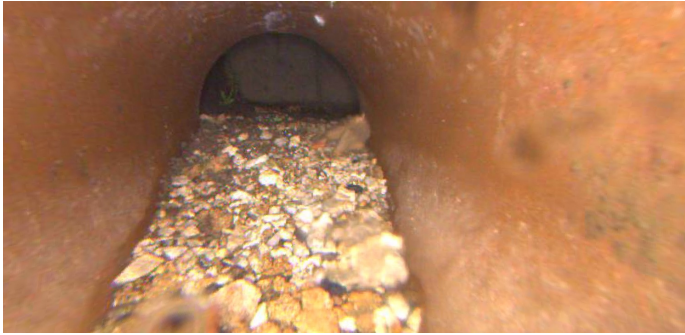
Code: **DSGV**  
Description: **Deposits Settled Gravel**

Distance (ft): **94.4**  
Structural Grade: **0**  
O&M Grade: **5**  
Clock Start/From: **4**  
Clock To: **8**  
1st Value:  
2nd Value:  
Value Percent: **40.000**  
Continuous Index:  
Within 8" of Joint: **NO**  
Remarks:

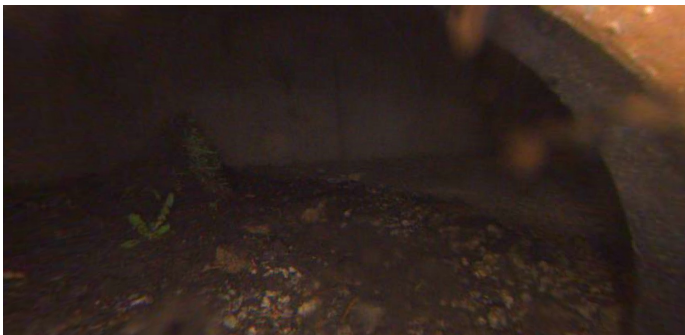
Code: **AMH**  
Description: **Manhole**

Distance (ft): **96.0**  
Structural Grade: **0**  
O&M Grade: **0**  
Clock Start/From:  
Clock To:  
1st Value:  
2nd Value:  
Value Percent:  
Continuous Index:  
Within 8" of Joint: **NO**  
Remarks: **M-803-006**
