Profile/Photo Observation Report

Date:	03/29/2018	Weather:		Coding:	PACP 6.0
Pipe Length (ft):	100.7	Owner:	NA	Pre Clean:	Not Known
P.O.#:		Surveyor:	Jen Costello	PSR:	P-803-006-005
Customer:		Clean Date:	01/01/1900	Shape:	C

Street:	ALLEY	Flow Control:	Not Controlled
City:	Hobart, IN	Year Renewed:	
Location:	Other	Tape/Media #:	
Purpose:	Not Known	Dia/Height:	10"
Use:	Sanitary	Material:	VCP
Drain Area:	NA	Lining:	
Category:	NA		
Comment:

Location Details:		Direction of Survey:	Downstream
US MH:	M-803-005	DS MH:	M-803-006
		Total Length Surveyed (ft):	96.0

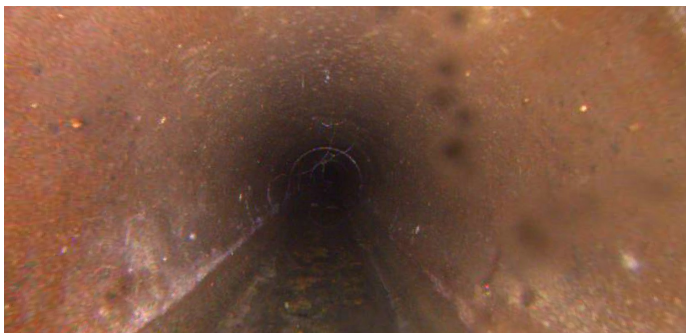
Code: **AMH**
Description: **Manhole**

Distance (ft): **.0**
Structural Grade: **0**
O&M Grade: **0**
Clock Start/From:
Clock To:
1st Value:
2nd Value:
Value Percent:
Continuous Index:
Within 8" of Joint: **NO**
Remarks: **M-803-005**

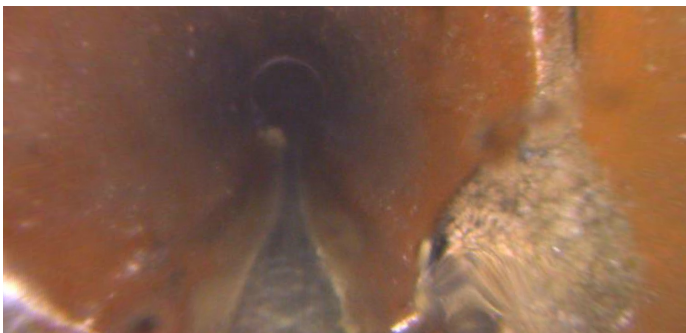
Code: **DAE**
Description: **Deposits Attached Encrustation**

Distance (ft): **42.2**
Structural Grade: **0**
O&M Grade: **2**
Clock Start/From: **3**
Clock To: **5**
1st Value:
2nd Value:
Value Percent: **5.000**
Continuous Index:
Within 8" of Joint: **YES**
Remarks:

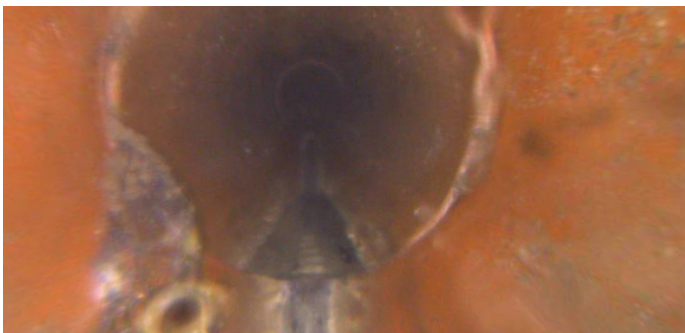
Code: **RMJ**
Description: **Roots Medium Joint**

Distance (ft): **44.9**
Structural Grade: **0**
O&M Grade: **3**
Clock Start/From: **8**
Clock To: **9**
1st Value:
2nd Value:
Value Percent: **5.000**
Continuous Index:
Within 8" of Joint: **YES**
Remarks:

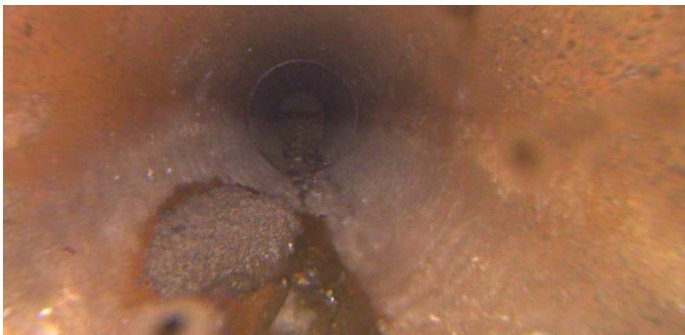
Code: **DSF**
Description: **Deposits Settled Fine**

Distance (ft): **90.8**
Structural Grade: **0**
O&M Grade: **2**
Clock Start/From: **6**
Clock To: **7**
1st Value:
2nd Value:
Value Percent: **5.000**
Continuous Index:
Within 8" of Joint: **NO**
Remarks:

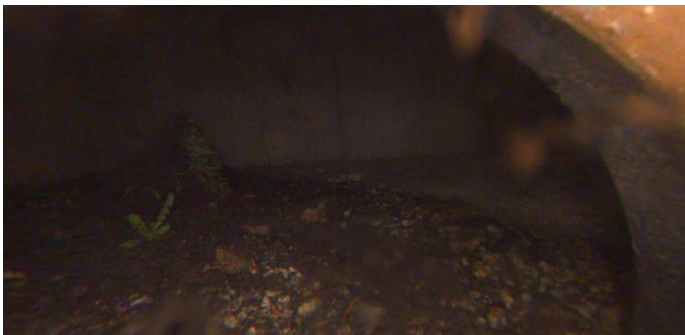
Code: **AMH**
Description: **Manhole**

Distance (ft): **96.0**
Structural Grade: **0**
O&M Grade: **0**
Clock Start/From:
Clock To:
1st Value:
2nd Value:
Value Percent:
Continuous Index:
Within 8" of Joint: **NO**
Remarks: **M-803-006**
