Profile/Photo Observation Report

Street:	E NORTH ST	Flow Control:	Not Controlled
City:	Hobart, IN	Year Renewed:	
Location:	Other	Tape/Media #:	
Purpose:	Not Known	Dia/Height:	10"
Use:	Sanitary	Material:	VCP
Drain Area:	NA	Lining:	
Category:	NA		
Comment:

Location Details:		Direction of Survey:	Upstream
US MH:	M-803-008	DS MH:	M-803-007
		Total Length Surveyed (ft):	21.9

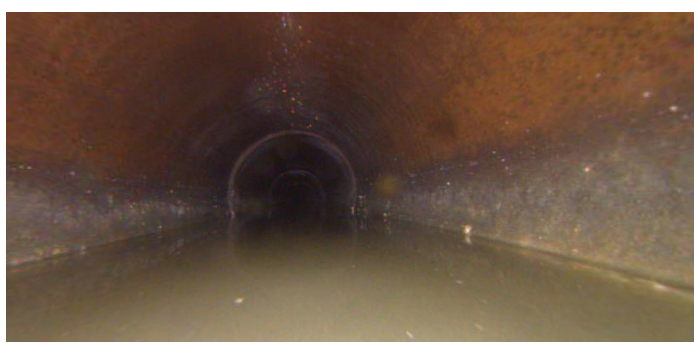
Code: **AMH**
Description: **Manhole**

Distance (ft): **.0**
Structural Grade: **0**
O&M Grade: **0**
Clock Start/From:
Clock To:
1st Value:
2nd Value:
Value Percent:
Continuous Index:
Within 8" of Joint: **NO**
Remarks: **M-803-007**

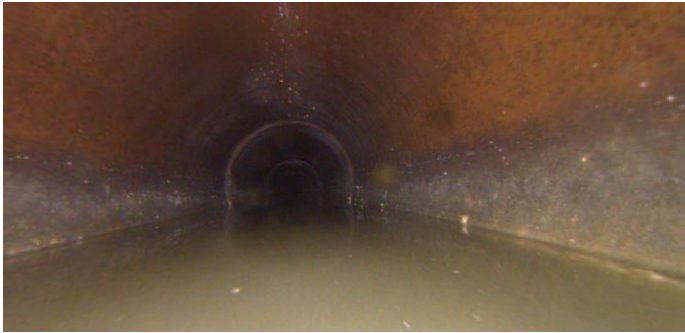
Code:	MWL
Description:	Water Level

Distance (ft):	.0
Structural Grade:	0
O&M Grade:	0
Clock Start/From:	
Clock To:	
1st Value:	
2nd Value:	
Value Percent:	30.000
Continuous Index:	
Within 8" of Joint:	NO
Remarks:

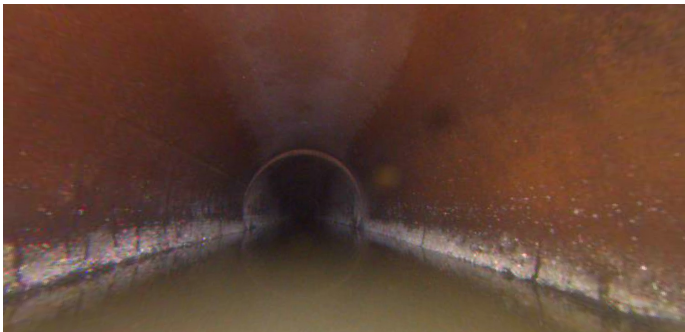
Code:	MSA
Description:	Abandoned Survey

Distance (ft):	21.9
Structural Grade:	0
O&M Grade:	0
Clock Start/From:	
Clock To:	
1st Value:	
2nd Value:	
Value Percent:	
Continuous Index:	
Within 8" of Joint:	NO
Remarks:	UNKNOWN
