Profile/Photo Observation Report

Date:	03/29/2018	Weather:		Coding:	PACP 6.0
Pipe Length (ft):	225.5	Owner:	NA	Pre Clean:	Not Known
P.O.#:		Surveyor:	Jen Costello	PSR:	P-803-008-007
Customer:		Clean Date:	01/01/1900	Shape:	C

Location Details:		Direction of Survey:	Upstream
US MH:	M-803-008	DS MH:	M-803-007
		Total Length Surveyed (ft):	21.9

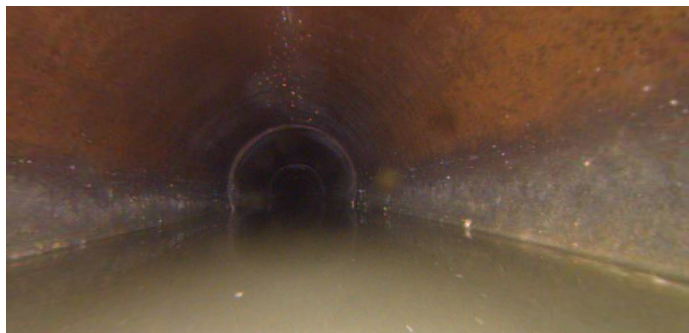
Code: **AMH**
Description: **Manhole**

Distance (ft): **.0**
Structural Grade: **0**
O&M Grade: **0**
Clock Start/From:
Clock To:
1st Value:
2nd Value:
Value Percent:
Continuous Index:
Within 8" of Joint: **NO**
Remarks: **M-803-007**

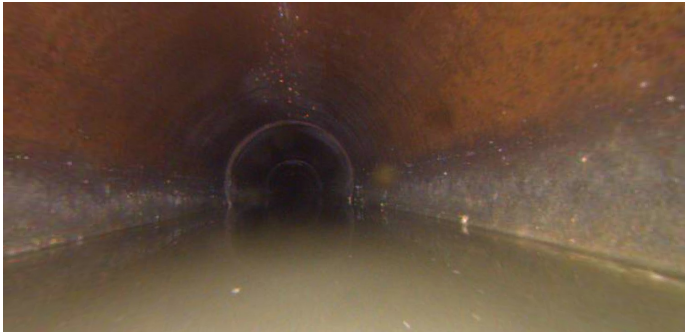
Code:	MWL
Description:	Water Level

Distance (ft):	.0
Structural Grade:	0
O&M Grade:	0
Clock Start/From:	
Clock To:	
1st Value:	
2nd Value:	
Value Percent:	30.000
Continuous Index:	
Within 8" of Joint:	NO
Remarks:

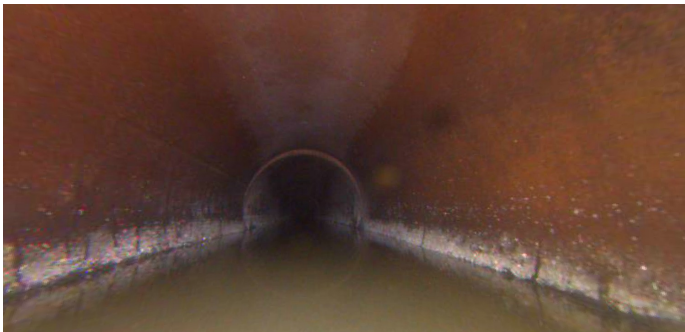
Code:	MSA
Description:	Abandoned Survey

Distance (ft):	21.9
Structural Grade:	0
O&M Grade:	0
Clock Start/From:	
Clock To:	
1st Value:	
2nd Value:	
Value Percent:	
Continuous Index:	
Within 8" of Joint:	NO
Remarks:	UNKNOWN
