Profile/Photo Observation Report

Date:	10/01/2018	Weather:		Coding:	PACP 6.0
Pipe Length (ft):	225.5	Owner:	NA	Pre Clean:	Not Known
P.O.#:		Surveyor:	Michael Carlino	PSR:	P-803-008-007
Customer:		Clean Date:	01/01/1900	Shape:	C

Location Details:		Direction of Survey:	Upstream
US MH:	M-803-008	DS MH:	M-803-007
		Total Length Surveyed (ft):	61.7

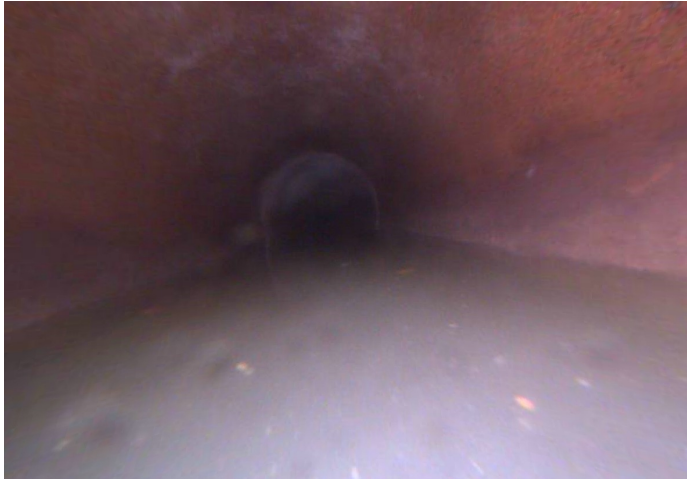
Code:	AMH
Description:	Manhole
Distance (ft):	.0
Structural Grade:	0
O&M Grade:	0
Clock Start/From:	
Clock To:	
1st Value:	
2nd Value:	
Value Percent:	
Continuous Index:	
Within 8" of Joint:	NO
Remarks:	M-803-007

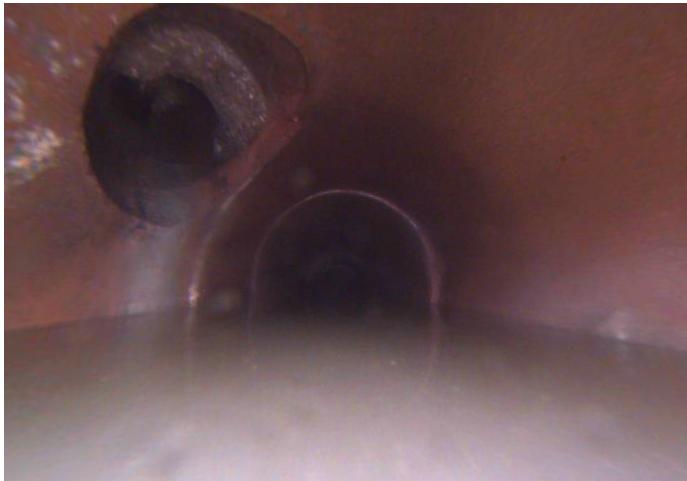
Code: **MWL**
Description: **Water Level**

Distance (ft): **.0**
Structural Grade: **0**
O&M Grade: **0**
Clock Start/From:
Clock To:
1st Value:
2nd Value:
Value Percent: **25.000**
Continuous Index:
Within 8" of Joint: **NO**
Remarks:
