Profile/Photo Observation Report

Street:	41st. Ave.	Flow Control:	Not Controlled
City:	Hobart, IN	Year Renewed:	
Location:	Light Highway	Tape/Media #:	
Purpose:	Routine Assessment	Dia/Height:	12"
Use:	Sanitary	Material:	VCP
Drain Area:	NA	Lining:	
Category:	NA		
Comment:

Location Details:		Direction of Survey:	Downstream
US MH:	M-803-008	DS MH:	M-803-007
		Total Length Surveyed (ft):	223.2

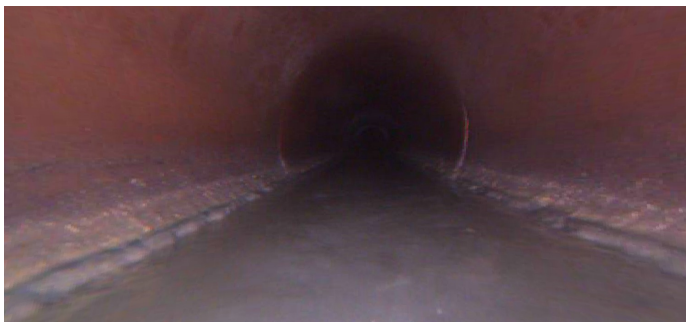
Code: **AMH**
Description: **Manhole**

Distance (ft): **.0**
Structural Grade: **0**
O&M Grade: **0**
Clock Start/From:
Clock To:
1st Value:
2nd Value:
Value Percent:
Continuous Index:
Within 8" of Joint: **NO**
Remarks: **M-803-008**

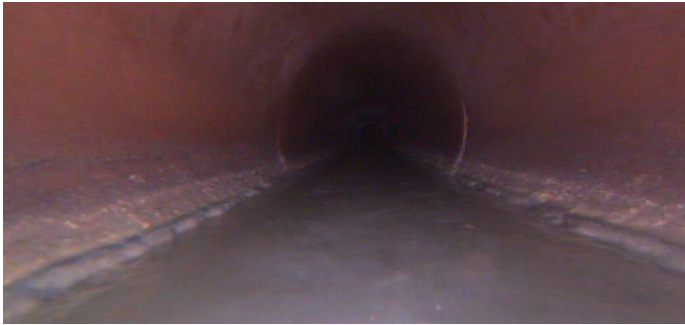
Code:	MWL
Description:	Water Level

Distance (ft):	.0
Structural Grade:	0
O&M Grade:	0
Clock Start/From:	
Clock To:	
1st Value:	
2nd Value:	
Value Percent:	10.000
Continuous Index:	
Within 8" of Joint:	NO
Remarks:

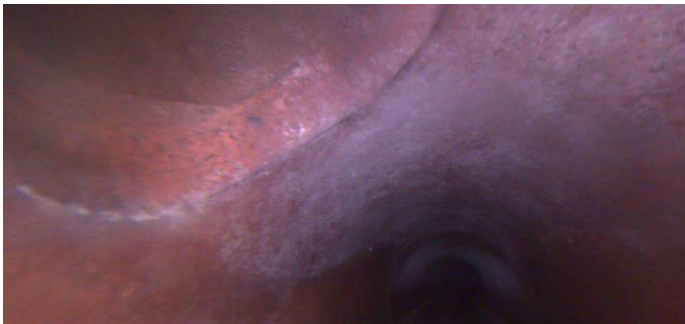
Code:	TF
Description:	Tap Factory

Distance (ft):	6.4
Structural Grade:	0
O&M Grade:	0
Clock Start/From:	10
Clock To:	
1st Value:	4.000
2nd Value:	
Value Percent:	
Continuous Index:	
Within 8" of Joint:	
Remarks:

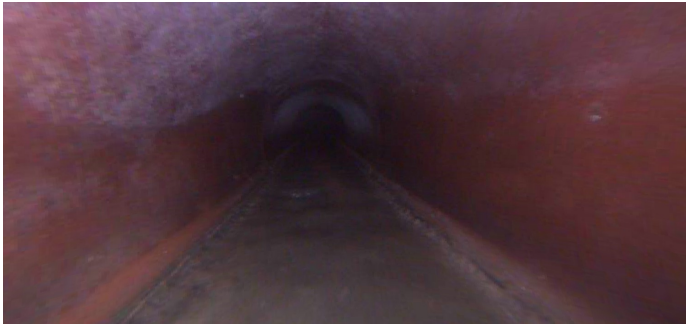
Code: **DAGS**
Description: **Deposits Attached Grease**

Distance (ft): **6.4**
Structural Grade: **0**
O&M Grade: **2**
Clock Start/From: **7**
Clock To: **5**
1st Value:
2nd Value:
Value Percent: **5.000**
Continuous Index: **S01**
Within 8" of Joint: **YES**
Remarks: **WANDER**

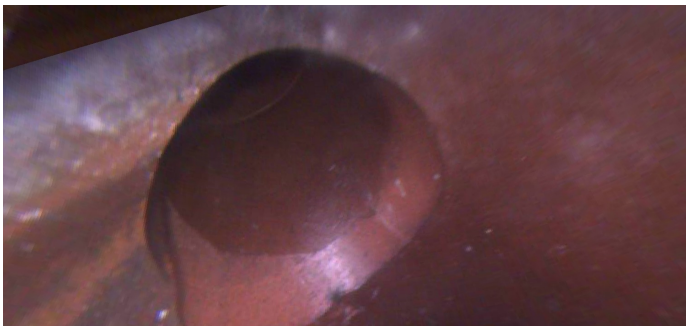
Code: **TF**
Description: **Tap Factory**

Distance (ft): **33.3**
Structural Grade: **0**
O&M Grade: **0**
Clock Start/From: **10**
Clock To:
1st Value: **4.000**
2nd Value:
Value Percent:
Continuous Index:
Within 8" of Joint:
Remarks:

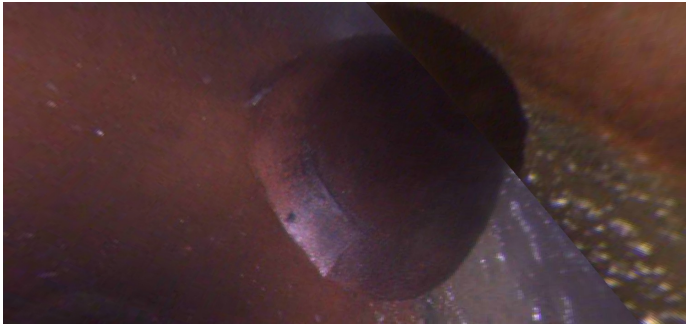
Code: **TF**
Description: **Tap Factory**

Distance (ft): **36.3**
Structural Grade: **0**
O&M Grade: **0**
Clock Start/From: **2**
Clock To:
1st Value: **4.000**
2nd Value:
Value Percent:
Continuous Index:
Within 8" of Joint:
Remarks:

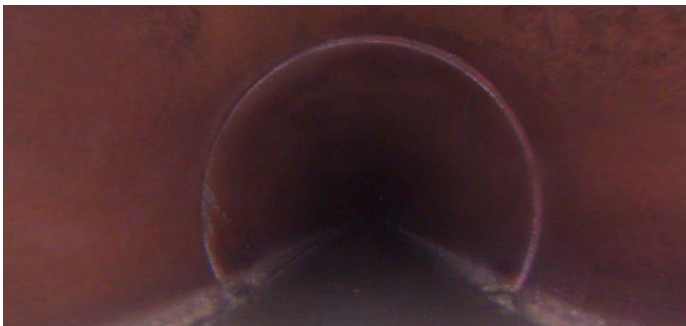
Code: **RFJ**
Description: **Roots Fine Joint**

Distance (ft): **43.9**
Structural Grade: **0**
O&M Grade: **1**
Clock Start/From: **8**
Clock To:
1st Value:
2nd Value:
Value Percent:
Continuous Index:
Within 8" of Joint: **YES**
Remarks:

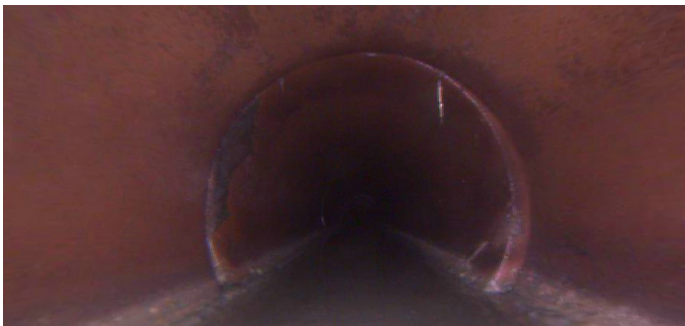
Code: **RFJ**
Description: **Roots Fine Joint**

Distance (ft): **50.0**
Structural Grade: **0**
O&M Grade: **1**
Clock Start/From: **8**
Clock To: **5**
1st Value:
2nd Value:
Value Percent:
Continuous Index:
Within 8" of Joint: **YES**
Remarks:

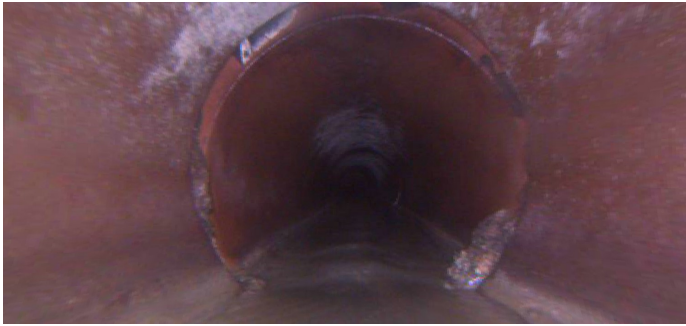
Code: **DAE**
Description: **Deposits Attached Encrustation**

Distance (ft): **59.1**
Structural Grade: **0**
O&M Grade: **2**
Clock Start/From: **8**
Clock To: **5**
1st Value:
2nd Value:
Value Percent: **5.000**
Continuous Index:
Within 8" of Joint: **YES**
Remarks:

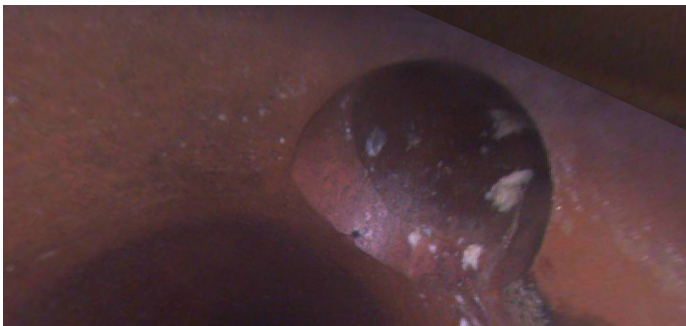
Code: **TF**
Description: **Tap Factory**

Distance (ft): **66.4**
Structural Grade: **0**
O&M Grade: **0**
Clock Start/From: **2**
Clock To:
1st Value: **4.000**
2nd Value:
Value Percent:
Continuous Index:
Within 8" of Joint:
Remarks:

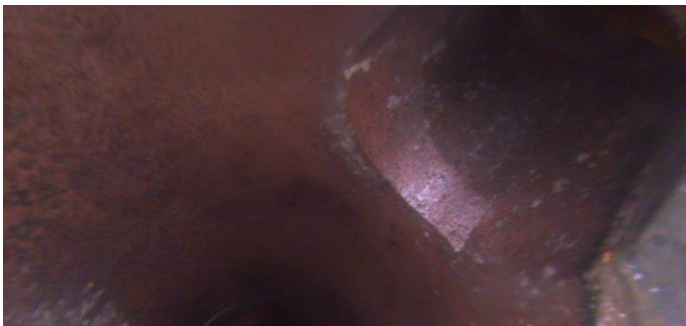
Code: **TF**
Description: **Tap Factory**

Distance (ft): **129.9**
Structural Grade: **0**
O&M Grade: **0**
Clock Start/From: **2**
Clock To:
1st Value: **4.000**
2nd Value:
Value Percent:
Continuous Index:
Within 8" of Joint:
Remarks:

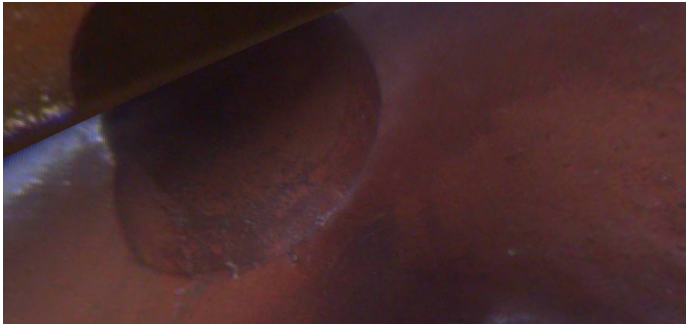
Code: **TF**
Description: **Tap Factory**

Distance (ft): **133.0**
Structural Grade: **0**
O&M Grade: **0**
Clock Start/From: **10**
Clock To:
1st Value: **4.000**
2nd Value:
Value Percent:
Continuous Index:
Within 8" of Joint:
Remarks:

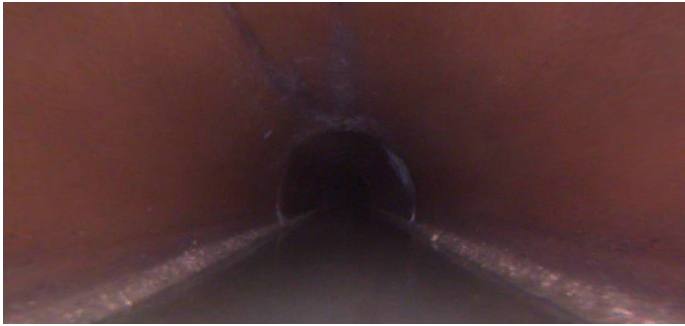
Code: **DAZ**
Description: **Deposits Attached Other**

Distance (ft): **163.6**
Structural Grade: **0**
O&M Grade: **2**
Clock Start/From: **11**
Clock To: **12**
1st Value:
2nd Value:
Value Percent: **5.000**
Continuous Index:
Within 8" of Joint: **YES**
Remarks:

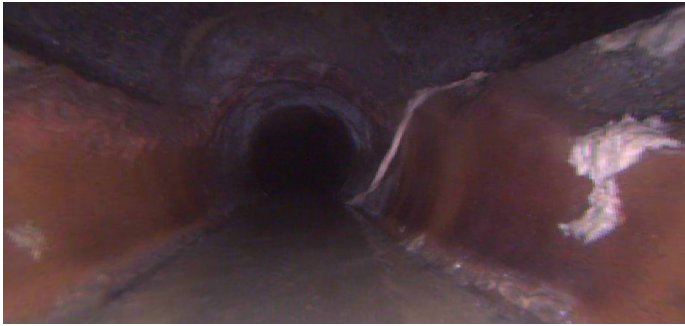
Code: **AMH**
Description: **Manhole**

Distance (ft): **223.2**
Structural Grade: **0**
O&M Grade: **0**
Clock Start/From:
Clock To:
1st Value:
2nd Value:
Value Percent:
Continuous Index:
Within 8" of Joint: **NO**
Remarks: **M-803-007**

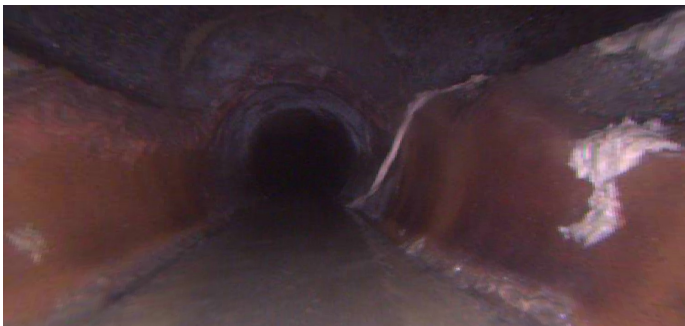
Code: **DAGS**
Description: **Deposits Attached Grease**

Distance (ft): **223.2**
Structural Grade: **0**
O&M Grade: **2**
Clock Start/From: **7**
Clock To: **5**
1st Value:
2nd Value:
Value Percent: **5.000**
Continuous Index: **F01**
Within 8" of Joint: **YES**
Remarks: **WANDER**
