Profile/Photo Observation Report

Street:	ALLEY BETWEEN N LAWRENCE ST &	Flow Control:	Not Controlled
City:	Hobart, IN	Year Renewed:	
Location:	Other	Tape/Media #:	
Purpose:	Not Known	Dia/Height:	10"
Use:	Sanitary	Material:	VCP
Drain Area:	NA	Lining:	
Category:	NA		
Comment:

Location Details:		Direction of Survey:	Upstream
US MH:	M-803-009	DS MH:	M-803-008
		Total Length Surveyed (ft):	14.8

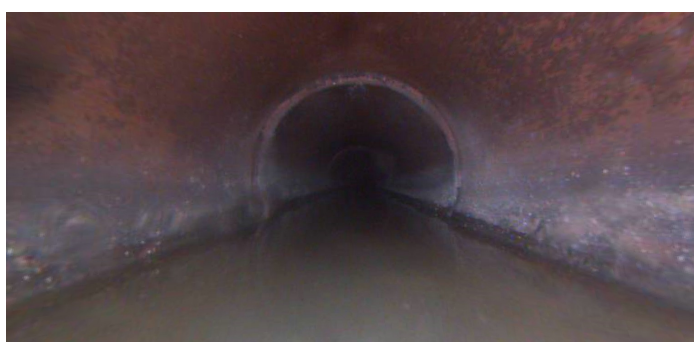
Code: **AMH**
Description: **Manhole**

Distance (ft): **.0**
Structural Grade: **0**
O&M Grade: **0**
Clock Start/From:
Clock To:
1st Value:
2nd Value:
Value Percent:
Continuous Index:
Within 8" of Joint: **NO**
Remarks: **M-803-008**

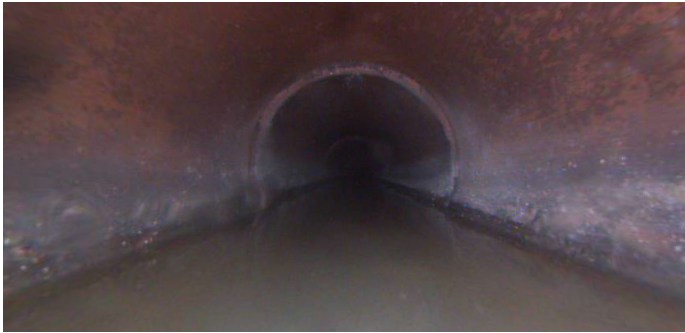
Code:	MWL
Description:	Water Level

Distance (ft):	.0
Structural Grade:	0
O&M Grade:	0
Clock Start/From:	
Clock To:	
1st Value:	
2nd Value:	
Value Percent:	30.000
Continuous Index:	
Within 8" of Joint:	NO
Remarks:

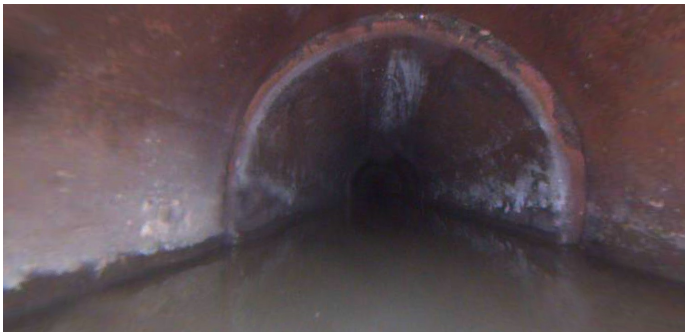
Code:	MSA
Description:	Abandoned Survey

Distance (ft):	14.8
Structural Grade:	0
O&M Grade:	0
Clock Start/From:	
Clock To:	
1st Value:	
2nd Value:	
Value Percent:	
Continuous Index:	
Within 8" of Joint:	NO
Remarks:	DEBRIS UNDER WATER
