Profile/Photo Observation Report

Date:	03/29/2018	Weather:		Coding:	PACP 6.0
Pipe Length (ft):	208.1	Owner:	NA	Pre Clean:	Not Known
P.O.#:		Surveyor:	Jen Costello	PSR:	P-803-009-008
Customer:		Clean Date:	01/01/1900	Shape:	C

Location Details:		Direction of Survey:	Upstream
US MH:	M-803-009	DS MH:	M-803-008
		Total Length Surveyed (ft):	14.8

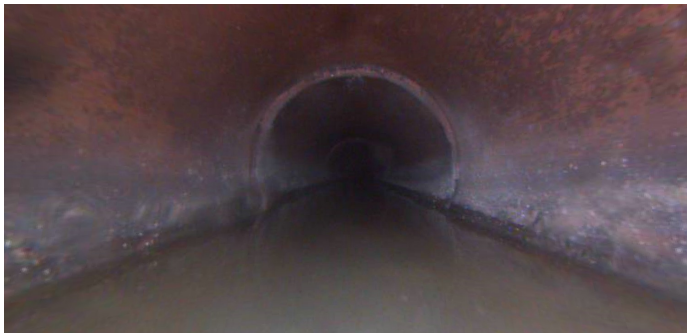
Code: **AMH**
Description: **Manhole**

Distance (ft): **.0**
Structural Grade: **0**
O&M Grade: **0**
Clock Start/From:
Clock To:
1st Value:
2nd Value:
Value Percent:
Continuous Index:
Within 8" of Joint: **NO**
Remarks: **M-803-008**

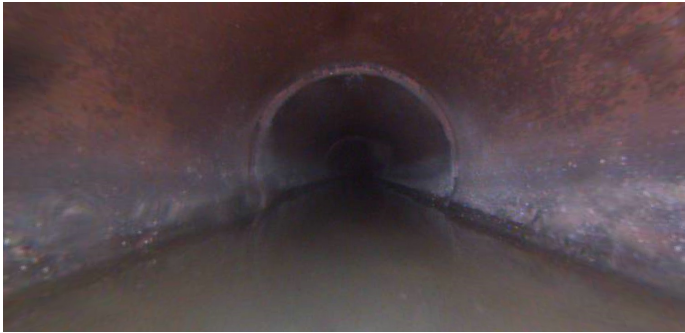
Code:	MWL
Description:	Water Level

Distance (ft):	.0
Structural Grade:	0
O&M Grade:	0
Clock Start/From:	
Clock To:	
1st Value:	
2nd Value:	
Value Percent:	30.000
Continuous Index:	
Within 8" of Joint:	NO
Remarks:

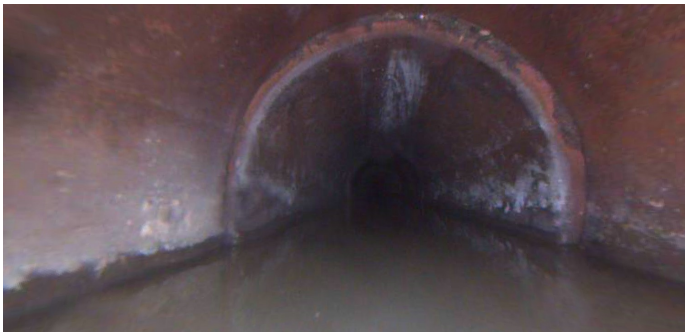
Code:	MSA
Description:	Abandoned Survey

Distance (ft):	14.8
Structural Grade:	0
O&M Grade:	0
Clock Start/From:	
Clock To:	
1st Value:	
2nd Value:	
Value Percent:	
Continuous Index:	
Within 8" of Joint:	NO
Remarks:	DEBRIS UNDER WATER
