Profile/Photo Observation Report

Date:	03/29/2018	Weather:		Coding:	PACP 6.0
Pipe Length (ft):	208.1	Owner:	NA	Pre Clean:	Not Known
P.O.#:		Surveyor:	Jen Costello	PSR:	P-803-009-008
Customer:		Clean Date:	01/01/1900	Shape:	C

Location Details:		Direction of Survey:	Downstream
US MH:	M-803-009	DS MH:	M-803-008
		Total Length Surveyed (ft):	200.5

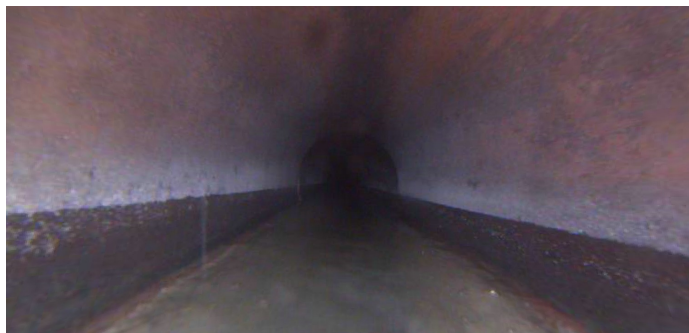
Code: **AMH**
 Description: **Manhole**

Distance (ft): **.0**
 Structural Grade: **0**
 O&M Grade: **0**
 Clock Start/From:
 Clock To:
 1st Value:
 2nd Value:
 Value Percent:
 Continuous Index:
 Within 8" of Joint: **NO**
 Remarks: **M-803-009**

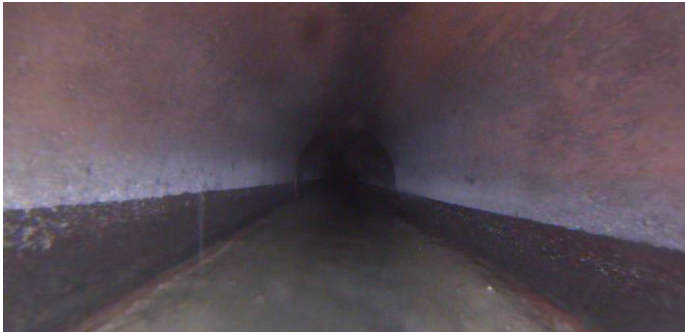
Code:	MWL
Description:	Water Level

Distance (ft):	.0
Structural Grade:	0
O&M Grade:	0
Clock Start/From:	
Clock To:	
1st Value:	
2nd Value:	
Value Percent:	10.000
Continuous Index:	
Within 8" of Joint:	NO
Remarks:

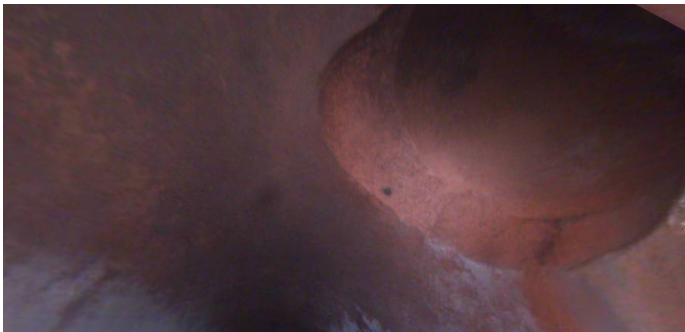
Code:	TF
Description:	Tap Factory

Distance (ft):	13.4
Structural Grade:	0
O&M Grade:	0
Clock Start/From:	2
Clock To:	
1st Value:	4.000
2nd Value:	
Value Percent:	
Continuous Index:	
Within 8" of Joint:	
Remarks:

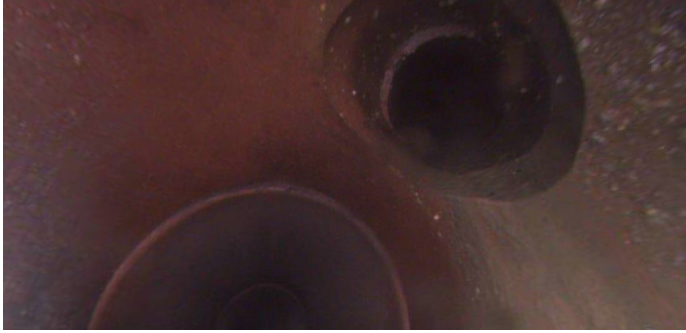
Code: **TF**
Description: **Tap Factory**

Distance (ft): **32.0**
Structural Grade: **0**
O&M Grade: **0**
Clock Start/From: **10**
Clock To:
1st Value: **4.000**
2nd Value:
Value Percent:
Continuous Index:
Within 8" of Joint:
Remarks:

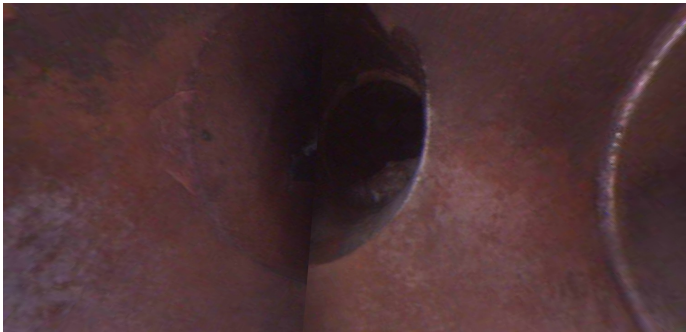
Code: **TF**
Description: **Tap Factory**

Distance (ft): **61.5**
Structural Grade: **0**
O&M Grade: **0**
Clock Start/From: **2**
Clock To:
1st Value: **4.000**
2nd Value:
Value Percent:
Continuous Index:
Within 8" of Joint:
Remarks:

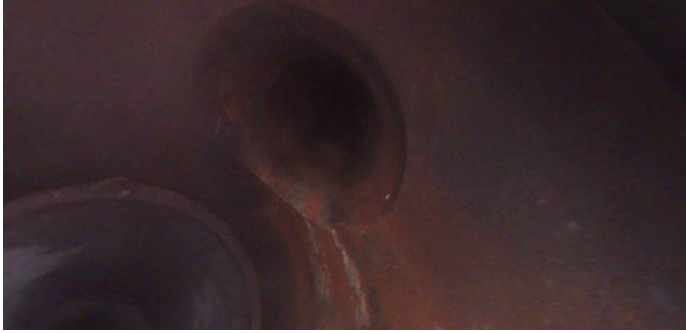
Code: **TF**
Description: **Tap Factory**

Distance (ft): **98.3**
Structural Grade: **0**
O&M Grade: **0**
Clock Start/From: **10**
Clock To:
1st Value: **4.000**
2nd Value:
Value Percent:
Continuous Index:
Within 8" of Joint:
Remarks:

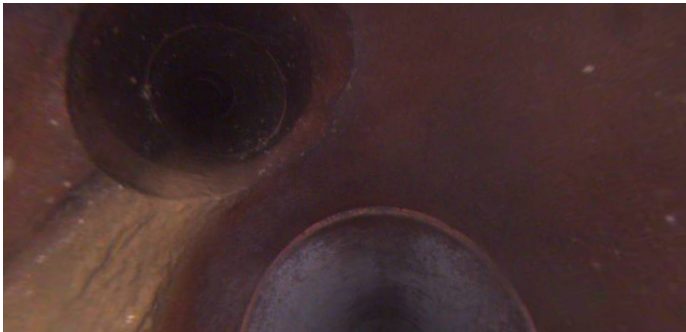
Code: **TF**
Description: **Tap Factory**

Distance (ft): **110.0**
Structural Grade: **0**
O&M Grade: **0**
Clock Start/From: **2**
Clock To:
1st Value: **4.000**
2nd Value:
Value Percent:
Continuous Index:
Within 8" of Joint:
Remarks:

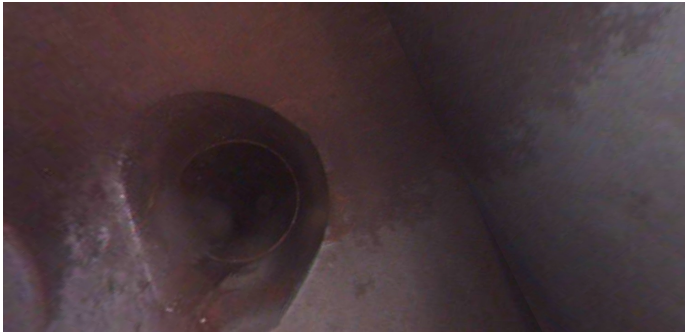
Code: **TF**
Description: **Tap Factory**

Distance (ft): **158.0**
Structural Grade: **0**
O&M Grade: **0**
Clock Start/From: **10**
Clock To:
1st Value: **4.000**
2nd Value:
Value Percent:
Continuous Index:
Within 8" of Joint:
Remarks:

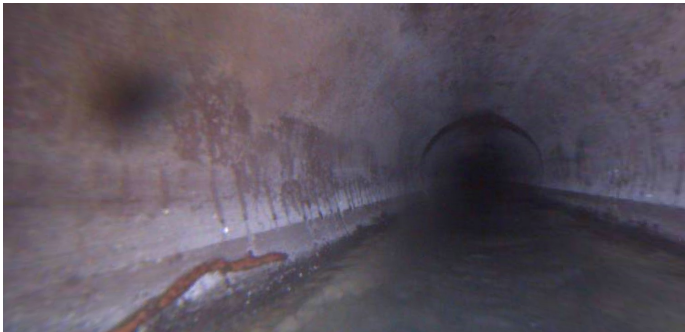
Code: **CL**
Description: **Crack Longitudinal**

Distance (ft): **160.0**
Structural Grade: **2**
O&M Grade: **0**
Clock Start/From: **8**
Clock To:
1st Value:
2nd Value:
Value Percent:
Continuous Index:
Within 8" of Joint:
Remarks:

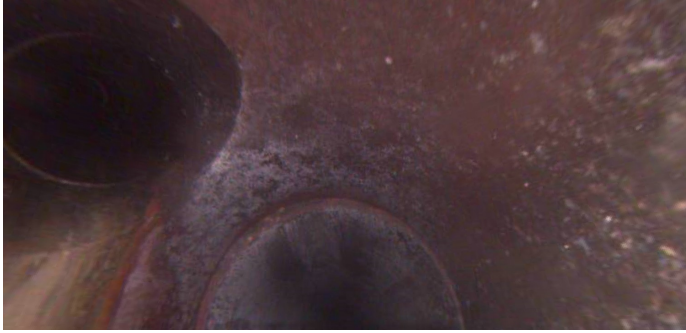
Code: **TF**
Description: **Tap Factory**

Distance (ft): **182.1**
Structural Grade: **0**
O&M Grade: **0**
Clock Start/From: **2**
Clock To:
1st Value: **4.000**
2nd Value:
Value Percent:
Continuous Index:
Within 8" of Joint:
Remarks:

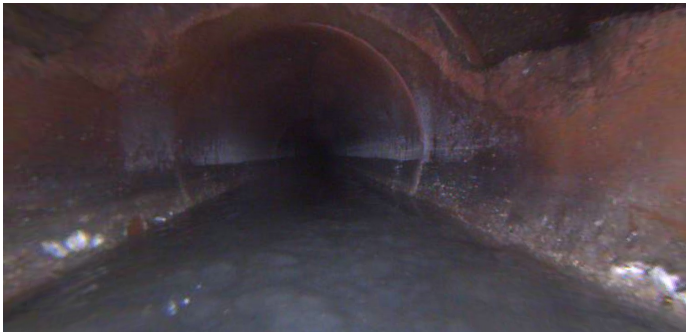
Code: **AMH**
Description: **Manhole**

Distance (ft): **200.5**
Structural Grade: **0**
O&M Grade: **0**
Clock Start/From:
Clock To:
1st Value:
2nd Value:
Value Percent:
Continuous Index:
Within 8" of Joint: **NO**
Remarks: **M-803-008**
