## Profile/Photo Observation Report

Location Details:		Direction of Survey:	<b>Upstream</b>
US MH:	<b>M-803-010</b>	DS MH:	<b>M-803-009</b>
		Total Length Surveyed (ft):	<b>195.8</b>

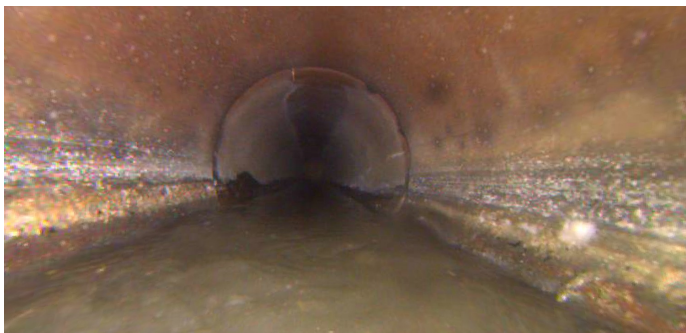
Code: **AMH**  
Description: **Manhole**

Distance (ft): **.0**  
Structural Grade: **0**  
O&M Grade: **0**  
Clock Start/From:  
Clock To:  
1st Value:  
2nd Value:  
Value Percent:  
Continuous Index:  
Within 8" of Joint: **NO**  
Remarks: **M-803-010**

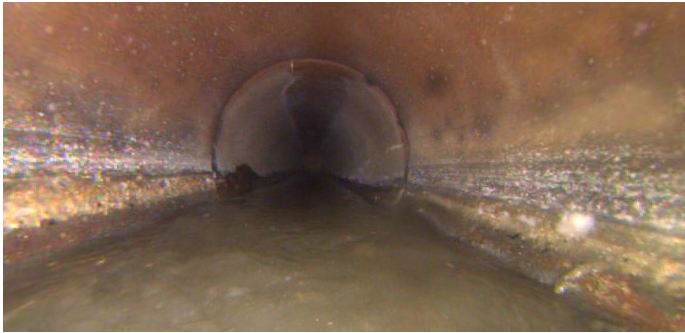
Code:	<b>MWL</b>
Description:	<b>Water Level</b>

Distance (ft):	<b>.0</b>
Structural Grade:	<b>0</b>
O&M Grade:	<b>0</b>
Clock Start/From:	
Clock To:	
1st Value:	
2nd Value:	
Value Percent:	<b>30.000</b>
Continuous Index:	
Within 8" of Joint:	<b>NO</b>
Remarks:

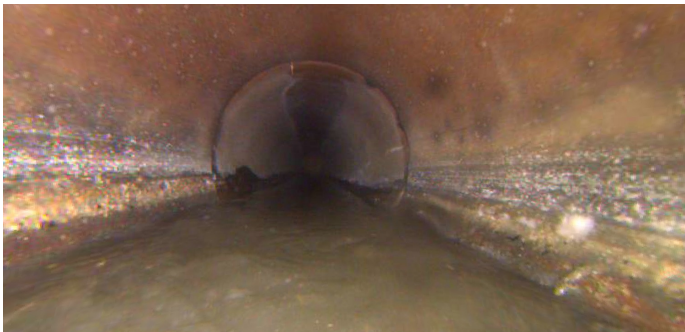
Code:	<b>DAGS</b>
Description:	<b>Deposits Attached Grease</b>

Distance (ft):	<b>.0</b>
Structural Grade:	<b>0</b>
O&M Grade:	<b>2</b>
Clock Start/From:	<b>8</b>
Clock To:	<b>4</b>
1st Value:	
2nd Value:	
Value Percent:	<b>5.000</b>
Continuous Index:	<b>S01</b>
Within 8" of Joint:	<b>NO</b>
Remarks:

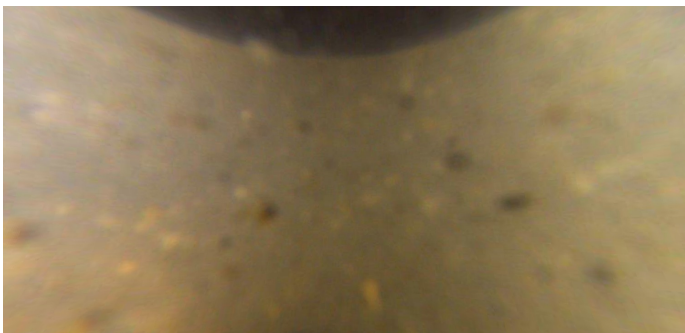
Code: **MCU**  
Description: **Camera Underwater**

Distance (ft): **24.9**  
Structural Grade: **0**  
O&M Grade: **4**  
Clock Start/From:  
Clock To:  
1st Value:  
2nd Value:  
Value Percent:  
Continuous Index:  
Within 8" of Joint: **NO**  
Remarks:

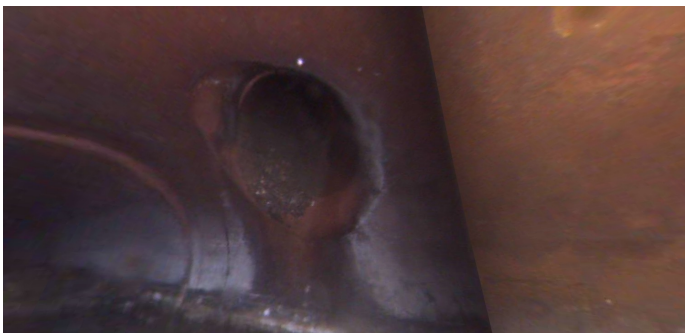
Code: **TF**  
Description: **Tap Factory**

Distance (ft): **30.6**  
Structural Grade: **0**  
O&M Grade: **0**  
Clock Start/From: **10**  
Clock To:  
1st Value: **4.000**  
2nd Value:  
Value Percent:  
Continuous Index:  
Within 8" of Joint:  
Remarks:

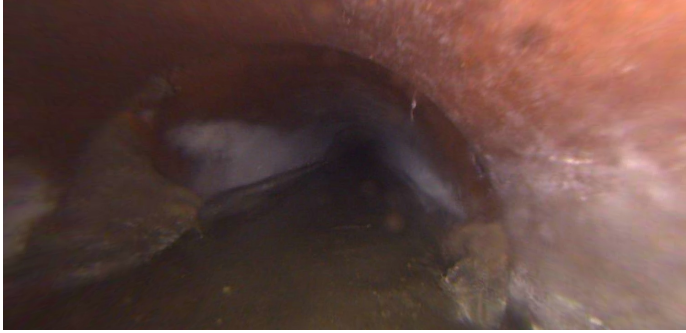
Code: **RMJ**  
Description: **Roots Medium Joint**

Distance (ft): **61.8**  
Structural Grade: **0**  
O&M Grade: **3**  
Clock Start/From: **8**  
Clock To: **4**  
1st Value:  
2nd Value:  
Value Percent: **5.000**  
Continuous Index:  
Within 8" of Joint: **YES**  
Remarks:

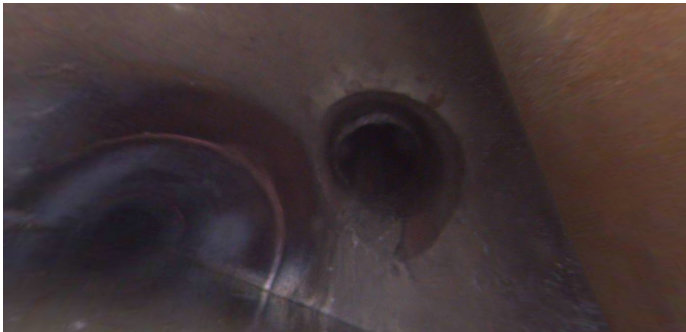
Code: **TF**  
Description: **Tap Factory**

Distance (ft): **78.3**  
Structural Grade: **0**  
O&M Grade: **0**  
Clock Start/From: **10**  
Clock To:  
1st Value: **4.000**  
2nd Value:  
Value Percent:  
Continuous Index:  
Within 8" of Joint:  
Remarks:

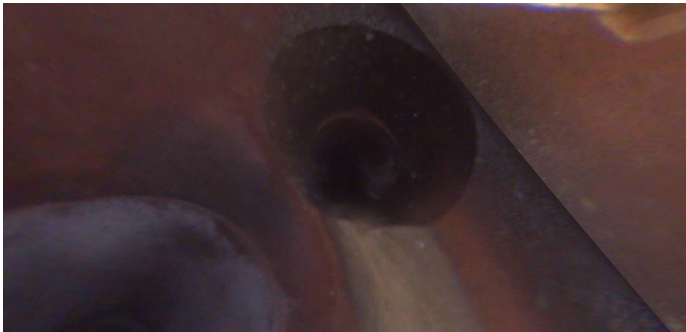
Code: **TF**  
Description: **Tap Factory**

Distance (ft): **120.0**  
Structural Grade: **0**  
O&M Grade: **0**  
Clock Start/From: **10**  
Clock To:  
1st Value: **4.000**  
2nd Value:  
Value Percent:  
Continuous Index:  
Within 8" of Joint:  
Remarks:

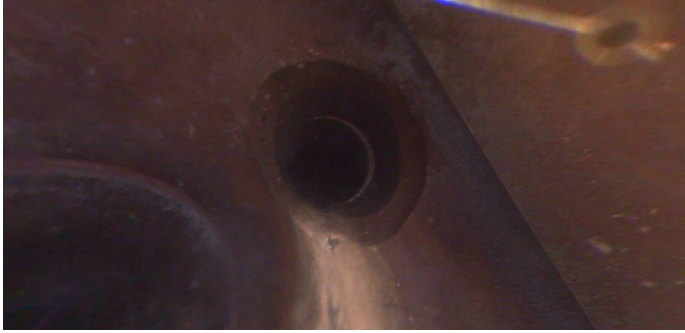
Code: **TF**  
Description: **Tap Factory**

Distance (ft): **185.9**  
Structural Grade: **0**  
O&M Grade: **0**  
Clock Start/From: **10**  
Clock To:  
1st Value: **4.000**  
2nd Value:  
Value Percent:  
Continuous Index:  
Within 8" of Joint:  
Remarks:

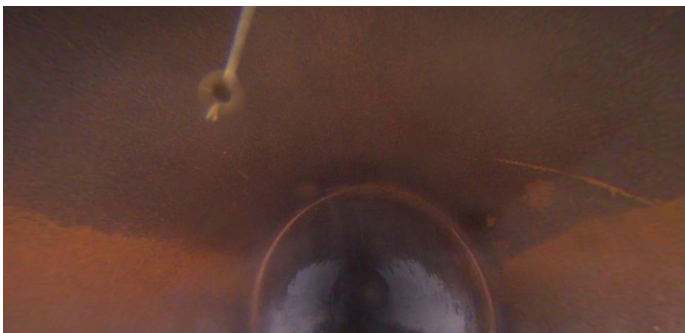
Code: **MSA**  
Description: **Abandoned Survey**

Distance (ft): **195.8**  
Structural Grade: **0**  
O&M Grade: **0**  
Clock Start/From:  
Clock To:  
1st Value:  
2nd Value:  
Value Percent:  
Continuous Index:  
Within 8" of Joint: **NO**  
Remarks: **debris under water**
