Profile/Photo Observation Report

Street:	E RAND ST	Flow Control:	Not Controlled
City:	Hobart, IN	Year Renewed:	
Location:	Other	Tape/Media #:	
Purpose:	Not Known	Dia/Height:	10"
Use:	Sanitary	Material:	VCP
Drain Area:	NA	Lining:	
Category:	NA		
Comment:

Location Details:		Direction of Survey:	Upstream
US MH:	M-803-010	DS MH:	M-803-012
		Total Length Surveyed (ft):	72.5

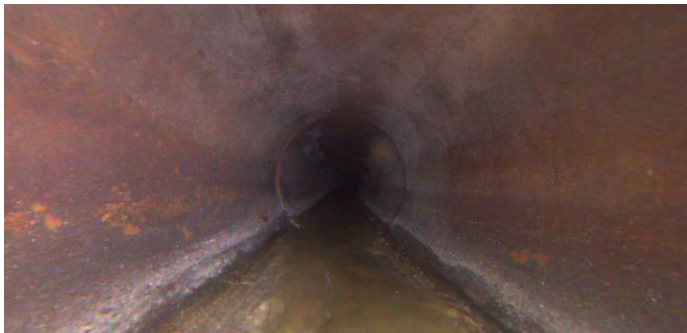
Code: **AMH**
 Description: **Manhole**
 Distance (ft): **.0**
 Structural Grade: **0**
 O&M Grade: **0**
 Clock Start/From:
 Clock To:
 1st Value:
 2nd Value:
 Value Percent:
 Continuous Index:
 Within 8" of Joint: **NO**
 Remarks: **M-803-012**

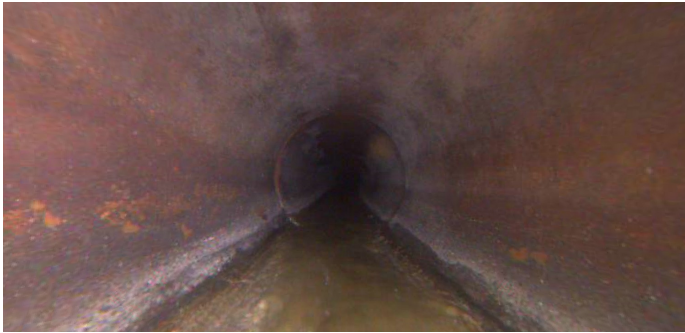
Code:	MWL
Description:	Water Level

Distance (ft):	.0
Structural Grade:	0
O&M Grade:	0
Clock Start/From:	
Clock To:	
1st Value:	
2nd Value:	
Value Percent:	5.000
Continuous Index:	
Within 8" of Joint:	NO
Remarks:

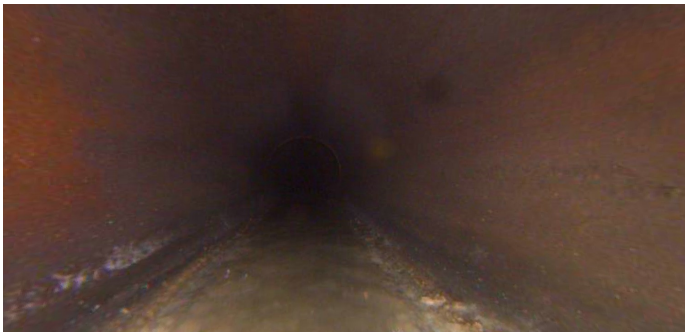
Code:	MSA
Description:	Abandoned Survey

Distance (ft):	72.5
Structural Grade:	0
O&M Grade:	0
Clock Start/From:	
Clock To:	
1st Value:	
2nd Value:	
Value Percent:	
Continuous Index:	
Within 8" of Joint:	NO
Remarks:	unknown
