Profile/Photo Observation Report

Street:	39th. Ave.	Flow Control:	Not Controlled
City:	Hobart, IN	Year Renewed:	
Location:	Light Highway	Tape/Media #:	
Purpose:	Routine Assessment	Dia/Height:	12"
Use:	Sanitary	Material:	VCP
Drain Area:	NA	Lining:	
Category:	NA		
Comment:

Location Details:		Direction of Survey:	Downstream
US MH:	M-803-010	DS MH:	M-803-012
		Total Length Surveyed (ft):	335.1

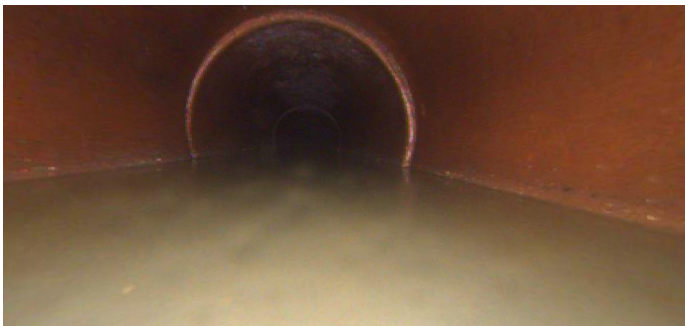
Code: **MWL**
Description: **Water Level**

Distance (ft): **.0**
Structural Grade: **0**
O&M Grade: **0**
Clock Start/From:
Clock To:
1st Value:
2nd Value:
Value Percent: **15.000**
Continuous Index:
Within 8" of Joint: **NO**
Remarks:

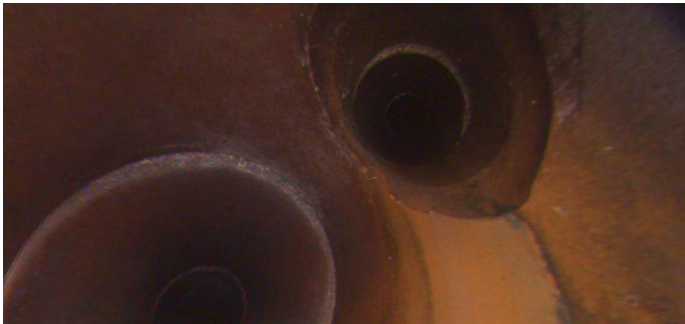
Code: **TF**
Description: **Tap Factory**

Distance (ft): **29.6**
Structural Grade: **0**
O&M Grade: **0**
Clock Start/From: **2**
Clock To:
1st Value: **4.000**
2nd Value:
Value Percent:
Continuous Index:
Within 8" of Joint:
Remarks:

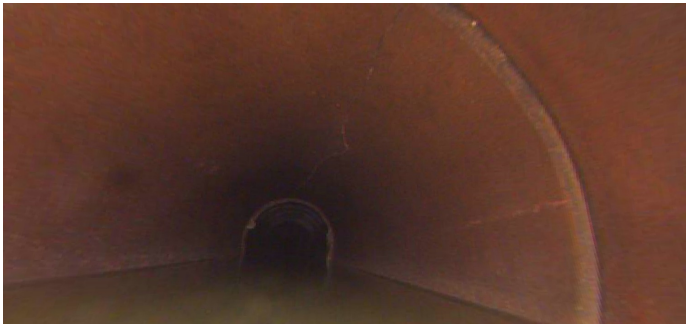
Code: **CM**
Description: **Crack Multiple**

Distance (ft): **121.4**
Structural Grade: **3**
O&M Grade: **0**
Clock Start/From: **12**
Clock To: **3**
1st Value:
2nd Value:
Value Percent:
Continuous Index:
Within 8" of Joint: **YES**
Remarks:

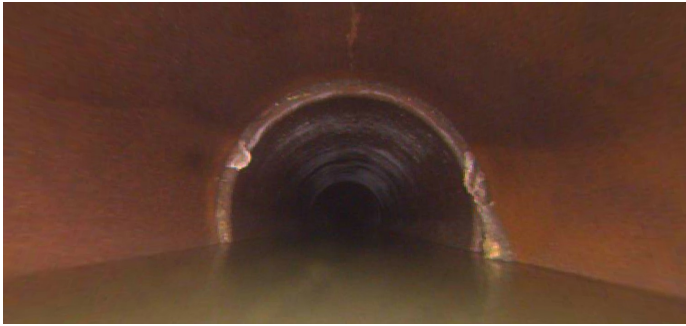
Code: **DAE**
Description: **Deposits Attached Encrustation**

Distance (ft): **123.7**
Structural Grade: **0**
O&M Grade: **2**
Clock Start/From: **10**
Clock To: **5**
1st Value:
2nd Value:
Value Percent: **5.000**
Continuous Index:
Within 8" of Joint: **YES**
Remarks:

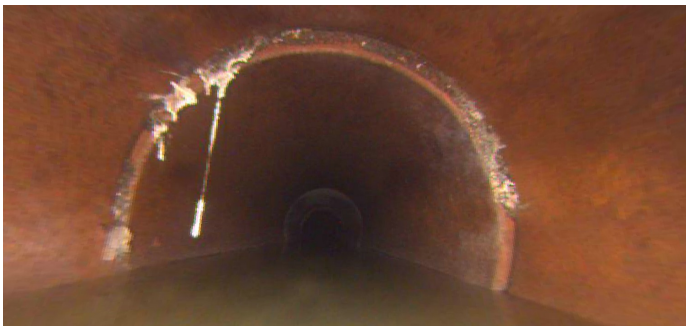
Code: **RFJ**
Description: **Roots Fine Joint**

Distance (ft): **171.0**
Structural Grade: **0**
O&M Grade: **1**
Clock Start/From: **7**
Clock To: **3**
1st Value:
2nd Value:
Value Percent:
Continuous Index:
Within 8" of Joint: **YES**
Remarks:

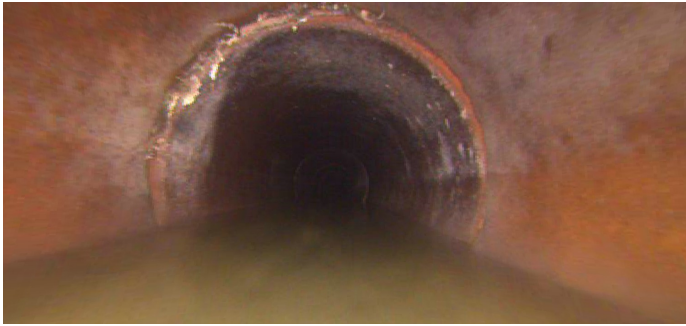
Code: **RFJ**
Description: **Roots Fine Joint**

Distance (ft): **176.8**
Structural Grade: **0**
O&M Grade: **1**
Clock Start/From: **9**
Clock To: **12**
1st Value:
2nd Value:
Value Percent:
Continuous Index:
Within 8" of Joint: **YES**
Remarks:

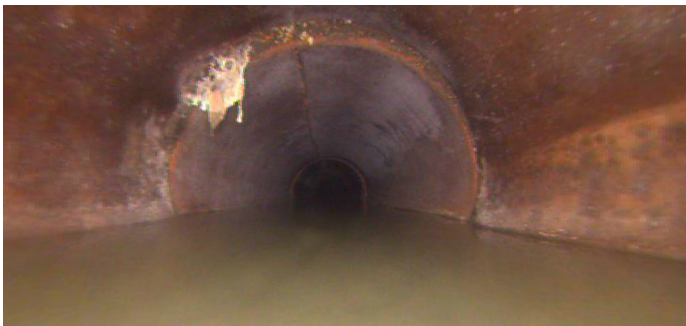
Code: **RFJ**
Description: **Roots Fine Joint**

Distance (ft): **194.2**
Structural Grade: **0**
O&M Grade: **1**
Clock Start/From: **9**
Clock To: **2**
1st Value:
2nd Value:
Value Percent:
Continuous Index:
Within 8" of Joint: **YES**
Remarks:

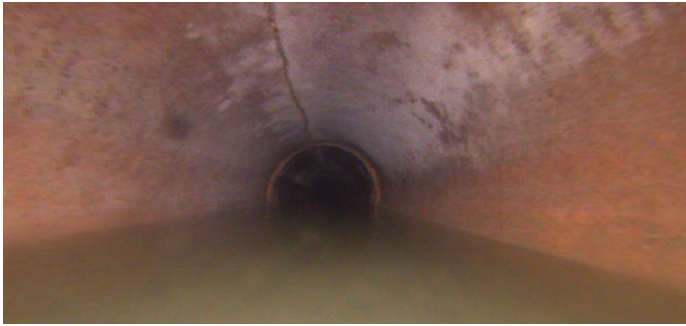
Code: **FL**
Description: **Fracture Longitudinal**

Distance (ft): **195.4**
Structural Grade: **3**
O&M Grade: **0**
Clock Start/From: **11**
Clock To:
1st Value:
2nd Value:
Value Percent:
Continuous Index:
Within 8" of Joint: **YES**
Remarks:

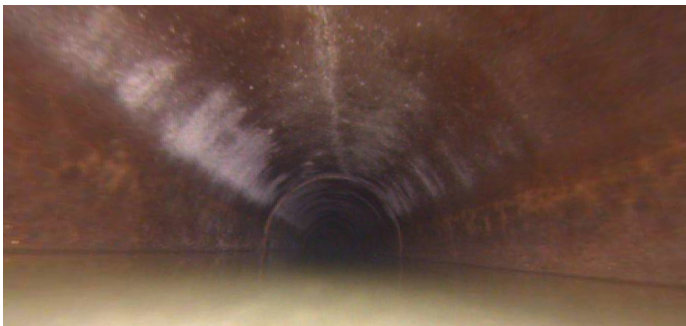
Code: **FL**
Description: **Fracture Longitudinal**

Distance (ft): **198.8**
Structural Grade: **3**
O&M Grade: **0**
Clock Start/From: **12**
Clock To:
1st Value:
2nd Value:
Value Percent:
Continuous Index:
Within 8" of Joint: **YES**
Remarks:

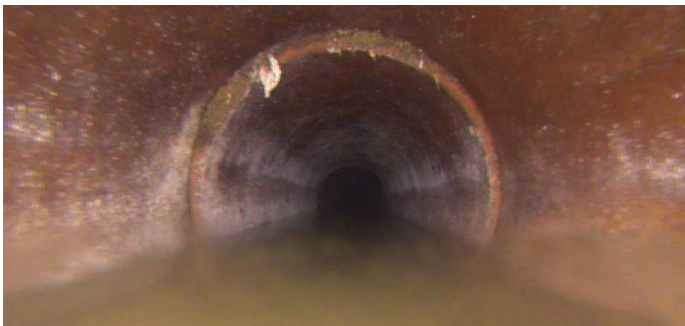
Code: **RFJ**
Description: **Roots Fine Joint**

Distance (ft): **211.9**
Structural Grade: **0**
O&M Grade: **1**
Clock Start/From: **7**
Clock To: **5**
1st Value:
2nd Value:
Value Percent:
Continuous Index: **S01**
Within 8" of Joint: **YES**
Remarks: **WANDER**

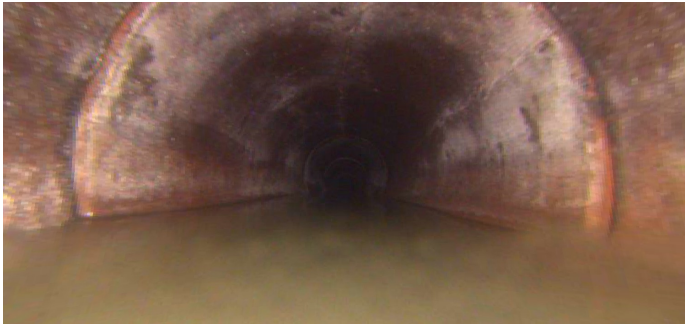
Code: **CM**
Description: **Crack Multiple**

Distance (ft): **215.1**
Structural Grade: **3**
O&M Grade: **0**
Clock Start/From: **12**
Clock To: **2**
1st Value:
2nd Value:
Value Percent:
Continuous Index:
Within 8" of Joint:
Remarks:

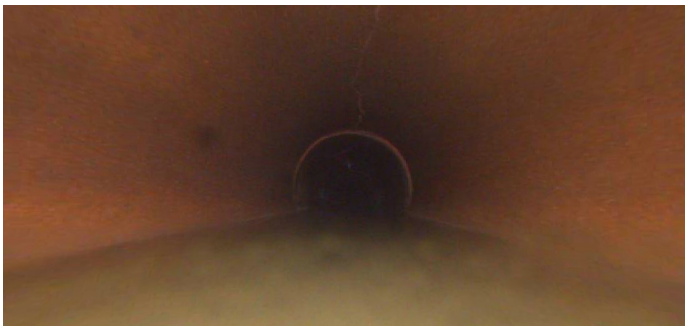
Code: **CL**
Description: **Crack Longitudinal**

Distance (ft): **235.3**
Structural Grade: **2**
O&M Grade: **0**
Clock Start/From: **12**
Clock To:
1st Value:
2nd Value:
Value Percent:
Continuous Index:
Within 8" of Joint: **YES**
Remarks:

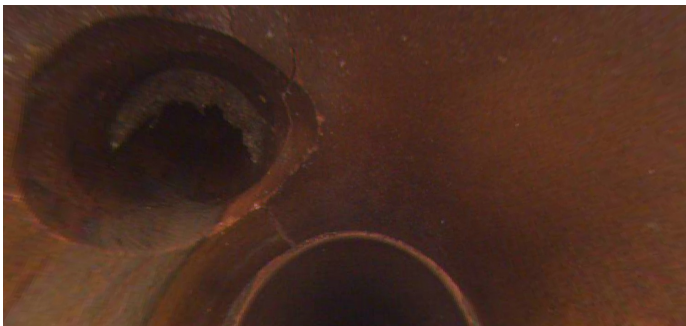
Code: **TF**
Description: **Tap Factory**

Distance (ft): **245.9**
Structural Grade: **0**
O&M Grade: **0**
Clock Start/From: **10**
Clock To:
1st Value: **4.000**
2nd Value:
Value Percent:
Continuous Index:
Within 8" of Joint:
Remarks:
