Profile/Photo Observation Report

Date:	04/04/2018	Weather:		Coding:	PACP 6.0
Pipe Length (ft):	94.6	Owner:	NA	Pre Clean:	Not Known
P.O.#:		Surveyor:	Jen Costello	PSR:	P-803-011-012
Customer:		Clean Date:	01/01/1900	Shape:	C

Street:	E RAND ST	Flow Control:	Not Controlled
City:	Hobart, IN	Year Renewed:	
Location:	Other	Tape/Media #:	
Purpose:	Not Known	Dia/Height:	12"
Use:	Sanitary	Material:	VCP
Drain Area:	NA	Lining:	
Category:	NA		
Comment:			
Location Details:		Direction of Survey:	Upstream
US MH:	M-803-012	DS MH:	M-803-011
		Total Length Surveyed (ft):	86.0

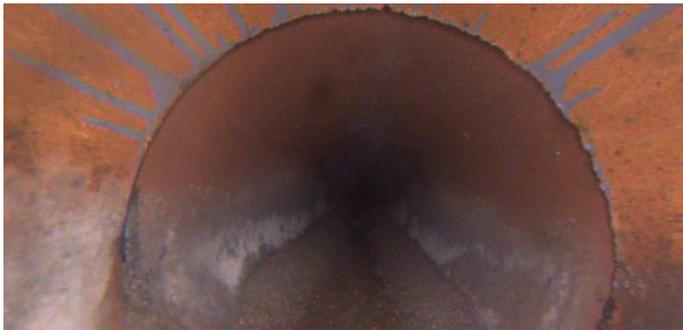
Code: **AMH**
 Description: **Manhole**
 Distance (ft): **.0**
 Structural Grade: **0**
 O&M Grade: **0**
 Clock Start/From:
 Clock To:
 1st Value:
 2nd Value:
 Value Percent:
 Continuous Index:
 Within 8" of Joint: **NO**
 Remarks: **M-803-011**

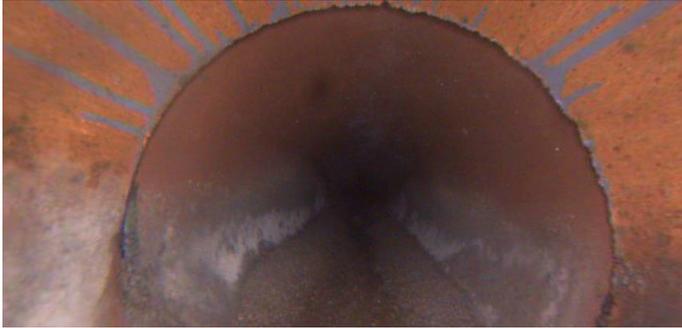
Code: **MWL**
Description: **Water Level**

Distance (ft): **.0**
Structural Grade: **0**
O&M Grade: **0**
Clock Start/From:
Clock To:
1st Value:
2nd Value:
Value Percent: **0.000**
Continuous Index:
Within 8" of Joint: **NO**
Remarks:

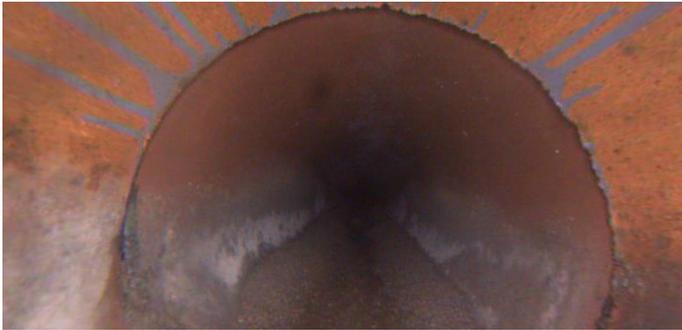
Code: **DSF**
Description: **Deposits Settled Fine**

Distance (ft): **.0**
Structural Grade: **0**
O&M Grade: **2**
Clock Start/From: **5**
Clock To: **7**
1st Value:
2nd Value:
Value Percent: **5.000**
Continuous Index: **S01**
Within 8" of Joint: **NO**
Remarks:

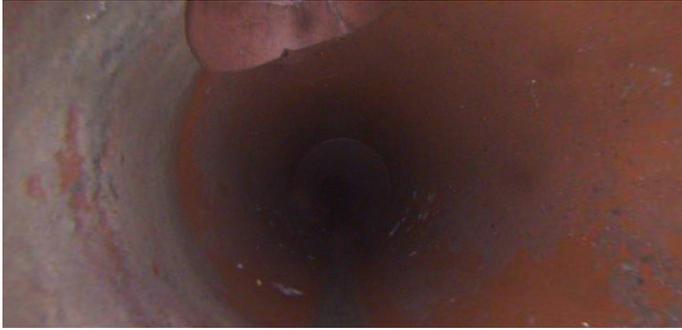
Code: **DSF**
Description: **Deposits Settled Fine**

Distance (ft): **10.9**
Structural Grade: **0**
O&M Grade: **2**
Clock Start/From: **5**
Clock To: **7**
1st Value:
2nd Value:
Value Percent: **5.000**
Continuous Index: **F01**
Within 8" of Joint: **NO**
Remarks:

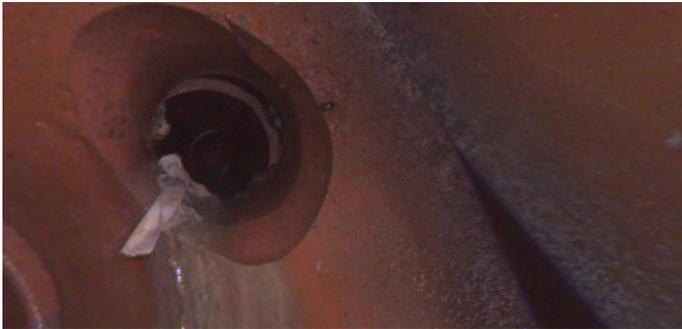
Code: **TFA**
Description: **Tap Factory Active**

Distance (ft): **12.1**
Structural Grade: **0**
O&M Grade: **0**
Clock Start/From: **10**
Clock To:
1st Value: **4.000**
2nd Value:
Value Percent:
Continuous Index:
Within 8" of Joint:
Remarks:

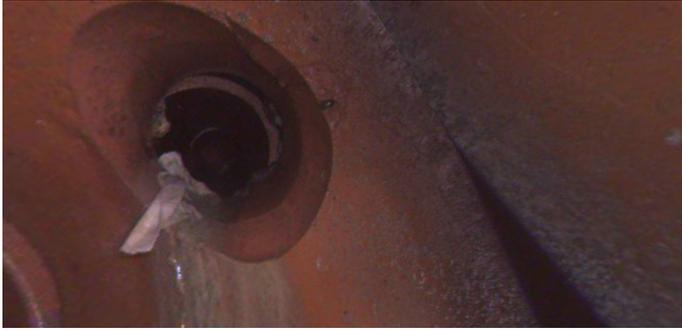
Code: **DAR**
Description: **Deposits Attached Ragging**

Distance (ft): **12.1**
Structural Grade: **0**
O&M Grade: **2**
Clock Start/From: **10**
Clock To:
1st Value:
2nd Value:
Value Percent: **5.000**
Continuous Index:
Within 8" of Joint: **NO**
Remarks:

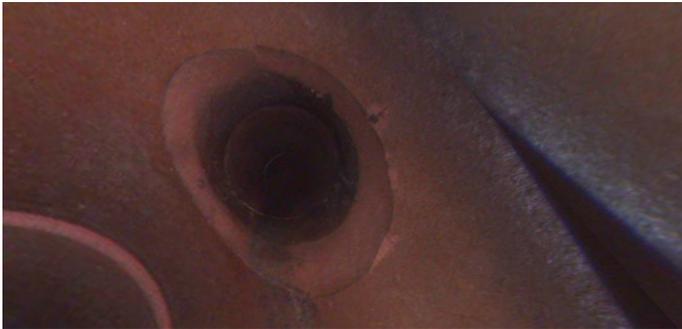
Code: **TF**
Description: **Tap Factory**

Distance (ft): **30.3**
Structural Grade: **0**
O&M Grade: **0**
Clock Start/From: **10**
Clock To:
1st Value: **4.000**
2nd Value:
Value Percent:
Continuous Index:
Within 8" of Joint:
Remarks:

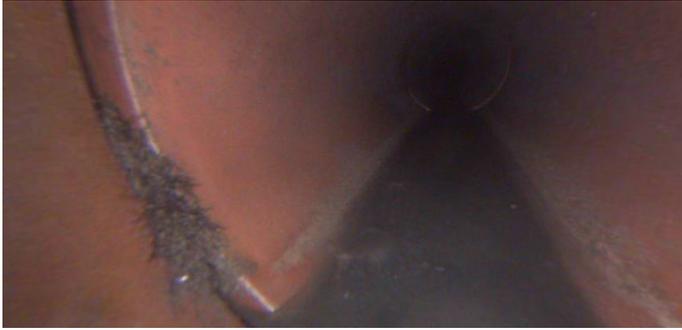
Code: **RFJ**
Description: **Roots Fine Joint**

Distance (ft): **53.0**
Structural Grade: **0**
O&M Grade: **1**
Clock Start/From: **8**
Clock To: **9**
1st Value:
2nd Value:
Value Percent:
Continuous Index:
Within 8" of Joint: **YES**
Remarks:

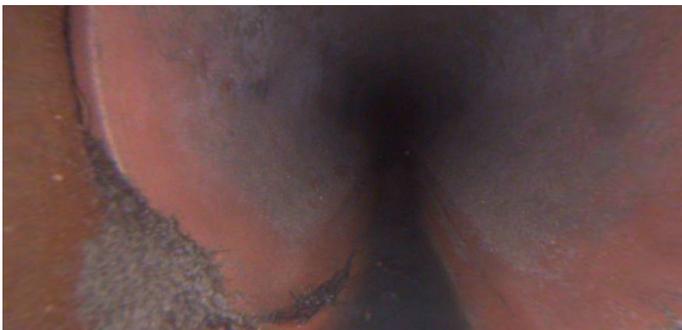
Code: **RFJ**
Description: **Roots Fine Joint**

Distance (ft): **59.1**
Structural Grade: **0**
O&M Grade: **1**
Clock Start/From: **8**
Clock To: **9**
1st Value:
2nd Value:
Value Percent:
Continuous Index:
Within 8" of Joint: **YES**
Remarks:

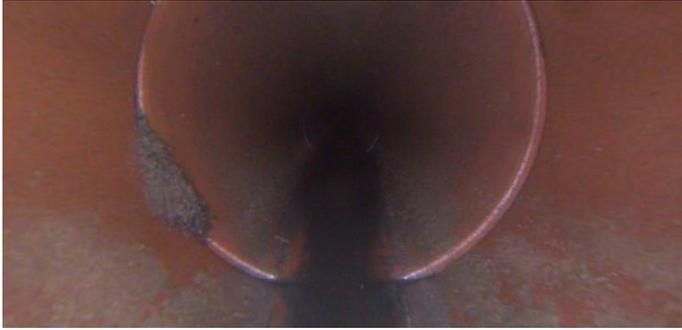
Code: **DAZ**
Description: **Deposits Attached Other**

Distance (ft): **67.9**
Structural Grade: **0**
O&M Grade: **2**
Clock Start/From: **8**
Clock To: **9**
1st Value:
2nd Value:
Value Percent: **5.000**
Continuous Index:
Within 8" of Joint: **YES**
Remarks:

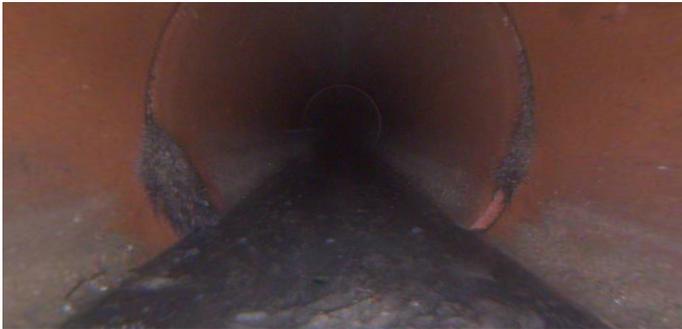
Code: **RMJ**
Description: **Roots Medium Joint**

Distance (ft): **74.0**
Structural Grade: **0**
O&M Grade: **3**
Clock Start/From: **8**
Clock To: **4**
1st Value:
2nd Value:
Value Percent: **5.000**
Continuous Index:
Within 8" of Joint: **YES**
Remarks:

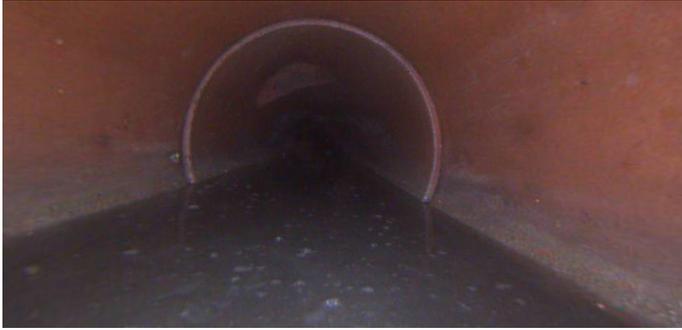
Code: **MWL**
Description: **Water Level**

Distance (ft): **86.0**
Structural Grade: **0**
O&M Grade: **0**
Clock Start/From:
Clock To:
1st Value:
2nd Value:
Value Percent: **30.000**
Continuous Index:
Within 8" of Joint: **NO**
Remarks:

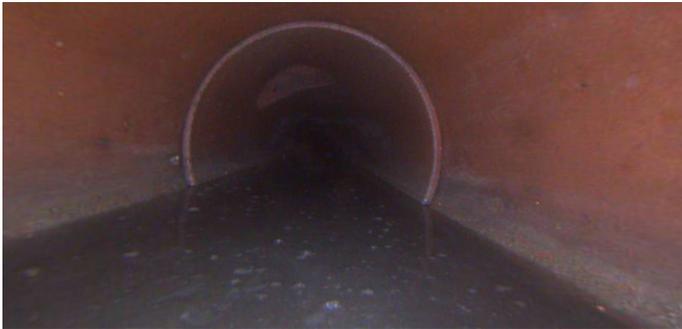
Code: **MSA**
Description: **Abandoned Survey**

Distance (ft): **86.0**
Structural Grade: **0**
O&M Grade: **0**
Clock Start/From:
Clock To:
1st Value:
2nd Value:
Value Percent:
Continuous Index:
Within 8" of Joint: **NO**
Remarks: **UNKNOWN**
