Profile/Photo Observation Report

Date:	04/04/2018	Weather:		Coding:	PACP 6.0
Pipe Length (ft):	94.6	Owner:	NA	Pre Clean:	Not Known
P.O.#:		Surveyor:	Jen Costello	PSR:	P-803-011-012
Customer:		Clean Date:	01/01/1900	Shape:	C

Street:	Rand St.	Flow Control:	Not Controlled
City:	Hobart, IN	Year Renewed:	
Location:	Other	Tape/Media #:	
Purpose:	Not Known	Dia/Height:	12"
Use:	Sanitary	Material:	VCP
Drain Area:	NA	Lining:	
Category:	NA		
Comment:

Location Details:		Direction of Survey:	Upstream
US MH:	M-803-012	DS MH:	M-803-011
		Total Length Surveyed (ft):	86.0

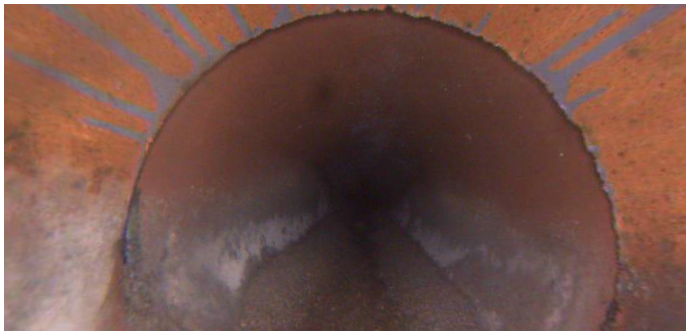
Code: **AMH**
Description: **Manhole**

Distance (ft): **.0**
Structural Grade: **0**
O&M Grade: **0**
Clock Start/From:
Clock To:
1st Value:
2nd Value:
Value Percent:
Continuous Index:
Within 8" of Joint: **NO**
Remarks: **M-803-011**

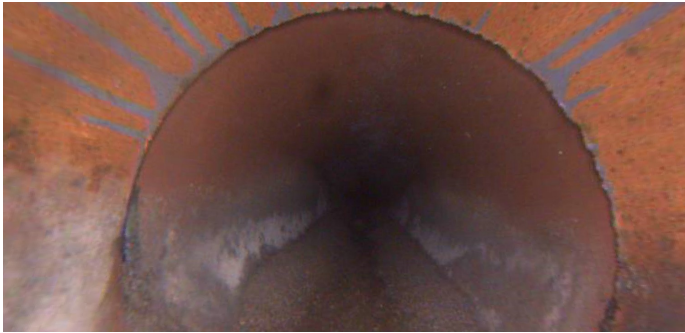
Code:	MWL
Description:	Water Level

Distance (ft):	.0
Structural Grade:	0
O&M Grade:	0
Clock Start/From:	
Clock To:	
1st Value:	
2nd Value:	
Value Percent:	0.000
Continuous Index:	
Within 8" of Joint:	NO
Remarks:

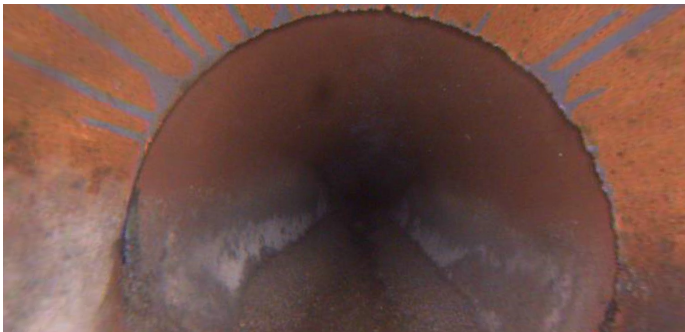
Code:	DSF
Description:	Deposits Settled Fine

Distance (ft):	.0
Structural Grade:	0
O&M Grade:	2
Clock Start/From:	5
Clock To:	7
1st Value:	
2nd Value:	
Value Percent:	5.000
Continuous Index:	S01
Within 8" of Joint:	NO
Remarks:

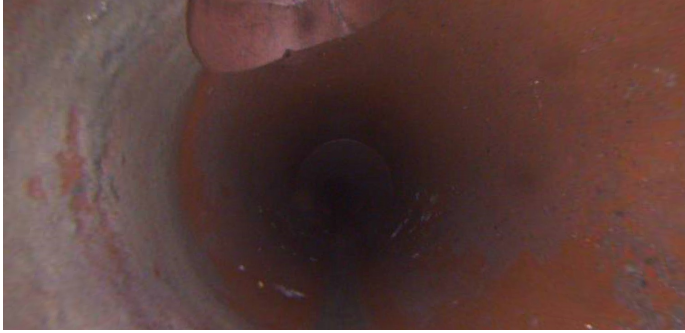
Code: **DSF**
Description: **Deposits Settled Fine**

Distance (ft): **10.9**
Structural Grade: **0**
O&M Grade: **2**
Clock Start/From: **5**
Clock To: **7**
1st Value:
2nd Value:
Value Percent: **5.000**
Continuous Index: **F01**
Within 8" of Joint: **NO**
Remarks:

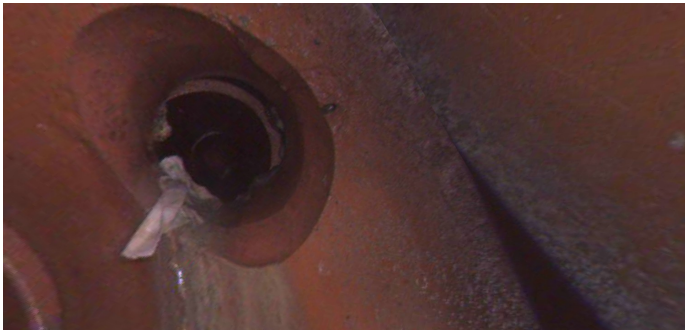
Code: **TFA**
Description: **Tap Factory Active**

Distance (ft): **12.1**
Structural Grade: **0**
O&M Grade: **0**
Clock Start/From: **10**
Clock To:
1st Value: **4.000**
2nd Value:
Value Percent:
Continuous Index:
Within 8" of Joint:
Remarks:

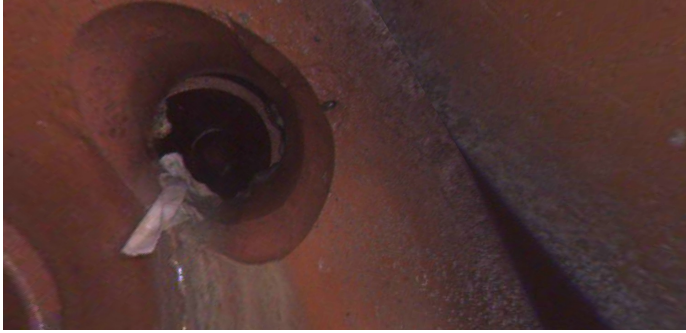
Code: **DAR**
Description: **Deposits Attached Ragging**

Distance (ft): **12.1**
Structural Grade: **0**
O&M Grade: **2**
Clock Start/From: **10**
Clock To:
1st Value:
2nd Value:
Value Percent: **5.000**
Continuous Index:
Within 8" of Joint: **NO**
Remarks:

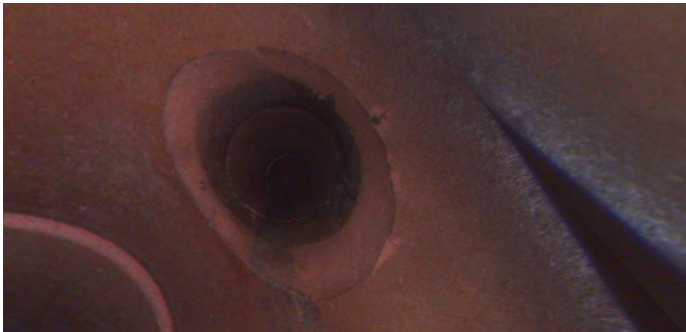
Code: **TF**
Description: **Tap Factory**

Distance (ft): **30.3**
Structural Grade: **0**
O&M Grade: **0**
Clock Start/From: **10**
Clock To:
1st Value: **4.000**
2nd Value:
Value Percent:
Continuous Index:
Within 8" of Joint:
Remarks:

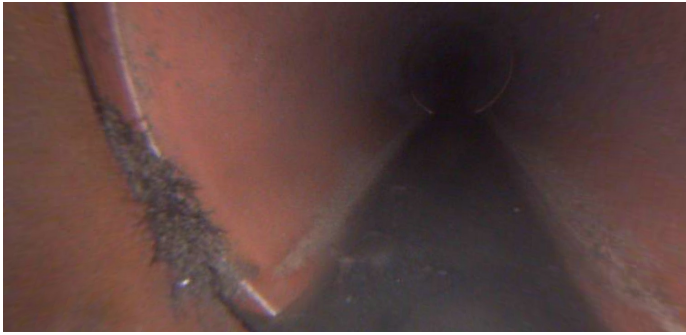
Code: **RFJ**
Description: **Roots Fine Joint**

Distance (ft): **53.0**
Structural Grade: **0**
O&M Grade: **1**
Clock Start/From: **8**
Clock To: **9**
1st Value:
2nd Value:
Value Percent:
Continuous Index:
Within 8" of Joint: **YES**
Remarks:

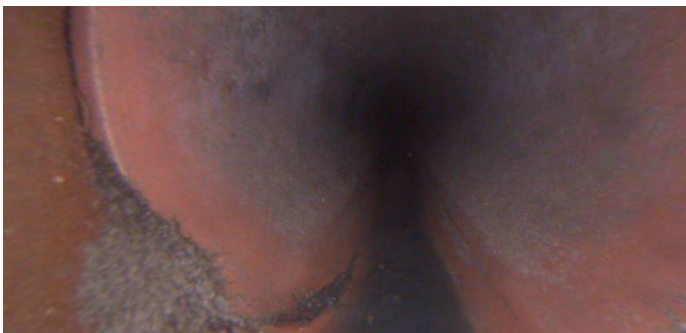
Code: **RFJ**
Description: **Roots Fine Joint**

Distance (ft): **59.1**
Structural Grade: **0**
O&M Grade: **1**
Clock Start/From: **8**
Clock To: **9**
1st Value:
2nd Value:
Value Percent:
Continuous Index:
Within 8" of Joint: **YES**
Remarks:

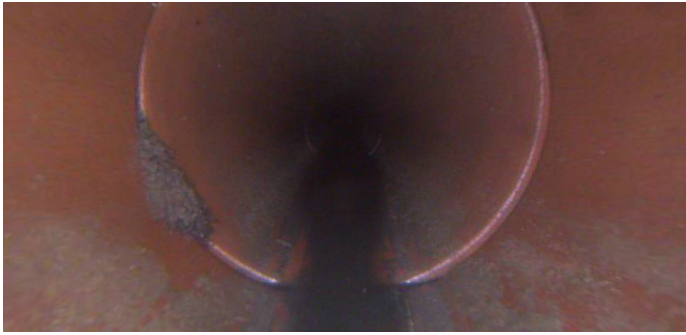
Code: **DAZ**
Description: **Deposits Attached Other**

Distance (ft): **67.9**
Structural Grade: **0**
O&M Grade: **2**
Clock Start/From: **8**
Clock To: **9**
1st Value:
2nd Value:
Value Percent: **5.000**
Continuous Index:
Within 8" of Joint: **YES**
Remarks:

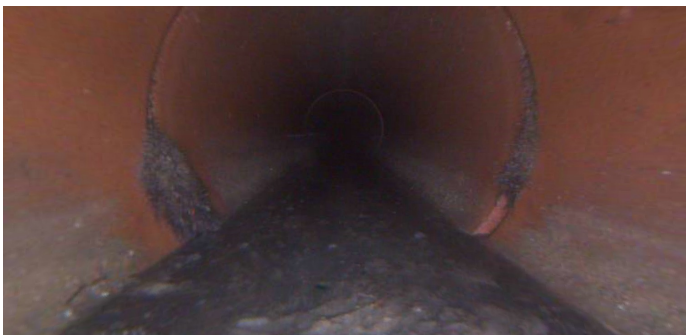
Code: **RMJ**
Description: **Roots Medium Joint**

Distance (ft): **74.0**
Structural Grade: **0**
O&M Grade: **3**
Clock Start/From: **8**
Clock To: **4**
1st Value:
2nd Value:
Value Percent: **5.000**
Continuous Index:
Within 8" of Joint: **YES**
Remarks:

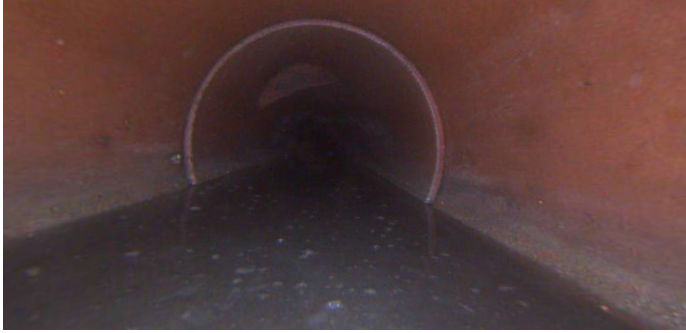
Code: **MWL**
Description: **Water Level**

Distance (ft): **86.0**
Structural Grade: **0**
O&M Grade: **0**
Clock Start/From:
Clock To:
1st Value:
2nd Value:
Value Percent: **30.000**
Continuous Index:
Within 8" of Joint: **NO**
Remarks:

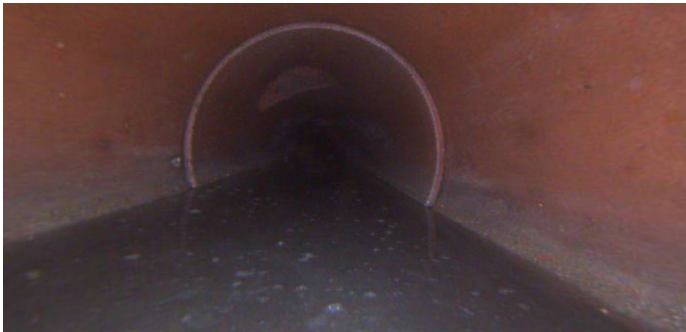
Code: **MSA**
Description: **Abandoned Survey**

Distance (ft): **86.0**
Structural Grade: **0**
O&M Grade: **0**
Clock Start/From:
Clock To:
1st Value:
2nd Value:
Value Percent:
Continuous Index:
Within 8" of Joint: **NO**
Remarks: **UNKNOWN**
