Profile/Photo Observation Report

Street:	E RAND ST & N HOBART RD	Flow Control:	Not Controlled
City:	Hobart, IN	Year Renewed:	
Location:	Other	Tape/Media #:	
Purpose:	Not Known	Dia/Height:	12"
Use:	Sanitary	Material:	VCP
Drain Area:	NA	Lining:	
Category:	NA		
Comment:

Location Details:		Direction of Survey:	Upstream
US MH:	M-803-012	DS MH:	M-803-013
		Total Length Surveyed (ft):	6.4

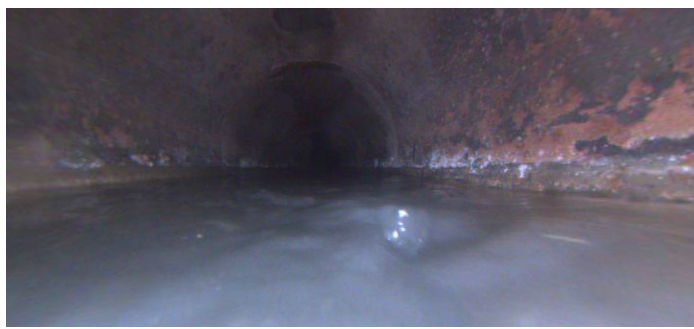
Code: **AMH**
Description: **Manhole**

Distance (ft): **.0**
Structural Grade: **0**
O&M Grade: **0**
Clock Start/From:
Clock To:
1st Value:
2nd Value:
Value Percent:
Continuous Index:
Within 8" of Joint: **NO**
Remarks: **M-803-013**

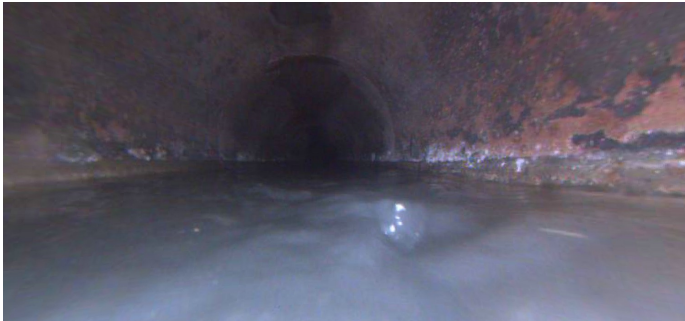
Code:	MWL
Description:	Water Level

Distance (ft):	.0
Structural Grade:	0
O&M Grade:	0
Clock Start/From:	
Clock To:	
1st Value:	
2nd Value:	
Value Percent:	30.000
Continuous Index:	
Within 8" of Joint:	NO
Remarks:
