Profile/Photo Observation Report

Date:	04/03/2018	Weather:		Coding:	PACP 6.0
Pipe Length (ft):	192.3	Owner:	NA	Pre Clean:	Not Known
P.O.#:		Surveyor:	Jen Costello	PSR:	P-803-013-012
Customer:		Clean Date:	01/01/1900	Shape:	C

Street:	Rand St.	Flow Control:	Not Controlled
City:	Hobart, IN	Year Renewed:	
Location:	Other	Tape/Media #:	
Purpose:	Not Known	Dia/Height:	12"
Use:	Sanitary	Material:	VCP
Drain Area:	NA	Lining:	
Category:	NA		
Comment:

Location Details:		Direction of Survey:	Upstream
US MH:	M-803-012	DS MH:	M-803-013
		Total Length Surveyed (ft):	6.4

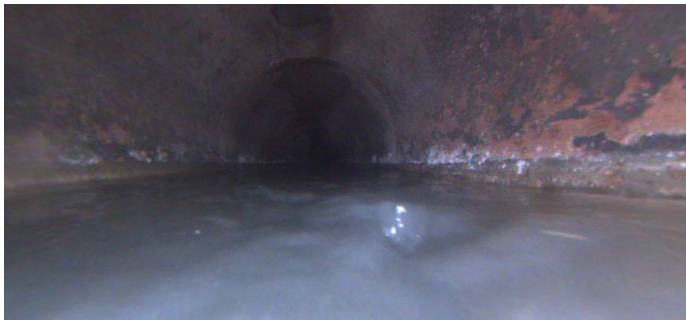
Code: **AMH**
Description: **Manhole**

Distance (ft): **.0**
Structural Grade: **0**
O&M Grade: **0**
Clock Start/From:
Clock To:
1st Value:
2nd Value:
Value Percent:
Continuous Index:
Within 8" of Joint: **NO**
Remarks: **M-803-013**

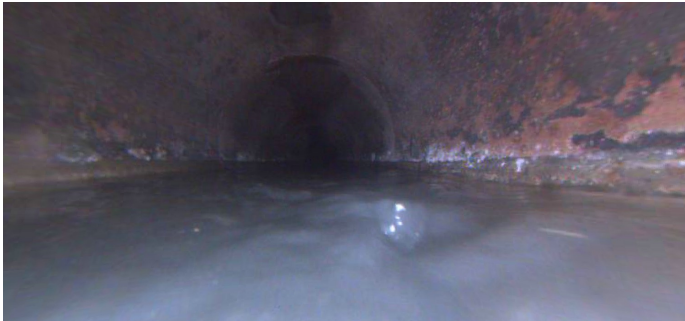
Code:	MWL
Description:	Water Level

Distance (ft):	.0
Structural Grade:	0
O&M Grade:	0
Clock Start/From:	
Clock To:	
1st Value:	
2nd Value:	
Value Percent:	30.000
Continuous Index:	
Within 8" of Joint:	NO
Remarks:
