Profile/Photo Observation Report

Street:	E RAND ST & N HOBART RD	Flow Control:	Not Controlled
City:	Hobart, IN	Year Renewed:	
Location:	Other	Tape/Media #:	
Purpose:	Not Known	Dia/Height:	12"
Use:	Sanitary	Material:	VCP
Drain Area:	NA	Lining:	
Category:	NA		
Comment:

Location Details:		Direction of Survey:	Downstream
US MH:	M-803-012	DS MH:	M-803-013
		Total Length Surveyed (ft):	38.0

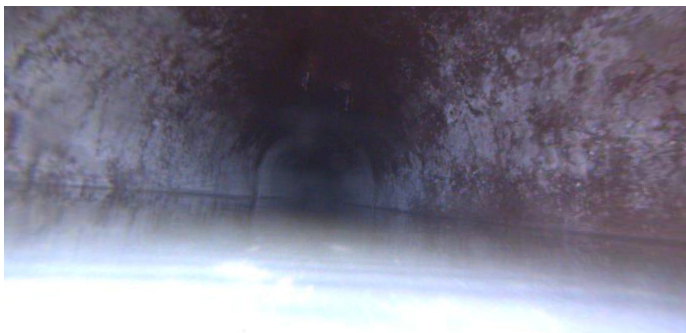
Code: **AMH**
Description: **Manhole**

Distance (ft): **.0**
Structural Grade: **0**
O&M Grade: **0**
Clock Start/From:
Clock To:
1st Value:
2nd Value:
Value Percent:
Continuous Index:
Within 8" of Joint: **NO**
Remarks: **M-803-012**

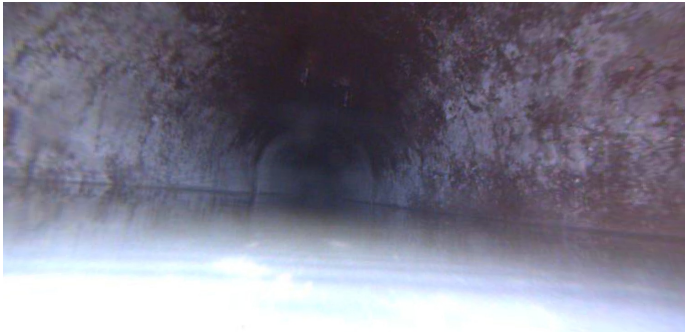
Code:	MWL
Description:	Water Level

Distance (ft):	.0
Structural Grade:	0
O&M Grade:	0
Clock Start/From:	
Clock To:	
1st Value:	
2nd Value:	
Value Percent:	40.000
Continuous Index:	
Within 8" of Joint:	NO
Remarks:

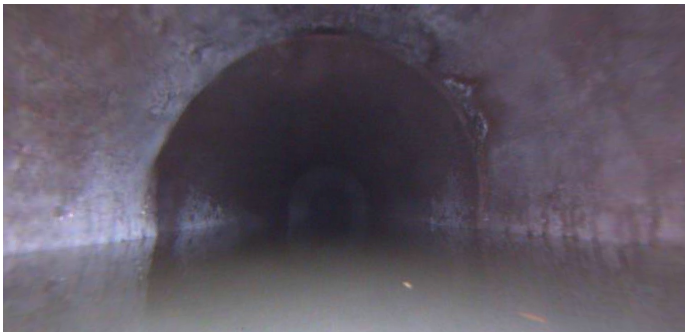
Code:	MSA
Description:	Abandoned Survey

Distance (ft):	38.0
Structural Grade:	0
O&M Grade:	0
Clock Start/From:	
Clock To:	
1st Value:	
2nd Value:	
Value Percent:	
Continuous Index:	
Within 8" of Joint:	NO
Remarks:	DEBRIS UNDER WATER
