Profile/Photo Observation Report

Street:	Rand St.	Flow Control:	Not Controlled
City:	Hobart, IN	Year Renewed:	
Location:	Other	Tape/Media #:	
Purpose:	Not Known	Dia/Height:	12"
Use:	Sanitary	Material:	VCP
Drain Area:	NA	Lining:	
Category:	NA		
Comment:

Location Details:		Direction of Survey:	Downstream
US MH:	M-803-012	DS MH:	M-803-013
		Total Length Surveyed (ft):	38.0

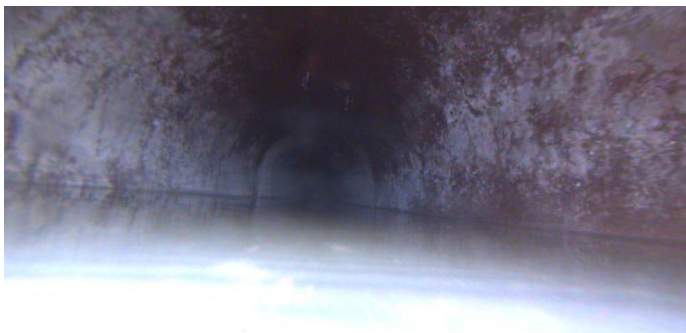
Code: **AMH**
Description: **Manhole**

Distance (ft): **.0**
Structural Grade: **0**
O&M Grade: **0**
Clock Start/From:
Clock To:
1st Value:
2nd Value:
Value Percent:
Continuous Index:
Within 8" of Joint: **NO**
Remarks: **M-803-012**

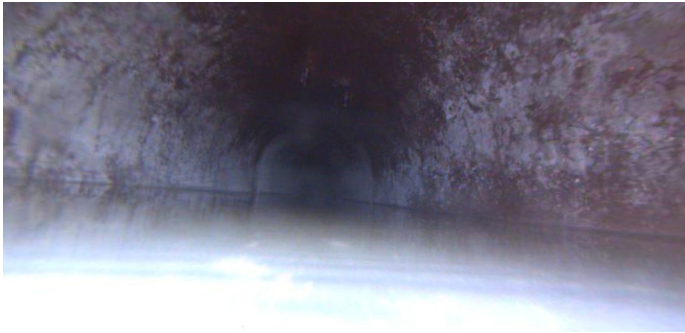
Code:	MWL
Description:	Water Level

Distance (ft):	.0
Structural Grade:	0
O&M Grade:	0
Clock Start/From:	
Clock To:	
1st Value:	
2nd Value:	
Value Percent:	40.000
Continuous Index:	
Within 8" of Joint:	NO
Remarks:

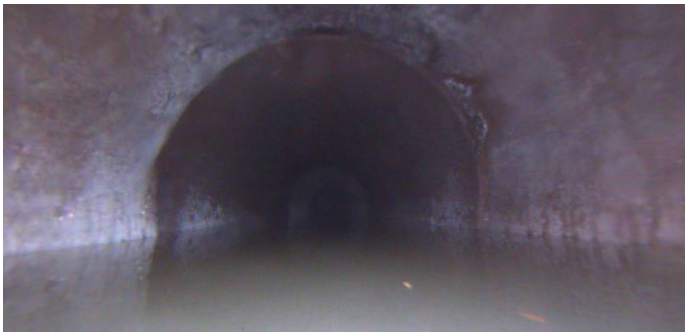
Code:	MSA
Description:	Abandoned Survey

Distance (ft):	38.0
Structural Grade:	0
O&M Grade:	0
Clock Start/From:	
Clock To:	
1st Value:	
2nd Value:	
Value Percent:	
Continuous Index:	
Within 8" of Joint:	NO
Remarks:	DEBRIS UNDER WATER
