Profile/Photo Observation Report

Street:	E RAND ST & N HOBART RD	Flow Control:	Not Controlled
City:	Hobart, IN	Year Renewed:	
Location:	Other	Tape/Media #:	
Purpose:	Not Known	Dia/Height:	12"
Use:	Sanitary	Material:	VCP
Drain Area:	NA	Lining:	
Category:	NA		
Comment:

Location Details:		Direction of Survey:	Downstream
US MH:	M-803-012	DS MH:	M-803-013
		Total Length Surveyed (ft):	183.1

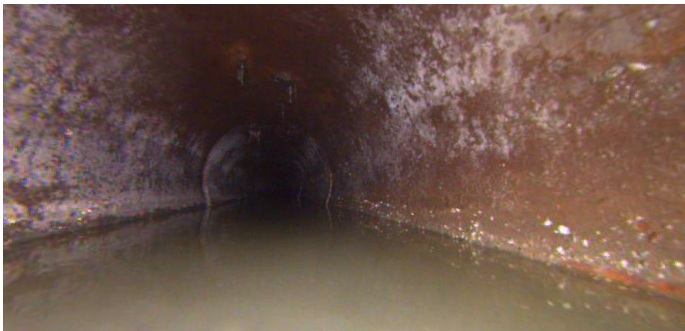
Code: **AMH**
Description: **Manhole**

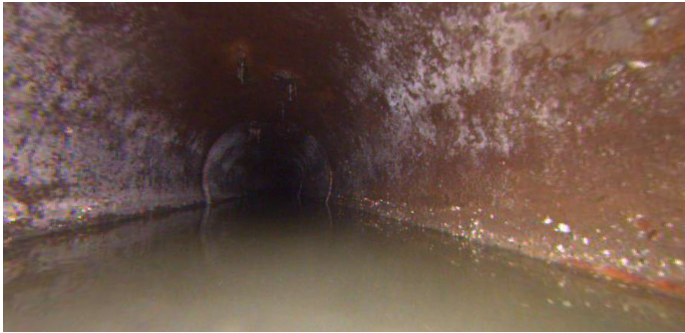
Code:	MWL
Description:	Water Level

Distance (ft):	.0
Structural Grade:	0
O&M Grade:	0
Clock Start/From:	
Clock To:	
1st Value:	
2nd Value:	
Value Percent:	40.000
Continuous Index:	
Within 8" of Joint:	NO
Remarks:

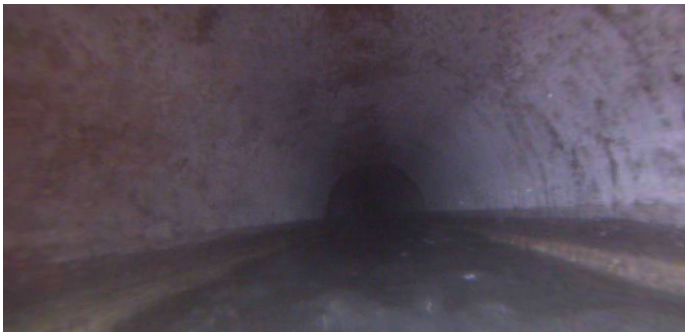
Code:	MGO
Description:	General Observation

Distance (ft):	69.7
Structural Grade:	0
O&M Grade:	0
Clock Start/From:	
Clock To:	
1st Value:	
2nd Value:	
Value Percent:	
Continuous Index:	
Within 8" of Joint:	NO
Remarks:	rear camera

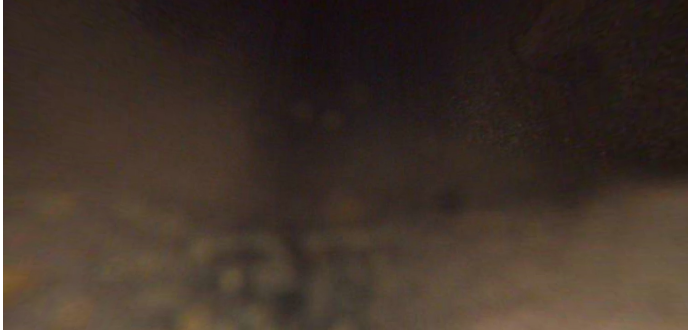
Code:	AMH
Description:	Manhole
Distance (ft):	183.1
Structural Grade:	0
O&M Grade:	0
Clock Start/From:	
Clock To:	
1st Value:	
2nd Value:	
Value Percent:	
Continuous Index:	
Within 8" of Joint:	NO
Remarks:	M-803-013
