Profile/Photo Observation Report

Street:	Rand St.	Flow Control:	Not Controlled
City:	Hobart, IN	Year Renewed:	
Location:	Other	Tape/Media #:	
Purpose:	Not Known	Dia/Height:	12"
Use:	Sanitary	Material:	VCP
Drain Area:	NA	Lining:	
Category:	NA		
Comment:

Location Details:		Direction of Survey:	Downstream
US MH:	M-803-012	DS MH:	M-803-013
		Total Length Surveyed (ft):	183.1

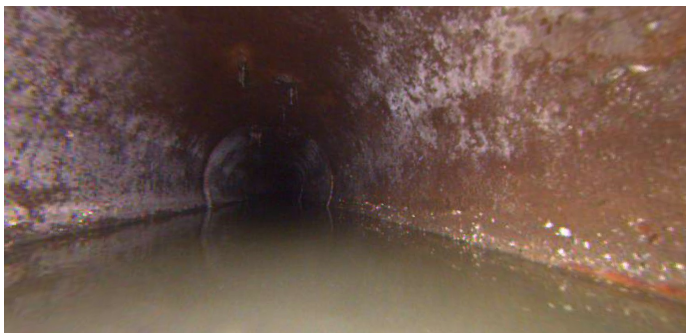
Code: **AMH**
Description: **Manhole**

Distance (ft): **.0**
Structural Grade: **0**
O&M Grade: **0**
Clock Start/From:
Clock To:
1st Value:
2nd Value:
Value Percent:
Continuous Index:
Within 8" of Joint: **NO**
Remarks: **M-803-012**

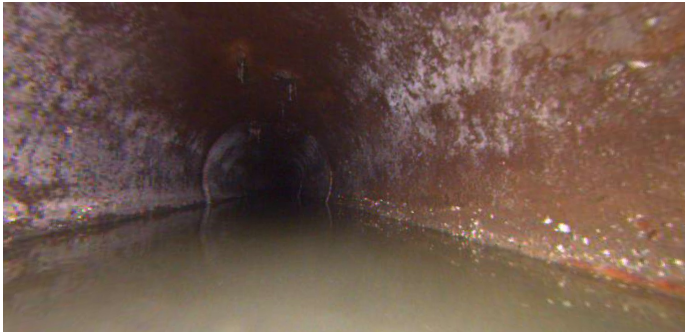
Code:	MWL
Description:	Water Level

Distance (ft):	.0
Structural Grade:	0
O&M Grade:	0
Clock Start/From:	
Clock To:	
1st Value:	
2nd Value:	
Value Percent:	40.000
Continuous Index:	
Within 8" of Joint:	NO
Remarks:

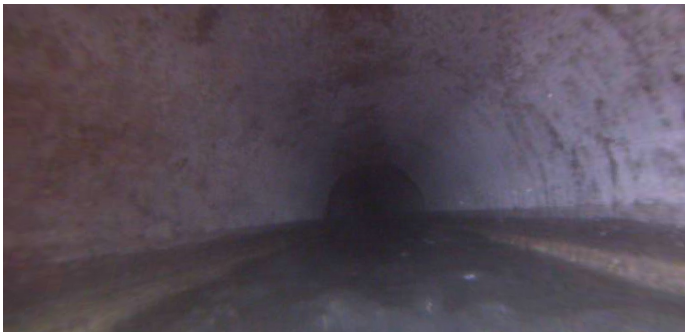
Code:	MGO
Description:	General Observation

Distance (ft):	69.7
Structural Grade:	0
O&M Grade:	0
Clock Start/From:	
Clock To:	
1st Value:	
2nd Value:	
Value Percent:	
Continuous Index:	
Within 8" of Joint:	NO
Remarks:	rear camera

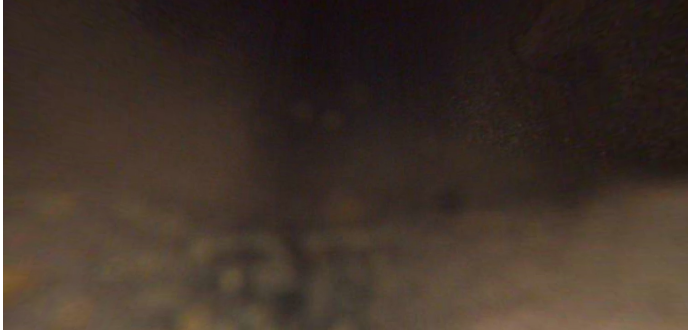
Code:	AMH
Description:	Manhole
Distance (ft):	183.1
Structural Grade:	0
O&M Grade:	0
Clock Start/From:	
Clock To:	
1st Value:	
2nd Value:	
Value Percent:	
Continuous Index:	
Within 8" of Joint:	NO
Remarks:	M-803-013
