Profile/Photo Observation Report

Street:	E RAND ST & N HOBART RD	Flow Control:	Not Controlled
City:	Hobart, IN	Year Renewed:	
Location:	Other	Tape/Media #:	
Purpose:	Not Known	Dia/Height:	12"
Use:	Sanitary	Material:	VCP
Drain Area:	NA	Lining:	
Category:	NA		
Comment:

Location Details:		Direction of Survey:	Downstream
US MH:	M-803-013	DS MH:	M-903-032
		Total Length Surveyed (ft):	67.1

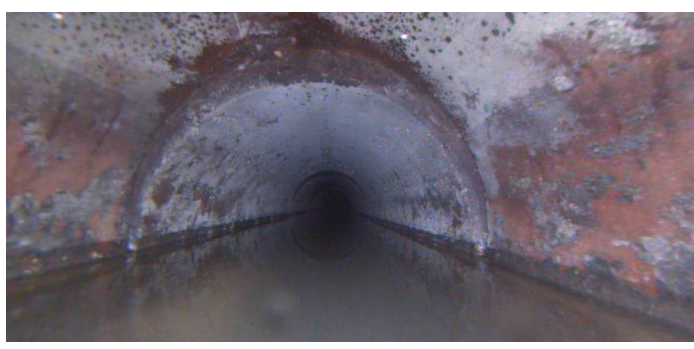
Code: **AMH**
Description: **Manhole**

Distance (ft): **.0**
Structural Grade: **0**
O&M Grade: **0**
Clock Start/From:
Clock To:
1st Value:
2nd Value:
Value Percent:
Continuous Index:
Within 8" of Joint: **NO**
Remarks: **M-803-013**

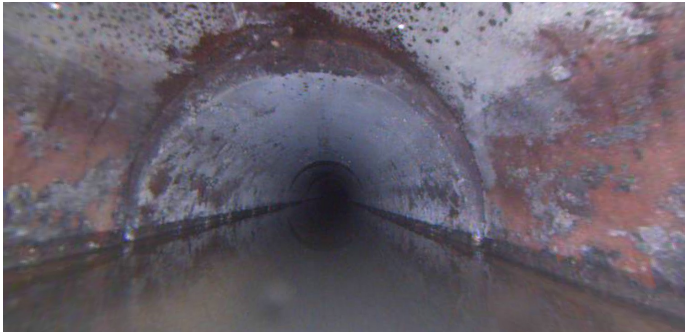
Code:	MWL
Description:	Water Level

Distance (ft):	.0
Structural Grade:	0
O&M Grade:	0
Clock Start/From:	
Clock To:	
1st Value:	
2nd Value:	
Value Percent:	30.000
Continuous Index:	
Within 8" of Joint:	NO
Remarks:

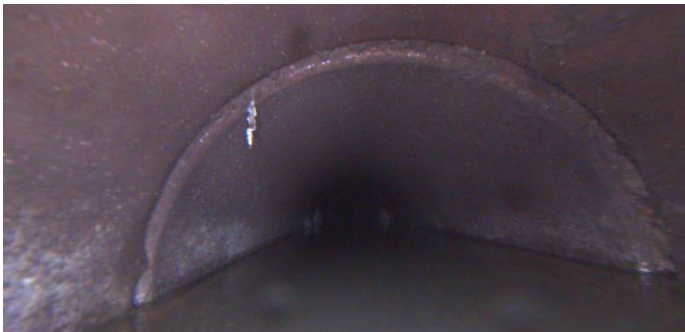
Code:	RFJ
Description:	Roots Fine Joint

Distance (ft):	16.4
Structural Grade:	0
O&M Grade:	1
Clock Start/From:	8
Clock To:	4
1st Value:	
2nd Value:	
Value Percent:	
Continuous Index:	
Within 8" of Joint:	YES
Remarks:

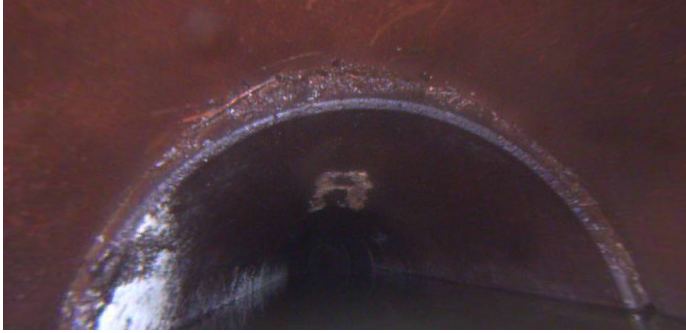
Code: **RFJ**
Description: **Roots Fine Joint**

Distance (ft): **37.7**
Structural Grade: **0**
O&M Grade: **1**
Clock Start/From: **12**
Clock To:
1st Value:
2nd Value:
Value Percent:
Continuous Index:
Within 8" of Joint: **YES**
Remarks:

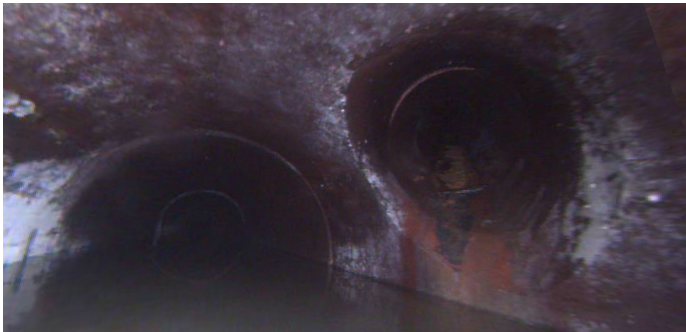
Code: **TF**
Description: **Tap Factory**

Distance (ft): **52.2**
Structural Grade: **0**
O&M Grade: **0**
Clock Start/From: **2**
Clock To:
1st Value: **4.000**
2nd Value:
Value Percent:
Continuous Index:
Within 8" of Joint:
Remarks:

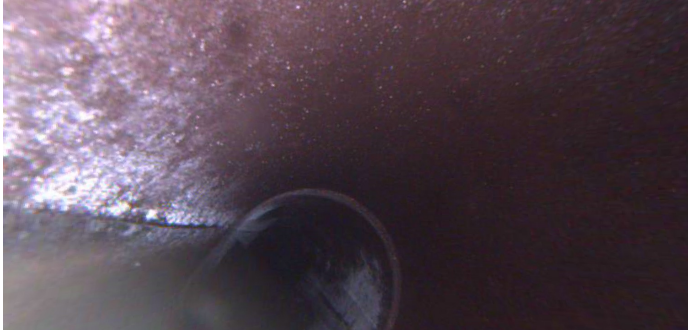
Code:	MSA
Description:	Abandoned Survey
Distance (ft):	67.1
Structural Grade:	0
O&M Grade:	0
Clock Start/From:	
Clock To:	
1st Value:	
2nd Value:	
Value Percent:	
Continuous Index:	
Within 8" of Joint:	NO
Remarks:	OVERTURNED
