## Profile/Photo Observation Report

Street:	<b>Rand St.</b>	Flow Control:	<b>Not Controlled</b>
City:	<b>Hobart, IN</b>	Year Renewed:	
Location:	<b>Other</b>	Tape/Media #:	
Purpose:	<b>Not Known</b>	Dia/Height:	<b>12"</b>
Use:	<b>Sanitary</b>	Material:	<b>VCP</b>
Drain Area:	<b>NA</b>	Lining:	
Category:	<b>NA</b>		
Comment:

Location Details:		Direction of Survey:	<b>Downstream</b>
US MH:	<b>M-803-013</b>	DS MH:	<b>M-903-032</b>
		Total Length Surveyed (ft):	<b>67.1</b>

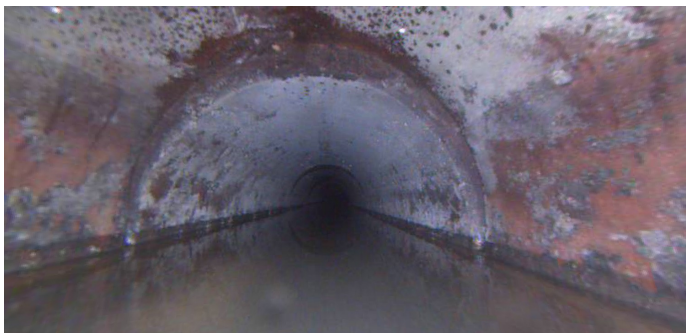
Code: **AMH**  
Description: **Manhole**

Distance (ft): **.0**  
Structural Grade: **0**  
O&M Grade: **0**  
Clock Start/From:  
Clock To:  
1st Value:  
2nd Value:  
Value Percent:  
Continuous Index:  
Within 8" of Joint: **NO**  
Remarks: **M-803-013**

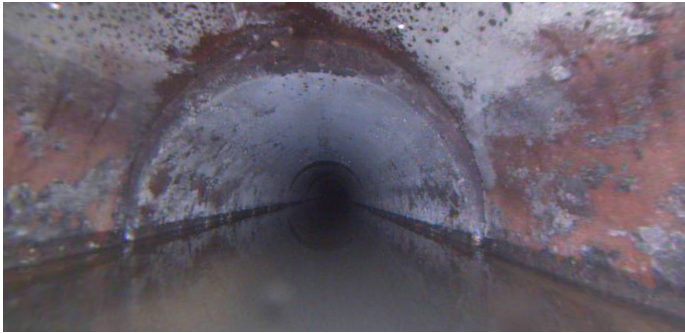
Code:	<b>MWL</b>
Description:	<b>Water Level</b>

Distance (ft):	<b>.0</b>
Structural Grade:	<b>0</b>
O&M Grade:	<b>0</b>
Clock Start/From:	
Clock To:	
1st Value:	
2nd Value:	
Value Percent:	<b>30.000</b>
Continuous Index:	
Within 8" of Joint:	<b>NO</b>
Remarks:

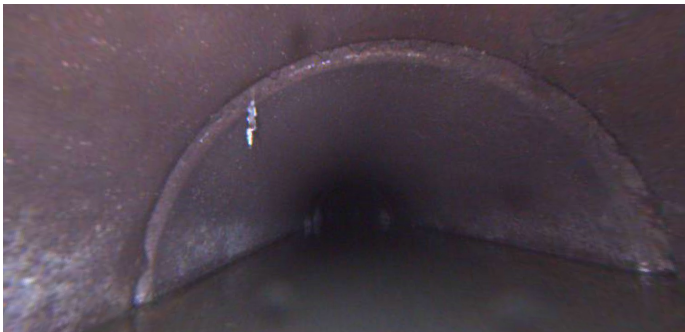
Code:	<b>RFJ</b>
Description:	<b>Roots Fine Joint</b>

Distance (ft):	<b>16.4</b>
Structural Grade:	<b>0</b>
O&M Grade:	<b>1</b>
Clock Start/From:	<b>8</b>
Clock To:	<b>4</b>
1st Value:	
2nd Value:	
Value Percent:	
Continuous Index:	
Within 8" of Joint:	<b>YES</b>
Remarks:

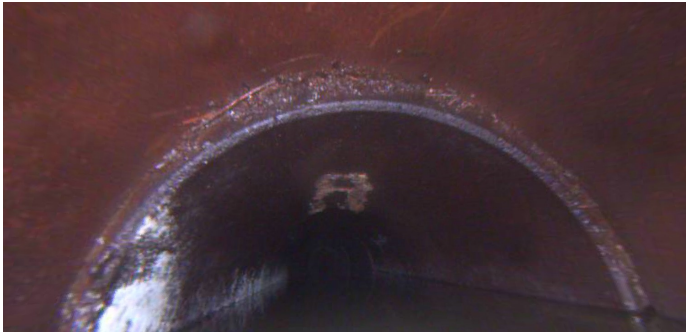
Code: **RFJ**  
Description: **Roots Fine Joint**

Distance (ft): **37.7**  
Structural Grade: **0**  
O&M Grade: **1**  
Clock Start/From: **12**  
Clock To:  
1st Value:  
2nd Value:  
Value Percent:  
Continuous Index:  
Within 8" of Joint: **YES**  
Remarks:

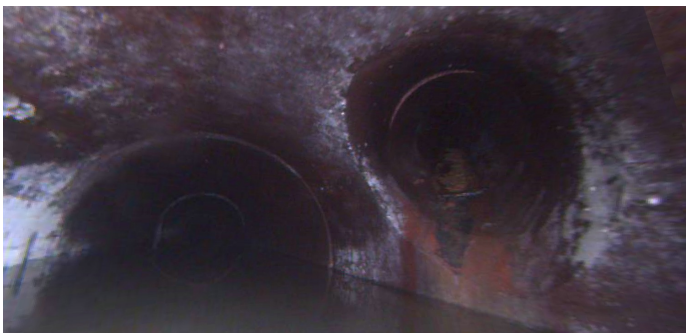
Code: **TF**  
Description: **Tap Factory**

Distance (ft): **52.2**  
Structural Grade: **0**  
O&M Grade: **0**  
Clock Start/From: **2**  
Clock To:  
1st Value: **4.000**  
2nd Value:  
Value Percent:  
Continuous Index:  
Within 8" of Joint:  
Remarks:

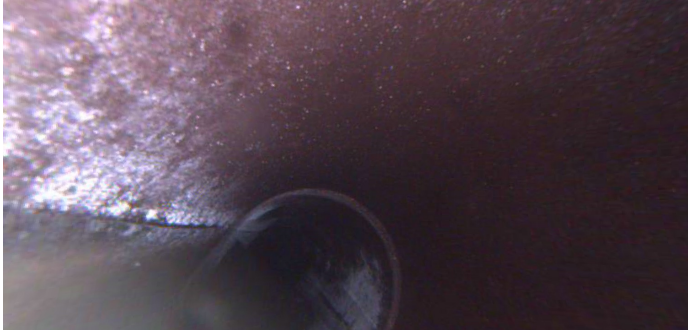
Code:	<b>MSA</b>
Description:	<b>Abandoned Survey</b>
Distance (ft):	<b>67.1</b>
Structural Grade:	<b>0</b>
O&M Grade:	<b>0</b>
Clock Start/From:	
Clock To:	
1st Value:	
2nd Value:	
Value Percent:	
Continuous Index:	
Within 8" of Joint:	<b>NO</b>
Remarks:	<b>OVERTURNED</b>
