Profile/Photo Observation Report

Date:	04/04/2018	Weather:		Coding:	PACP 6.0
Pipe Length (ft):	225.0	Owner:	NA	Pre Clean:	Not Known
P.O.#:		Surveyor:	Jen Costello	PSR:	P-903-032-013
Customer:		Clean Date:	01/01/1900	Shape:	C

Street:	E RAND ST & N HOBART RD	Flow Control:	Not Controlled
City:	Hobart, IN	Year Renewed:	
Location:	Other	Tape/Media #:	
Purpose:	Not Known	Dia/Height:	12"
Use:	Sanitary	Material:	VCP
Drain Area:	NA	Lining:	
Category:	NA		
Comment:

Location Details:		Direction of Survey:	Upstream
US MH:	M-803-013	DS MH:	M-903-032
		Total Length Surveyed (ft):	69.1

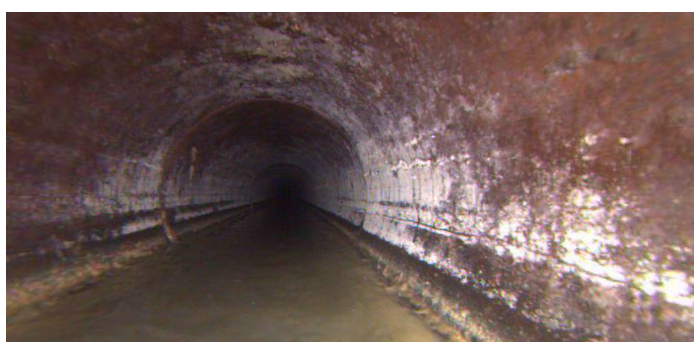
Code: **AMH**
Description: **Manhole**

Distance (ft): **.0**
Structural Grade: **0**
O&M Grade: **0**
Clock Start/From:
Clock To:
1st Value:
2nd Value:
Value Percent:
Continuous Index:
Within 8" of Joint: **NO**
Remarks: **M-903-032**

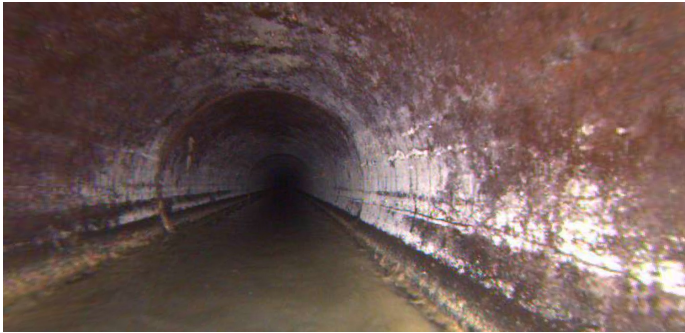
Code:	MWL
Description:	Water Level

Distance (ft):	.0
Structural Grade:	0
O&M Grade:	0
Clock Start/From:	
Clock To:	
1st Value:	
2nd Value:	
Value Percent:	20.000
Continuous Index:	
Within 8" of Joint:	NO
Remarks:

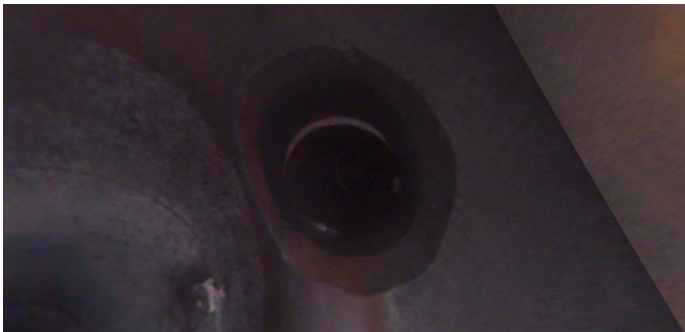
Code:	TF
Description:	Tap Factory

Distance (ft):	54.4
Structural Grade:	0
O&M Grade:	0
Clock Start/From:	10
Clock To:	
1st Value:	4.000
2nd Value:	
Value Percent:	
Continuous Index:	
Within 8" of Joint:	
Remarks:
