Profile/Photo Observation Report

Street:	N Hobart St.	Flow Control:	Not Controlled
City:	Hobart, IN	Year Renewed:	
Location:	Other	Tape/Media #:	
Purpose:	Not Known	Dia/Height:	12"
Use:	Sanitary	Material:	VCP
Drain Area:	NA	Lining:	
Category:	NA		
Comment:

Location Details:		Direction of Survey:	Upstream
US MH:	M-803-013	DS MH:	M-903-032
		Total Length Surveyed (ft):	69.1

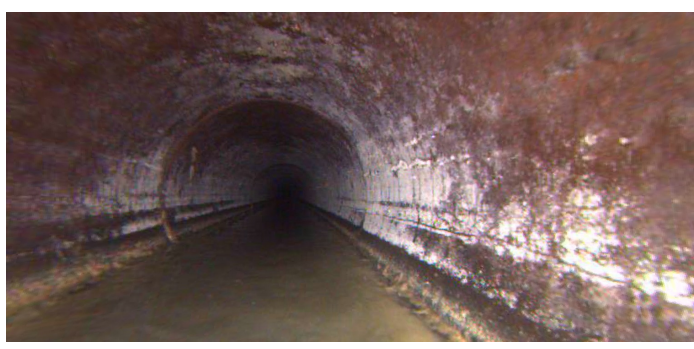
Code: **AMH**
Description: **Manhole**

Distance (ft): **.0**
Structural Grade: **0**
O&M Grade: **0**
Clock Start/From:
Clock To:
1st Value:
2nd Value:
Value Percent:
Continuous Index:
Within 8" of Joint: **NO**
Remarks: **M-903-032**

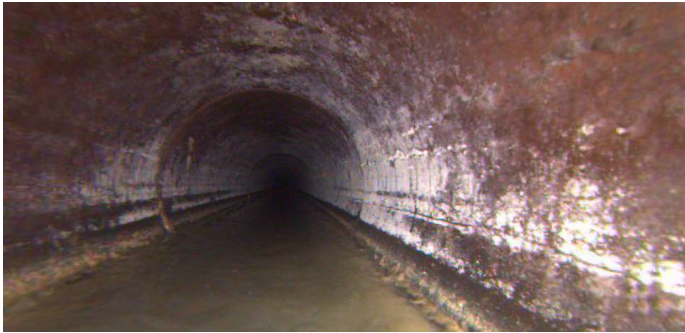
Code: **MWL**
Description: **Water Level**

Distance (ft): **.0**
Structural Grade: **0**
O&M Grade: **0**
Clock Start/From:
Clock To:
1st Value:
2nd Value:
Value Percent: **20.000**
Continuous Index:
Within 8" of Joint: **NO**
Remarks:

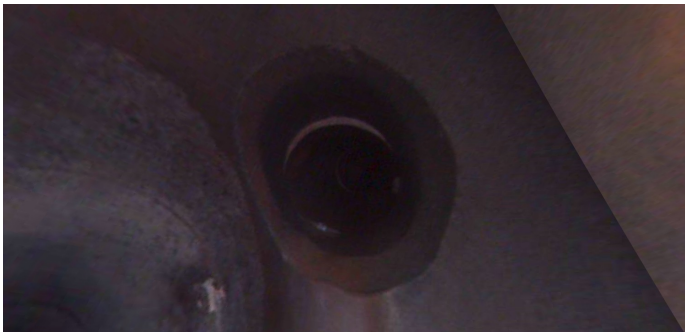
Code: **TF**
Description: **Tap Factory**

Distance (ft): **54.4**
Structural Grade: **0**
O&M Grade: **0**
Clock Start/From: **10**
Clock To:
1st Value: **4.000**
2nd Value:
Value Percent:
Continuous Index:
Within 8" of Joint:
Remarks:

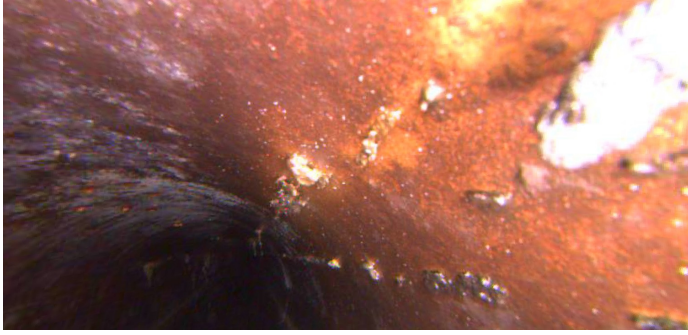
Code:	MSA
Description:	Abandoned Survey
Distance (ft):	69.1
Structural Grade:	0
O&M Grade:	0
Clock Start/From:	
Clock To:	
1st Value:	
2nd Value:	
Value Percent:	
Continuous Index:	
Within 8" of Joint:	NO
Remarks:	DEBRIS UNDER WATER
