Profile/Photo Observation Report

Date:	10/04/2018	Weather:		Coding:	PACP 6.0
Pipe Length (ft):	225.0	Owner:	NA	Pre Clean:	Not Known
P.O.#:		Surveyor:	Justin Gonzales	PSR:	P-903-032-013
Customer:		Clean Date:	01/01/1900	Shape:	C

Street:	Hobart Rd.	Flow Control:	Not Controlled
City:	Hobart, IN	Year Renewed:	
Location:	Light Highway	Tape/Media #:	
Purpose:	Routine Assessment	Dia/Height:	12"
Use:	Sanitary	Material:	VCP
Drain Area:	NA	Lining:	
Category:	NA		
Comment:

Location Details:		Direction of Survey:	Upstream
US MH:	M-803-013	DS MH:	M-903-032
		Total Length Surveyed (ft):	221.2

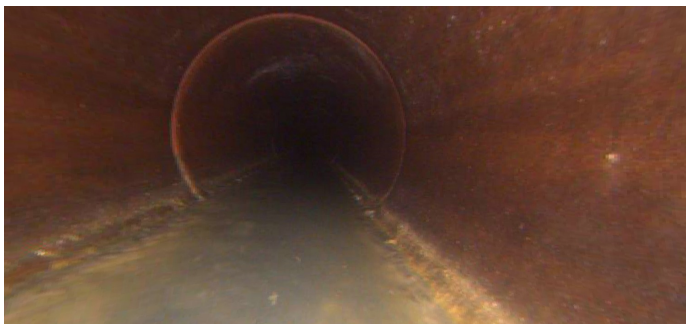
Code: **AMH**
Description: **Manhole**

Distance (ft): **.0**
Structural Grade: **0**
O&M Grade: **0**
Clock Start/From:
Clock To:
1st Value:
2nd Value:
Value Percent:
Continuous Index:
Within 8" of Joint: **NO**
Remarks: **M-903-032**

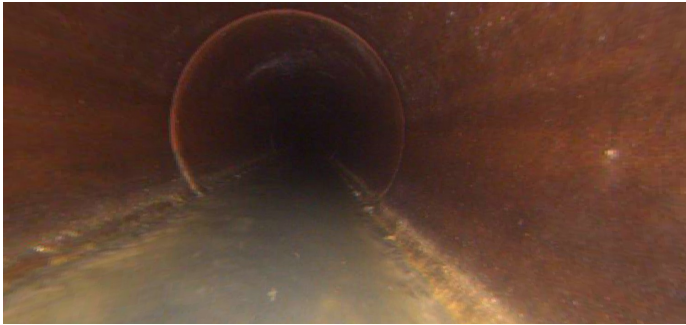
Code: **MWL**
Description: **Water Level**

Distance (ft): **.0**
Structural Grade: **0**
O&M Grade: **0**
Clock Start/From:
Clock To:
1st Value:
2nd Value:
Value Percent: **10.000**
Continuous Index:
Within 8" of Joint: **NO**
Remarks:

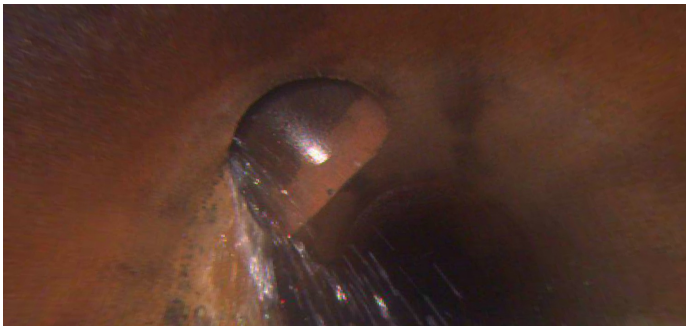
Code: **TFA**
Description: **Tap Factory Active**

Distance (ft): **53.6**
Structural Grade: **0**
O&M Grade: **0**
Clock Start/From: **10**
Clock To:
1st Value: **4.000**
2nd Value:
Value Percent:
Continuous Index:
Within 8" of Joint:
Remarks:

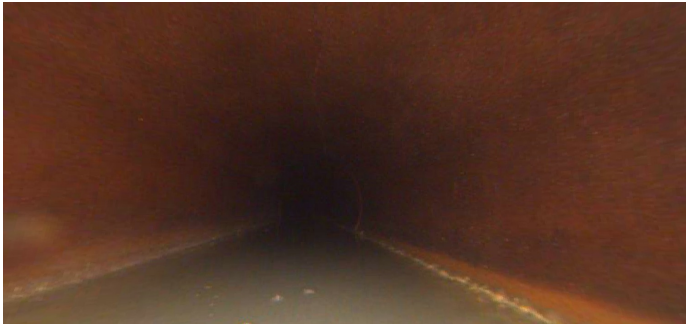
Code: **CL**
Description: **Crack Longitudinal**

Distance (ft): **139.0**
Structural Grade: **2**
O&M Grade: **0**
Clock Start/From: **1**
Clock To:
1st Value:
2nd Value:
Value Percent:
Continuous Index:
Within 8" of Joint: **YES**
Remarks:

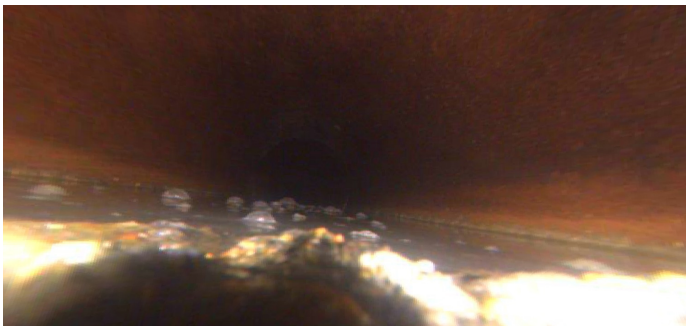
Code: **MWLS**
Description: **Water Level Sag**

Distance (ft): **147.6**
Structural Grade: **3**
O&M Grade: **3**
Clock Start/From:
Clock To:
1st Value:
2nd Value:
Value Percent: **40.000**
Continuous Index:
Within 8" of Joint: **NO**
Remarks:

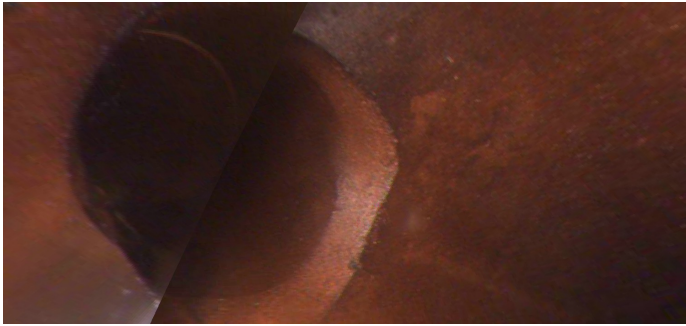
Code: **TF**
Description: **Tap Factory**

Distance (ft): **166.1**
Structural Grade: **0**
O&M Grade: **0**
Clock Start/From: **10**
Clock To:
1st Value: **4.000**
2nd Value:
Value Percent:
Continuous Index:
Within 8" of Joint:
Remarks:

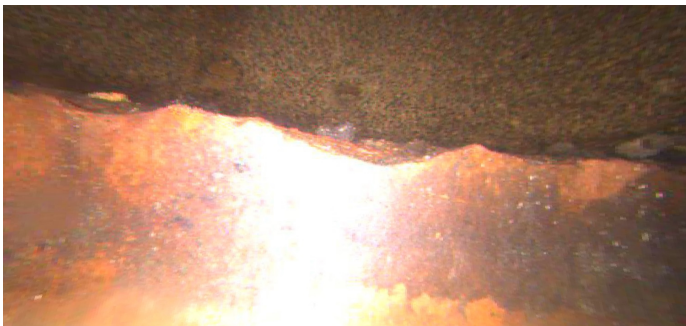
Code: **AMH**
Description: **Manhole**

Distance (ft): **221.2**
Structural Grade: **0**
O&M Grade: **0**
Clock Start/From:
Clock To:
1st Value:
2nd Value:
Value Percent:
Continuous Index:
Within 8" of Joint: **NO**
Remarks: **M-803-013**
