## Profile/Photo Observation Report

Street:	<b>E NORTH ST</b>	Flow Control:	<b>Not Controlled</b>
City:	<b>Hobart, IN</b>	Year Renewed:	
Location:	<b>Other</b>	Tape/Media #:	
Purpose:	<b>Not Known</b>	Dia/Height:	<b>10"</b>
Use:	<b>Sanitary</b>	Material:	<b>VCP</b>
Drain Area:	<b>NA</b>	Lining:	
Category:	<b>NA</b>		
Comment:

Location Details:		Direction of Survey:	<b>Downstream</b>
US MH:	<b>M-803-014</b>	DS MH:	<b>M-803-015</b>
		Total Length Surveyed (ft):	<b>160.4</b>

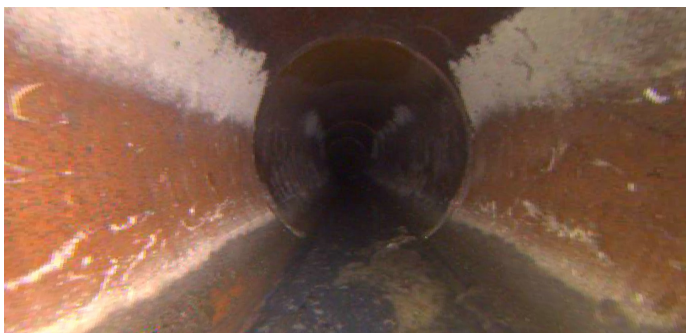
Code: **AMH**  
Description: **Manhole**

Distance (ft): **.0**  
Structural Grade: **0**  
O&M Grade: **0**  
Clock Start/From:  
Clock To:  
1st Value:  
2nd Value:  
Value Percent:  
Continuous Index:  
Within 8" of Joint: **NO**  
Remarks: **M-803-014**

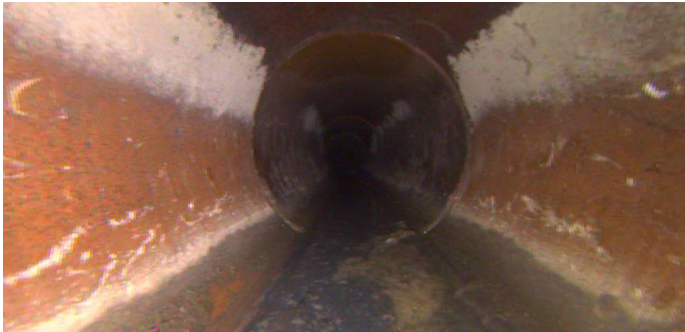
Code:	<b>MWL</b>
Description:	<b>Water Level</b>

Distance (ft):	<b>.0</b>
Structural Grade:	<b>0</b>
O&M Grade:	<b>0</b>
Clock Start/From:	
Clock To:	
1st Value:	
2nd Value:	
Value Percent:	<b>5.000</b>
Continuous Index:	
Within 8" of Joint:	<b>NO</b>
Remarks:

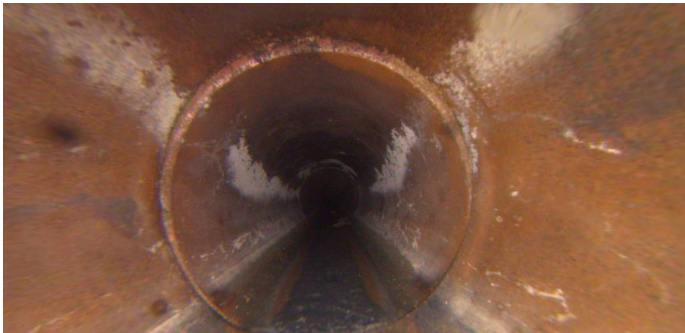
Code:	<b>CM</b>
Description:	<b>Crack Multiple</b>

Distance (ft):	<b>4.7</b>
Structural Grade:	<b>3</b>
O&M Grade:	<b>0</b>
Clock Start/From:	<b>8</b>
Clock To:	<b>4</b>
1st Value:	
2nd Value:	
Value Percent:	
Continuous Index:	<b>S01</b>
Within 8" of Joint:	<b>YES</b>
Remarks:

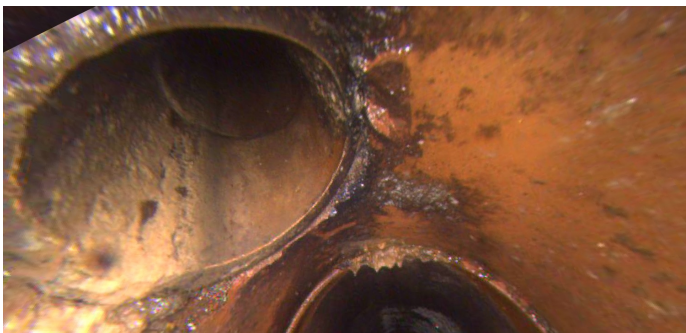
Code: **TBI**  
Description: **Tap Break-in Intruding**

Distance (ft): **48.9**  
Structural Grade: **0**  
O&M Grade: **2**  
Clock Start/From: **11**  
Clock To:  
1st Value: **4.000**  
2nd Value: **1.000**  
Value Percent:  
Continuous Index:  
Within 8" of Joint:  
Remarks:

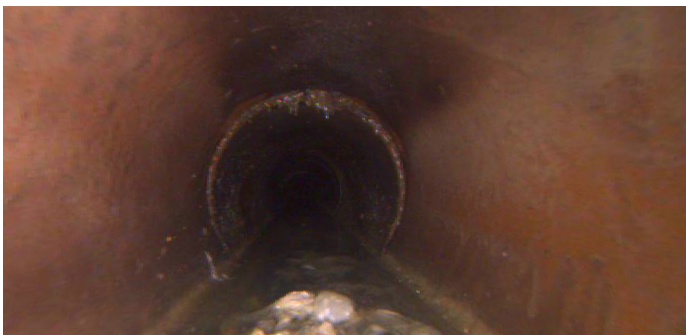
Code: **RFJ**  
Description: **Roots Fine Joint**

Distance (ft): **54.3**  
Structural Grade: **0**  
O&M Grade: **1**  
Clock Start/From: **10**  
Clock To: **2**  
1st Value:  
2nd Value:  
Value Percent:  
Continuous Index:  
Within 8" of Joint: **YES**  
Remarks:

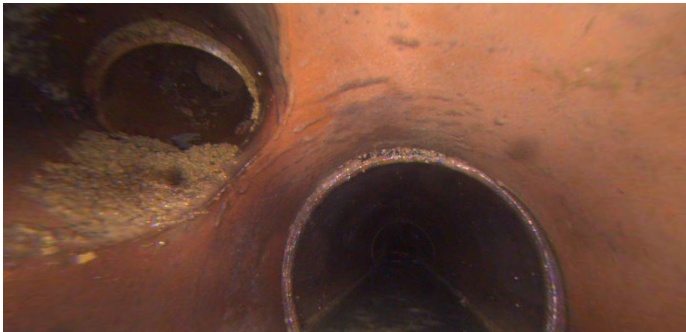
Code: **TF**  
Description: **Tap Factory**

Distance (ft): **60.8**  
Structural Grade: **0**  
O&M Grade: **0**  
Clock Start/From: **10**  
Clock To:  
1st Value: **4.000**  
2nd Value:  
Value Percent:  
Continuous Index:  
Within 8" of Joint:  
Remarks:

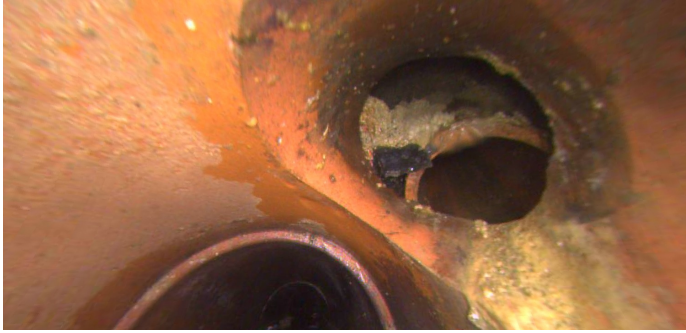
Code: **TF**  
Description: **Tap Factory**

Distance (ft): **78.8**  
Structural Grade: **0**  
O&M Grade: **0**  
Clock Start/From: **2**  
Clock To:  
1st Value: **4.000**  
2nd Value:  
Value Percent:  
Continuous Index:  
Within 8" of Joint:  
Remarks:

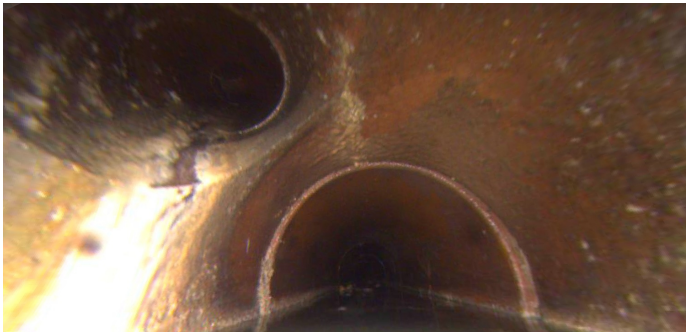
Code: **TF**  
Description: **Tap Factory**

Distance (ft): **87.7**  
Structural Grade: **0**  
O&M Grade: **0**  
Clock Start/From: **10**  
Clock To:  
1st Value: **4.000**  
2nd Value:  
Value Percent:  
Continuous Index:  
Within 8" of Joint:  
Remarks:

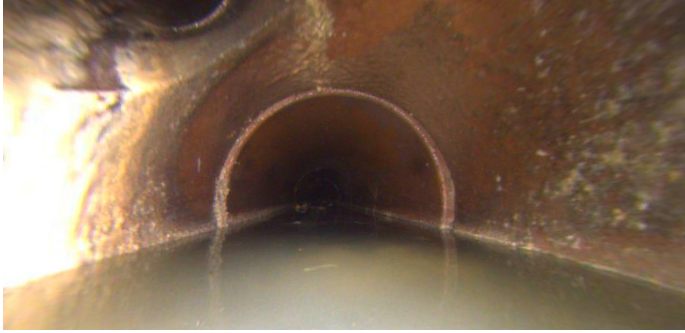
Code: **MWL**  
Description: **Water Level**

Distance (ft): **87.7**  
Structural Grade: **0**  
O&M Grade: **0**  
Clock Start/From:  
Clock To:  
1st Value:  
2nd Value:  
Value Percent: **40.000**  
Continuous Index:  
Within 8" of Joint: **NO**  
Remarks:

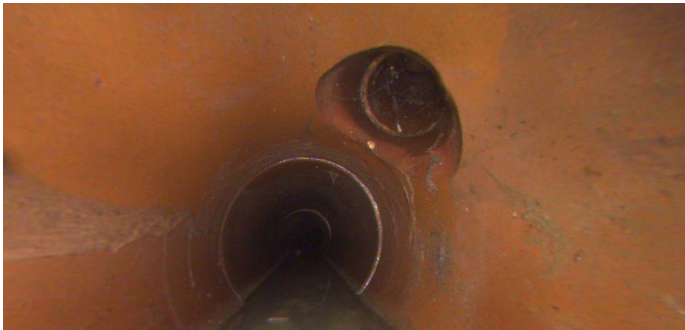
Code: **TF**  
Description: **Tap Factory**

Distance (ft): **108.1**  
Structural Grade: **0**  
O&M Grade: **0**  
Clock Start/From: **2**  
Clock To:  
1st Value: **4.000**  
2nd Value:  
Value Percent:  
Continuous Index:  
Within 8" of Joint:  
Remarks:

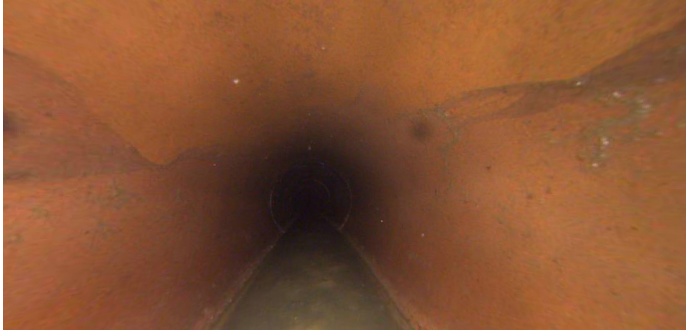
Code: **MWL**  
Description: **Water Level**

Distance (ft): **121.8**  
Structural Grade: **0**  
O&M Grade: **0**  
Clock Start/From:  
Clock To:  
1st Value:  
2nd Value:  
Value Percent: **5.000**  
Continuous Index:  
Within 8" of Joint: **NO**  
Remarks:

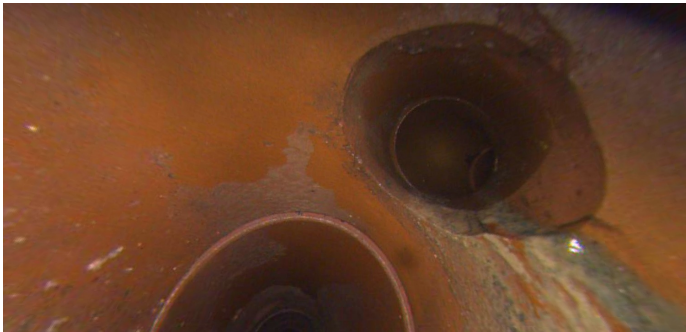
Code: **TF**  
Description: **Tap Factory**

Distance (ft): **138.5**  
Structural Grade: **0**  
O&M Grade: **0**  
Clock Start/From: **1**  
Clock To:  
1st Value: **4.000**  
2nd Value:  
Value Percent:  
Continuous Index:  
Within 8" of Joint:  
Remarks:

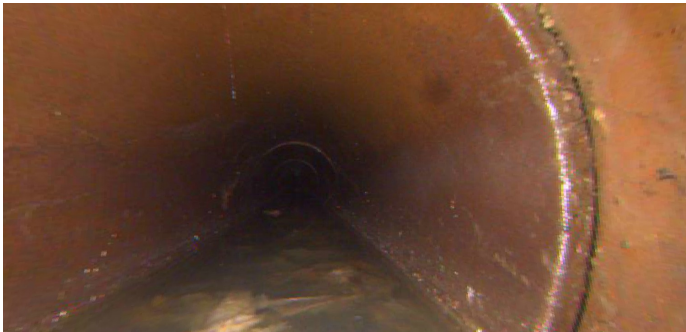
Code: **MSA**  
Description: **Abandoned Survey**

Distance (ft): **160.4**  
Structural Grade: **0**  
O&M Grade: **0**  
Clock Start/From:  
Clock To:  
1st Value:  
2nd Value:  
Value Percent:  
Continuous Index:  
Within 8" of Joint: **NO**  
Remarks: **debris**
